# Scriver Block Exterior Investigation Northfield, MN

Prepared for the  
Northfield Historical Society

Submitted June 2, 2023

PREPARED BY  
**MACDONALD & MACK**  
ARCHITECTS

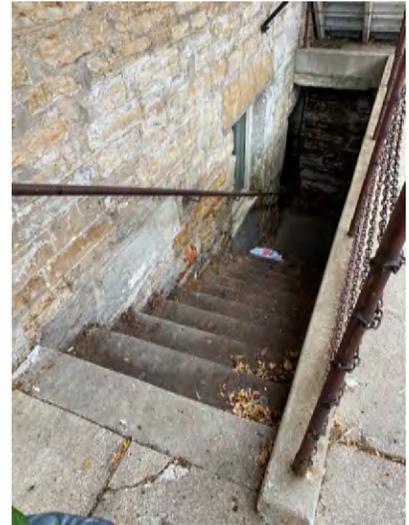
4. Stairwell

On the northeast corner of the building there is a basement stairwell that is accessed from the sidewalk along Division Street. At the base of these stairs is an area drain. In the earliest photos of the building from 1874 the basement access did not exist. It was in the 1915 image that a railing and the steps to the basement appear. This corresponds with the note in the HSR that in 1895 the J. H. McGuire barber shop was first located in the basement. The area drain is not from this vintage, but may have been installed more recently, maybe in 1978, a time noted in the HSR that the Basement Meeting Room was remodeled.

- Regularly cleaning debris from the drums may help the water to flow more readily to the underlying soils.
- As noted in the 2022 condition report under Priority 2: install a sidewalk curb at the top of the stairs to redirect sidewalk runoff.
- Install a larger drywell in the same general area when the Exterior Stairwell is restored.

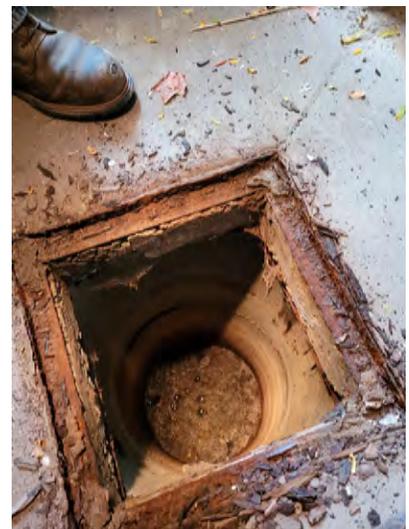
5. Area Drain

George LaRoche has come and gone and all we're dealing with is a drainage pit. It appears to be two 3' drums about 16" in diameter and coated with concrete stacked on top of one another and not sealed together. The drum/ pipe goes down about 6' into 8" of mud. It drains to the ground. No pipe connects anywhere to [drain] the water anywhere. It just holds it until it seeps into the ground. It is FAR below the city's pipes and George said he would not be surprised if the bottom was actually bedrock.

Without a connection to a more formal drainage system, the water seeps into the ground at various rates depending on the saturation and porosity of the surrounding earth and stone. Since the drums are below the level of the basement, water in the pit should not enter the building. If, on the other hand, the surrounding soil is unable to absorb the water, it can fill the drums and overflow into the area way and into the building. The location of the drums prevents any modification to flow by gravity to the City's sewer system, therefore other repairs should be considered.

The NHS has not noted water infiltration from the area drain outside the door which hopefully points to the proper functioning of the drain. However, relying on its continued function to prevent water from entering the basement is risky.

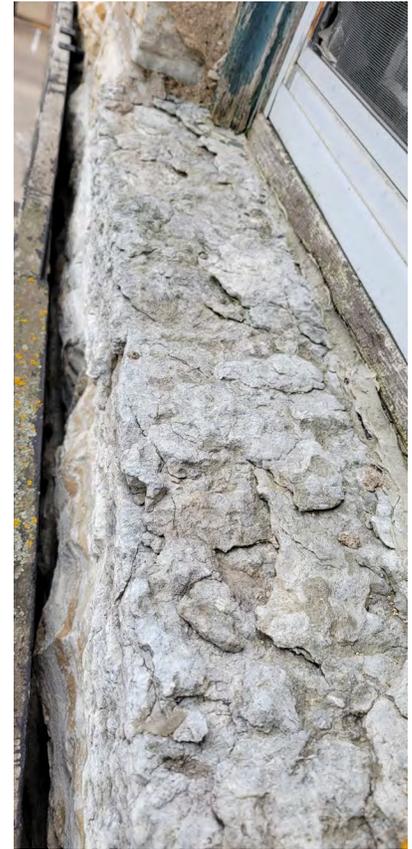
The original exterior walls are Platteville Limestone, a material with distinct layers of sedimentation. It is moderately durable as long as the layers are under compression and it is not exposed to extreme weathering, as they are at most locations on the wall. Where there is no compression, such as on windowsills, column capitals, or arch tops, the layers are easily separated by freeze-thaw action. The lack of compression is even more problematic when the layers are placed in a vertical orientation.

8. Deteriorating Windowsill

*Recommendations: The layered nature of the stone means that consolidation treatments and water-repellent coatings are ineffective, so no remedial treatments currently are available. It is wise, however, to remove flaking stone so that it does not fall in an uncontrolled manner. It also may be appropriate to add a sheet-metal cover the prevent water from sitting on the sill. Such a treatment would not be noticeable from the ground and would be easily eversible. This sheet metal would turn up on the jambs (preferably into a mortar joint) and under the sill of the window. It would be sloped to drain with a small drip edge to ensure no water stays on the metal or causes deterioration to the underlying sill.*

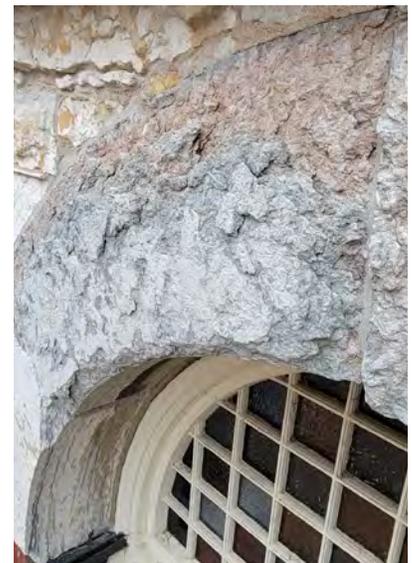
9. Deteriorating Stone with Vertical Bedding Planes

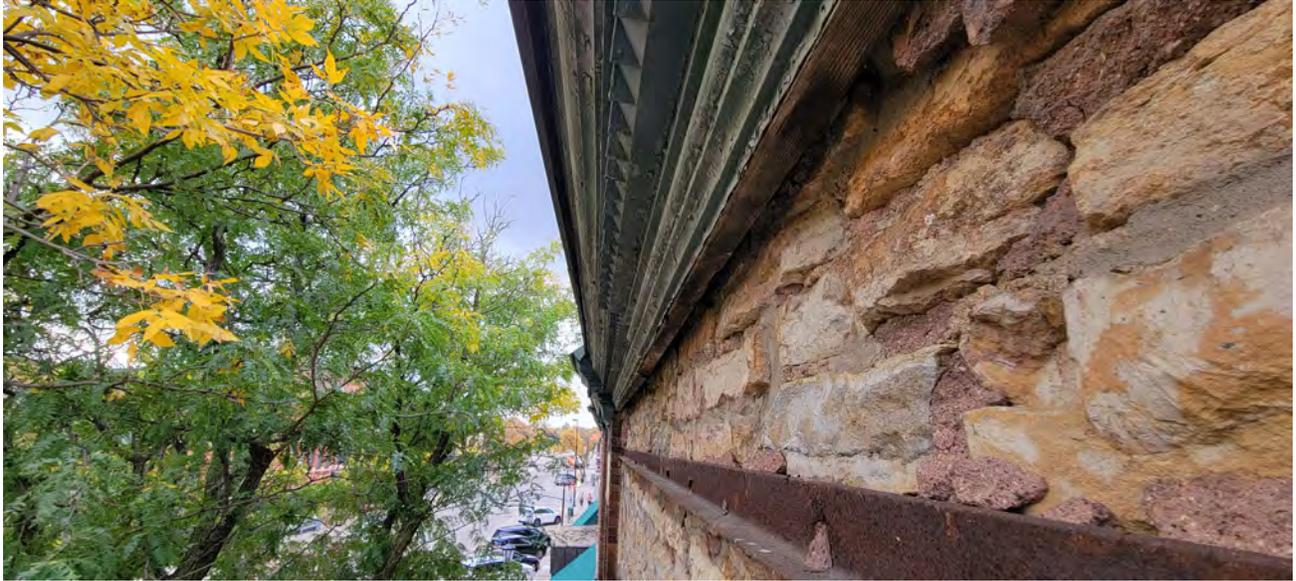
14. Cornice

and the metal cornice have been created. Because the roof configuration has changed over time, it is assumed that the cornice has been salvaged and reinstalled with a wood nailer at the bottom of the cornice. Now where the brick is missing and the rough surface of the stone is exposed, large gaps between the masonry and metal have opened up. The gap is big enough for squirrels and chipmunks to enter the void behind the cornice. Most likely they are using this area as a space for their nests.

It does not appear that water is entering the cornice at the open joints, so, at this time, it seems that the goal should be to keep the squirrels out while considering longer-term plans for the building. These plans might include returning the historic appearance to these facades. However, any potential treatment should, therefore, be easily reversible.

*Recommendations: Install a sealant backer rod in the crack then to fill the outer layer with a material such as stainless steel wool (<https://pestplug.com/>) Squirrels will not chew materials such as this, so it would keep them out while not rusting and still remaining easily removable.*

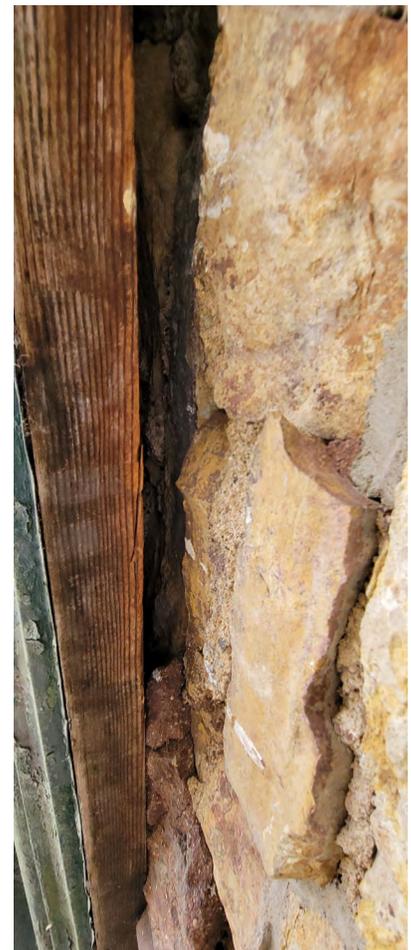
15. Cornice Gap

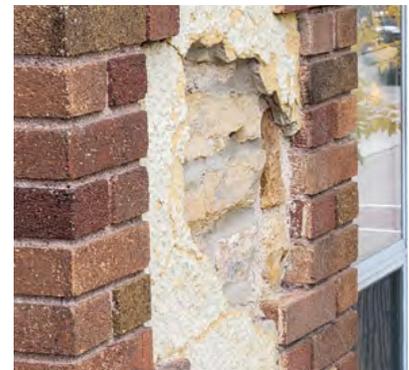
While the lower portion of these facades were restored in the 1980s, the upper portion of the buildings remain in their altered state. However, the condition of these materials is failing. Portions of the stucco and brick have fallen, and the remainder is easily removed. There are large areas of cracking in the stucco and numerous areas where water can infiltrate the stucco and dislodge it through freeze-thaw cycles. The mortar below the stucco appears to be original to the building. It is very soft, and samples were removed for further analysis; please see the Mortar Analysis section of this report.

17. Deteriorated stucco

*Recommendations: We believe now is the most economical opportunity to restore the facade. The repair of the existing materials will be expensive But these costs will only be applied to maintain or replace non-historic materials. Additionally, any future restoration will only undo the money spent to maintain this current configuration. While the restoration will be more expensive, in the long run, it will be the least money spent to achieve the goal of a restored east facade.*

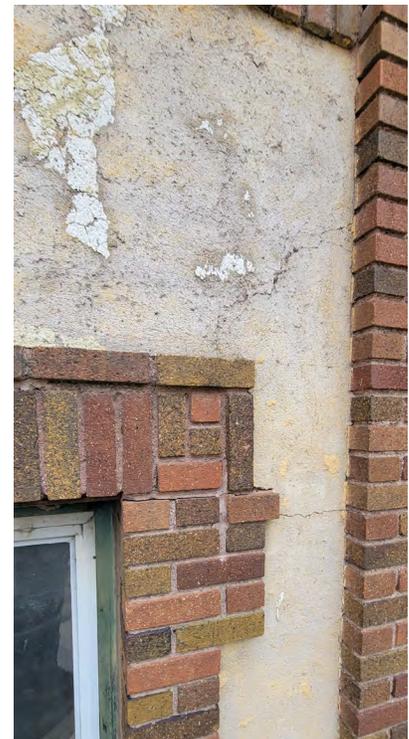
18. Cracked stucco

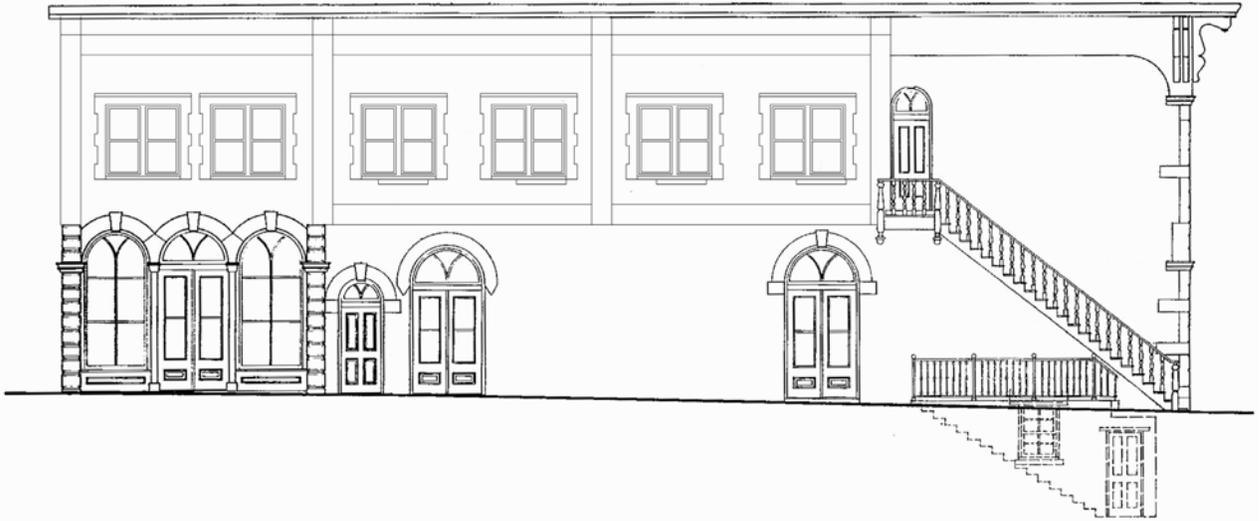
19. Current Configuration of West Elevation

As noted previously, and as seen in the photos and the HSR, the second floor of the Division Street elevation has been modified starting in the 1950s. Single arched windows trimmed in Plattleville limestone were located on the second floor rather than the paired of windows that currently exist. The decorative cornice seen on the north side of the building continued along the entire east side. Stone piers extended to the cornice and brick chimneys were placed atop the building. The restoration of these elements would follow the already restored elements

on the first floor. However, the decision to restore to this original appearance is becoming more present because the windows, brick, stucco, and surrounding materials are in poor condition and must be repaired in the next two years. Accelerated decay is creating more issues of water migrating through the exterior walls, now impacting once sound materials. One example of the condition of the restored keystones on the First National Bank Building. When we were conducting our investigation we noticed that two of the keystones had shifted due to rusting/shifted anchors. As the stucco and brick deteriorates, more and more water is able to enter the exterior walls, furthering the deterioration.

- Remove the stucco, brick, and windows
- Restore the original window openings with new stone
- Repoint stone on entire facade
- Install new arched top windows and storms
- Restore metal cornice, which necessitates the fabrication of missing elements
- The restoration of the chimneys is not a critical, as they no longer serve the individual units below.

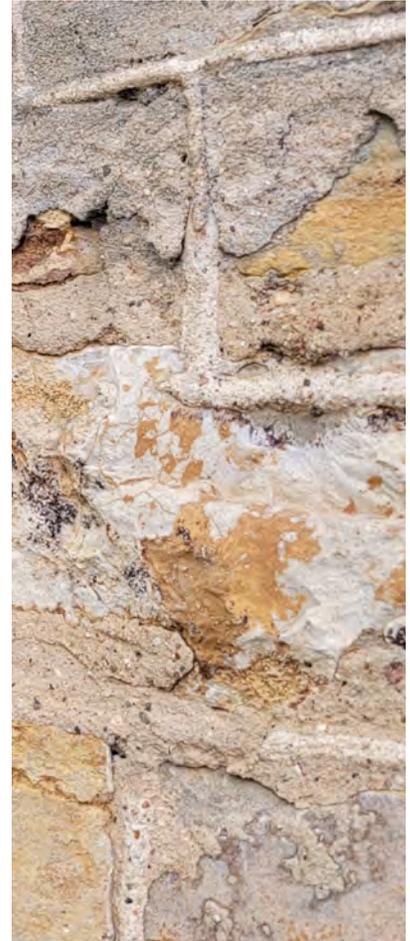
21. Existing mortar

Mortar samples were taken on both the north and east facades. These mortar samples were delivered to American Engineering Testing (AET) in St. Paul for both chemical and petrographic analysis. AET did full analysis of only Sample 2, from the unaltered portion of the east façade. The report suggests that the historic mortar has a compressive strength of approximately 1,000 pounds per square inch (psi). The analysis determined that the mortar consisted of natural cement, lime, and sand. Whether the lime was a separate ingredient, or a component of the natural cement could not be determined.

The investigations also revealed remnants of a softer lime-based mortar on the weather side of the sample. The origins of this mortar also could not be determined. If it were from an earlier repointing project there probably would have been more mortar remaining, and since it was from the unaltered portion of the east façade it is not remnants of a later stucco application.

*Recommendations: We recommend that for future restoration work NHS work with a qualified mason and a Historic Architect to oversee the work. The mortar must be softer than the underlying mortar.*

*The Natural Cement found in the original mortar is a material that is not as frequently used in contemporary restoration mortars. Before any work is to occur, the historic mason should develop samples of Natural Cement, Lime/Portland Cement, and Hydraulic Lime mortars using matching sand to develop a mixture that is less than 1000 psi, matches the color and texture of the existing mortar, but would be durable to weathering.*

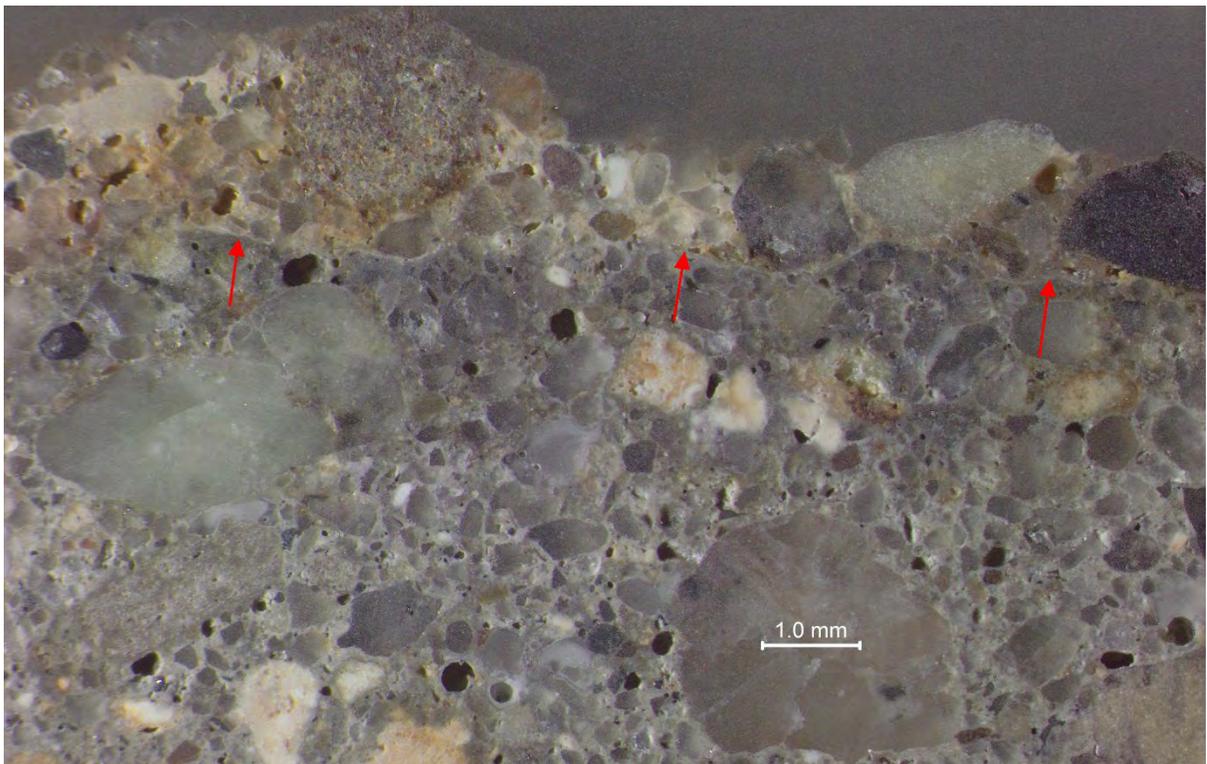
Photo: 6

3. Thin (< few millimeters) remnants of a lighter-colored and softer lime-based mortar coated the surfaces of the darker-colored natural cement mortar. The lime mortar was very soft (Mohs < 2) and very pale orange in coloration (Munsell® 10YR 8/2). The lime mortar was possibly a tuckpoint or repair material.
4. The fine aggregate in the mortar was a natural quartz, feldspar, and lithic sand. Lithic particles documented in the fine aggregate included: granite, basalt, felsite, greywacke, chert, and a few carbonates. The sand was fairly well graded with a wide range of particle sizes present in the mortar. The individual grains were mostly sub-round to sub-angular.

Description: Contact (red arrows) between darker-colored natural cement mortar (bottom) and lighter-colored lime-based mortar (top), viewed on saw cut and lapped surface of mortar sample under magnification.

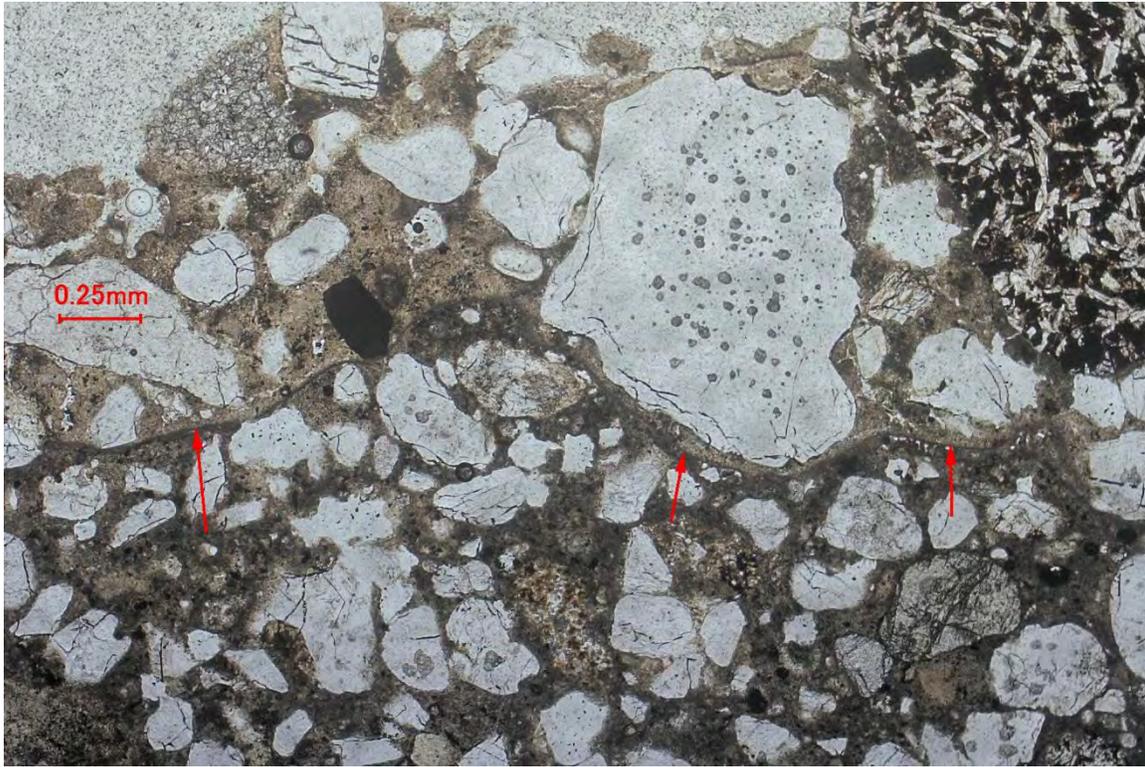
Photo: 9

Description: Contact (red arrows) between natural cement mortar (bottom) and lime-based mortar (top), viewed in thin section under transmitted plane polarized light.

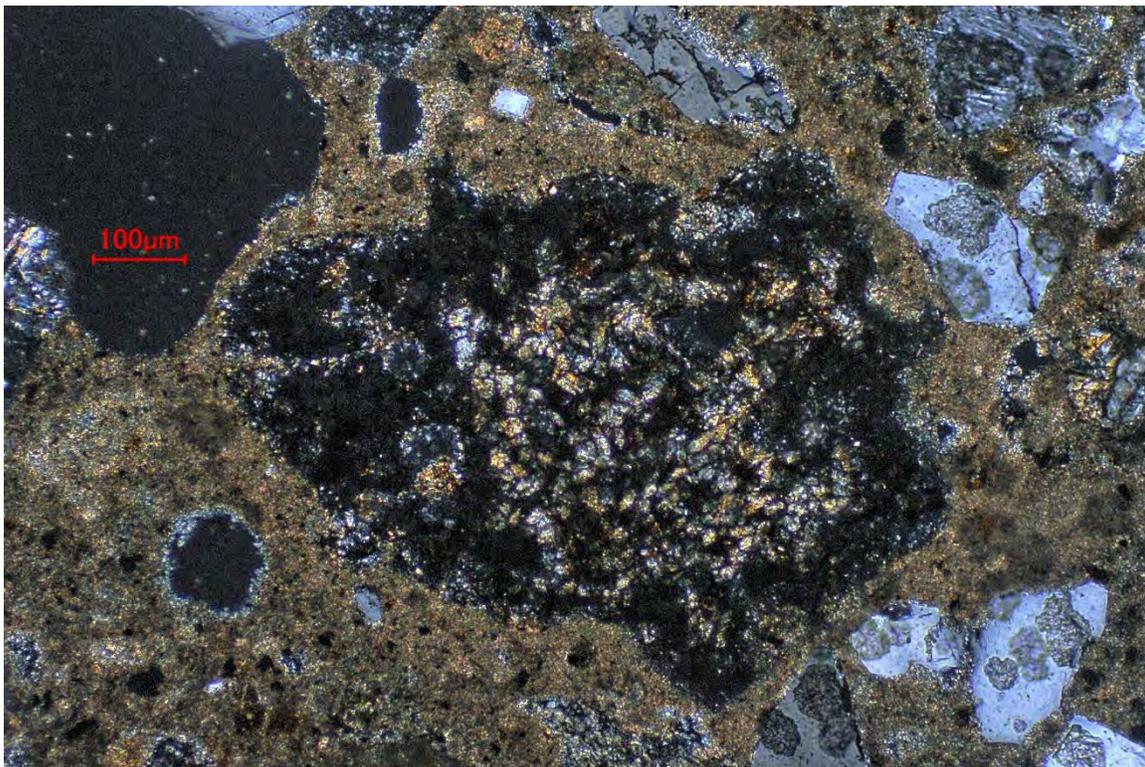
Photo: 12

Description: Same view as above under transmitted cross polarized light. Note the perimeter of the grain has hydrated (black/isotropic) while the center remains unhydrated.

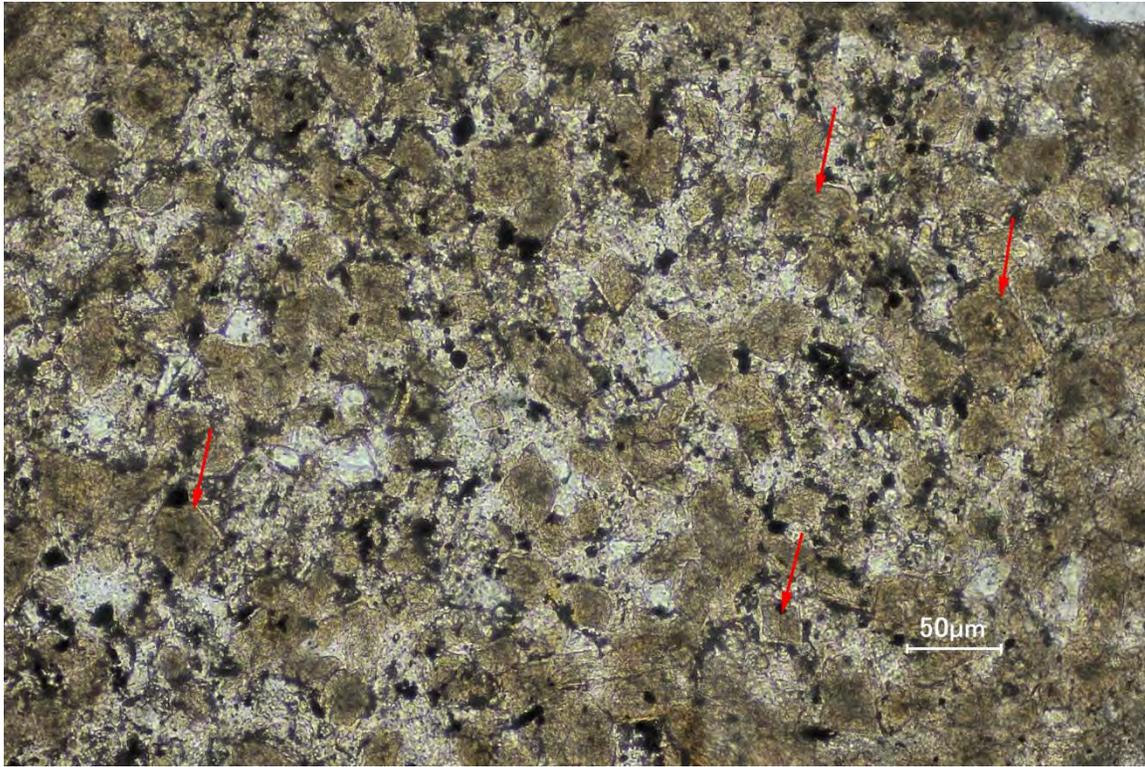
Photo: 15

Description: Relict dolomite rhombs (red arrows) within nodule of natural cement/lime viewed in thin section under transmitted plane polarized light.
