KCI Conservation - Sculpture & Object Conservators
2220 Bayard Ave. - St. Paul, MN 55116 - 612.564.3176 - kciconservation.com

TREATMENT REPORT

Object/Title: Sheldahl Anniversary Fountain

Location: Bridge Square, Northfield, MN

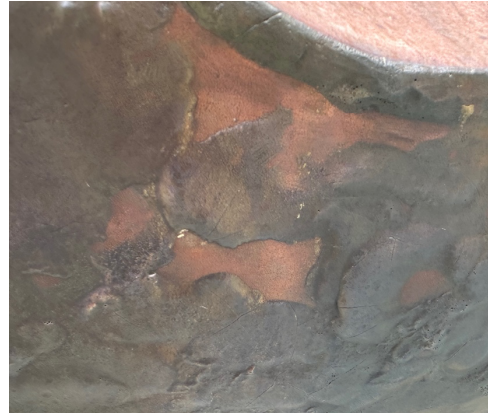
- During treatment we discovered that the fountain was made from copper sheets that had phos-copper braising rod dripped on top of them. In some areas there is no phos-copper, and this creates natural areas of red copper showing through the otherwise brown patina. See figure 1.

Figure 1. Red areas are copper under the phos-copper

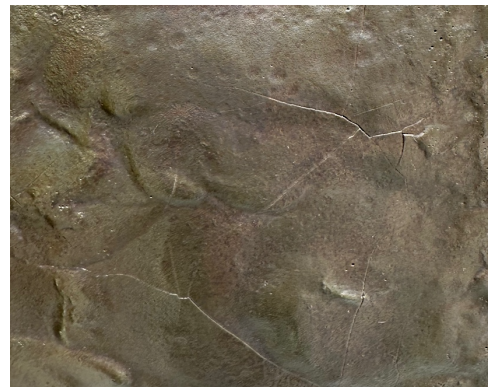
- There are hundreds of surface cracks in the phos-copper layer of the sculpture. These are original and due to the fabrication method. They are stable and not a problem but could appear alarming to someone who is not familiar with this artwork. See figure 2.
- Some of the smooth copper valleys in the sculptures have dark lines, which are original welds in the surface. The copper panels are joined with a different alloy (probably phos-copper) that cannot look the same as the copper itself. See figure 3.

Figure 2. Original cracks from fabrication

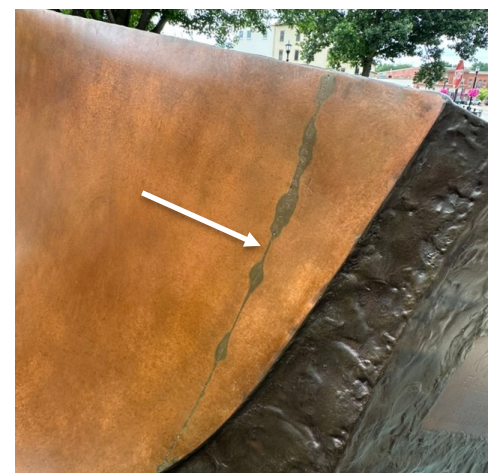
Figure 3. Visible, original weld on copper sheet
