Scriver Block Condition Assessment Northfield, MN

Prepared for the
Northfield Historical Society

Submitted January 17, 2022

PREPARED BY
MACDONALD & MACK
ARCHITECTS

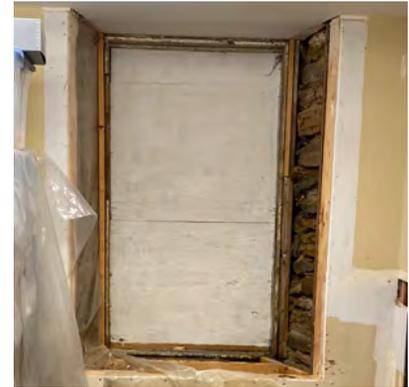
Historic documents note that the stairwell was once an open areaway with open metal stairs accessing the basement door and allowing light into two basement windows facing out onto the areaway. One of these windows partially remains visible on the exterior and is covered over on the interior. The second window was fully enclosed when the areaway was infilled to install the concrete stairs. The opening is covered over but still visible on the interior. This haphazard construction of stairs and infill has allowed for significant water infiltration issues to persist. Now, the interior wall of the North Collections Room in the basement is seeing ongoing and significant areas of deterioration through the wall impacting the interior finishes and artifacts stored in the North Collections Room. See also **Interior Moisture Issues**.

41. Infilled window opening

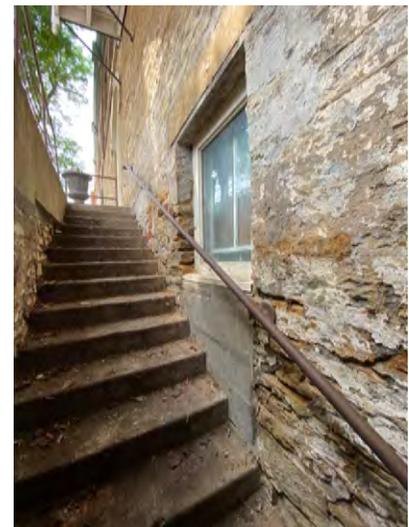
The first area of water infiltration is from the Division Street sidewalk into the Basement stairwell. While there is a functioning area drain at the bottom of the concrete steps, it is unknown where this drain empties. Storm water cascades down the concrete steps from the sidewalk, and snow/ice accumulate in the stairwell during the winter. This has significantly deteriorated the stone foundation walls and the window openings. Mortar is missing, stones are eroded, and there are gaps that extend almost 18" into the wall. One hole near the door to the basement was large enough to stick an arm through and the back of the interior construction could be seen.

43. Stone deterioration of stairwell foundation wall and infilled windows

- Remove the existing concrete stair from the Basement stairwell.
- Repair all stone/mortar deterioration on the foundation walls, especially in the stairwell.
- Inspect, televise, and ensure the basement stairwell areaway drain functions and drains to code compliant piping.
- Remove infill from the basement stairwell and install metal stairs.
- Install a curb/landing at the top of the basement stairwell to divert water away from the stair.
- Repair minor wood deterioration and peeling paint on the exterior staircase to the second floor.
- Seal around the base of the building at the Historical Society main entrance to prevent water from infiltrating the basement window wells along Bridge Square.

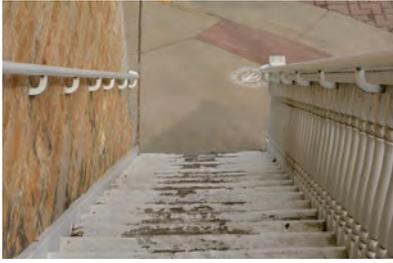
44. Stairway peeling paint

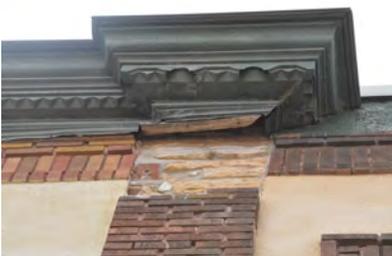
53. Pilaster cap between Scriver Block West and the Addition

- On the northeast corner Mifflin Limestone is also used as a corner pilaster. While some of the stone is cracked, it is in compression, which reduces the issues with the separating layers of the stone. At the top of the pilaster, a carved capital shows signs of heavy deterioration as water can accumulate on its horizontal projections.

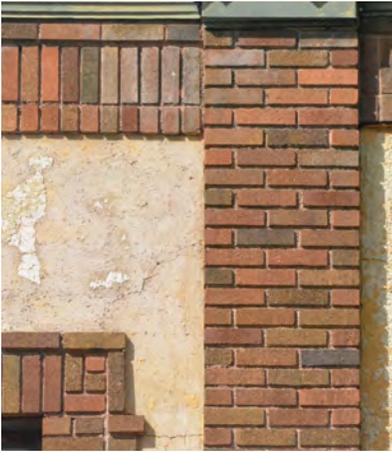
- The brick on the building is a decorative veneer around modified openings and to articulate bays on the building.
- The brick and mortar are in generally good condition.
- There is one area between Scriver Block West and the Addition where brick has fallen and continues to deteriorate below the cornice.

57. Brick

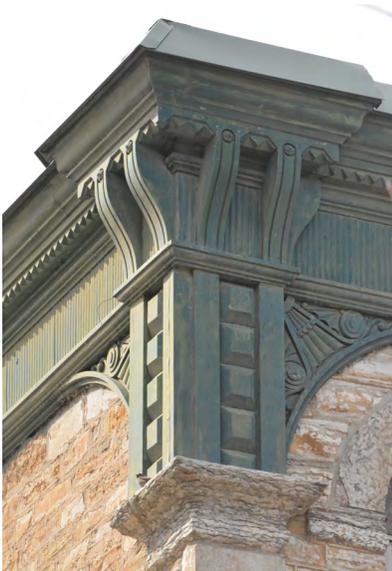
- All buildings are topped with a painted metal (assumed galvanized) cornice.
- Originally the cornice had a broad cantilevered extension, but that was removed in 1888 when a pitched roof was added to the structures. This pitched roof has been removed, and now the top of the cornice is capped with simple flashing.
- The flashing material is in good condition, with some areas of peeling paint.
- The connection of the flashing to the stone/stucco/brick walls below is of concern. It appears the flashing is lifting from the building, creating a large gap that allows squirrels to climb under and run along the cornice.

59. Metal cornice and deteriorated stone capital

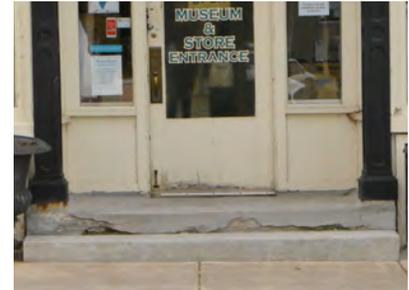
- The concrete steps at the Historical Society main entrance are chipped and broken.
- The steps have been patched, but the deterioration continues.

60. Scriver Block East concrete entrance stair

- Remove and replace concrete steps on Bridge Square entrance to Scriver Block East.

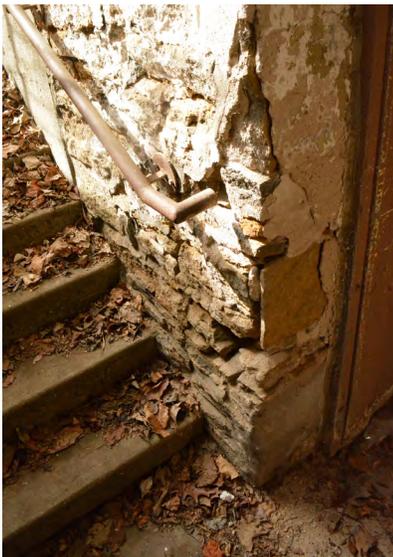
64. Basement stairwell

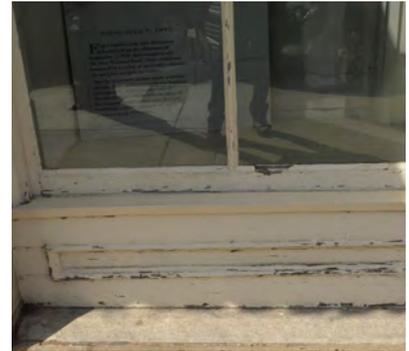
74. Paint loss on storefront windows

- Scrape, patch and epoxy wood repair, and repaint the doors and sidelight panels.
- See **Site** and **Air Infiltration/Exfiltration** for discussions of an added threshold at the 406 Division Street main entrance door that is letting water into the building and for weatherstripping.

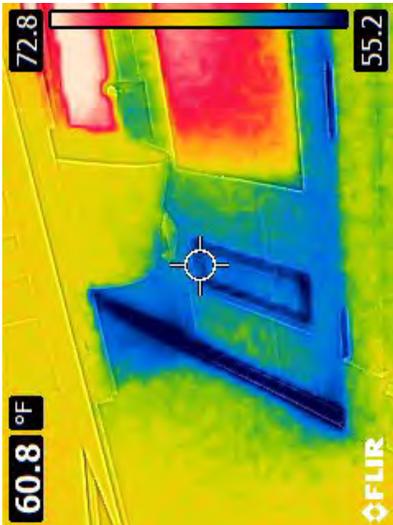
84. Thermal imaging of air infiltration at 406 Division Street entry doors

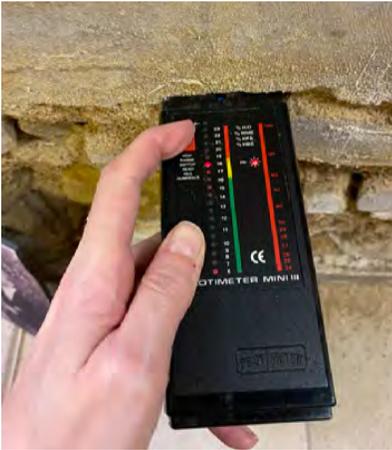
87. Above average moisture meter reading in basement

- Eliminate the water coming into the basement from outside. Please see **Site** for a more in-depth description of water infiltration solutions.
 - Work with the City of Northfield to correct exterior sidewalk drainage to direct runoff away from the building

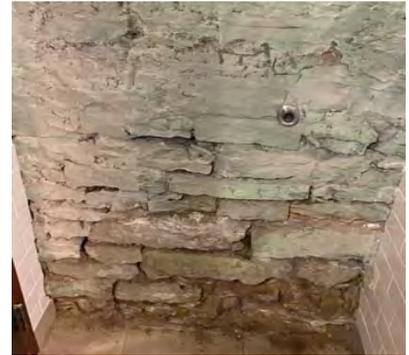
89. Basement masonry evidence of rising damp

- Address points of water infiltration into the exterior masonry walls, around door and window openings, and at the parapet. Please see **Exterior** for more in-depth descriptions of masonry repair solutions

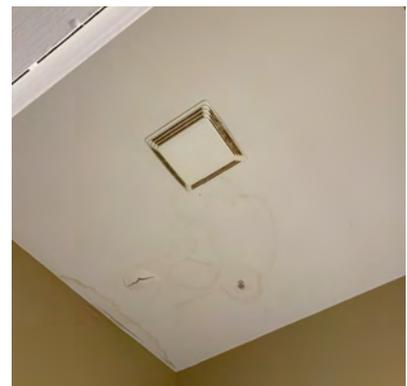
98. Second floor ceiling stains

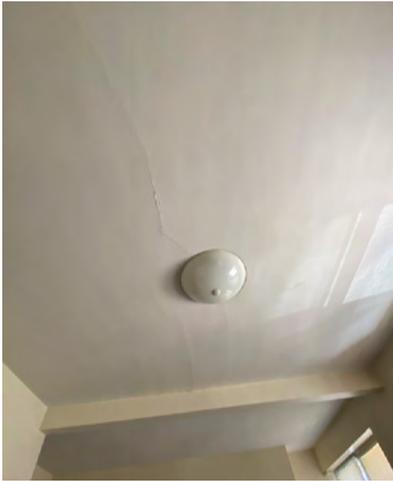
99. Plaster cracks

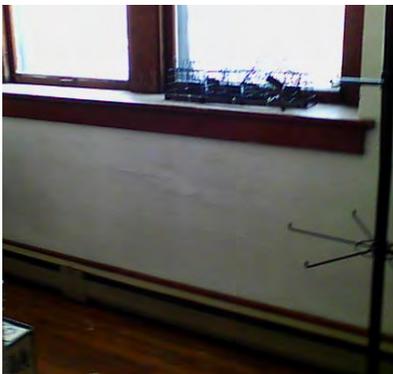
100. Blistered plaster
