Northfield Ice Arena

Facility Condition Assessment

October 31, 2016 (Updated: November 14, 2016)

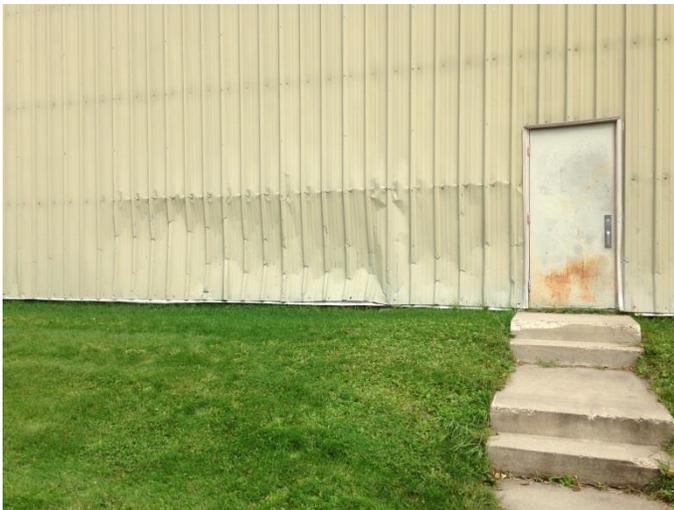
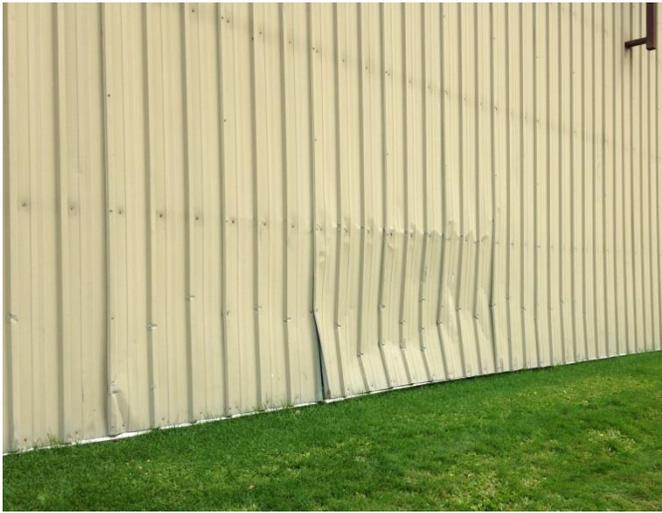
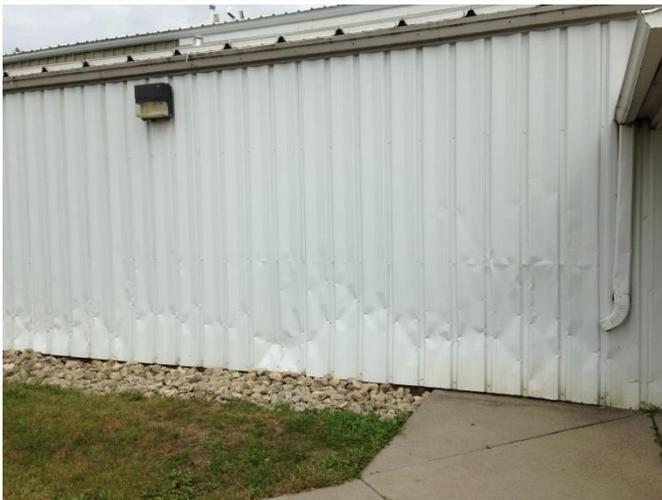
1. Dented exterior metal wall panels: the exterior metal wall panels, constructed of industry-standard "R" panels with ribs on 12" centers, are dented primarily along the west elevation of the original building and the addition, due to snow sliding off the metal roof and falling against the metal panel walls. There is also damage to miscellaneous panels around the perimeter of the building, likely cause by snow removal or mowing equipment. The dented panels are not a structural concern but are primarily an aesthetic issue. The estimated construction cost to replace the exterior metal panels along the entire west elevation is \$27,500.

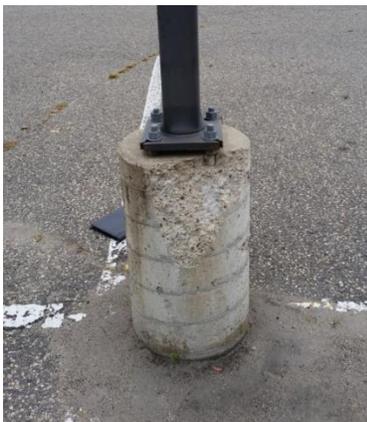
Parking lot lighting appeared to provide adequate light levels and was in good condition. It was observed that one concrete light pole base was damaged and is recommended to be replaced. The estimated construction cost to replace the light pole base is \$3,750.
