Northfield Ice Arena

Facility Condition Assessment

October 31, 2016 (Updated: November 14, 2016)

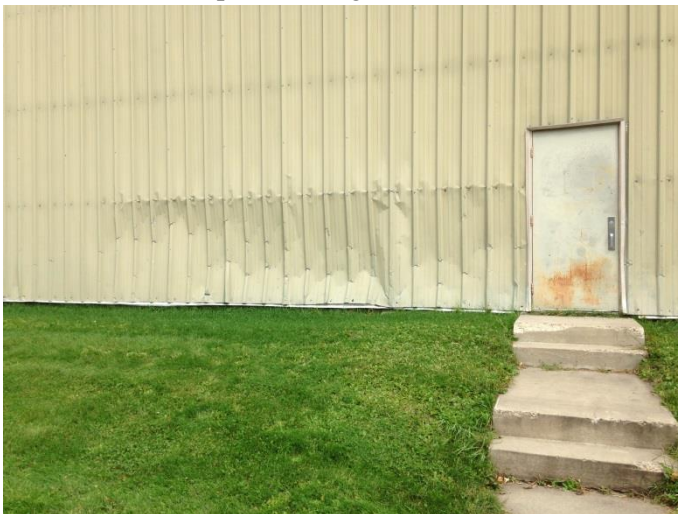
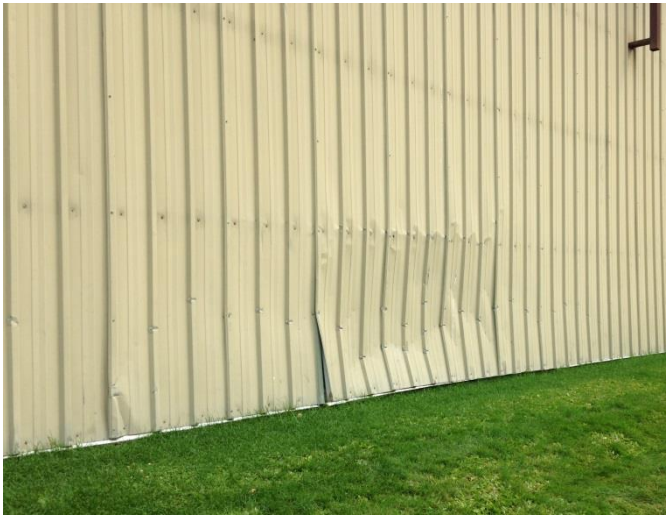
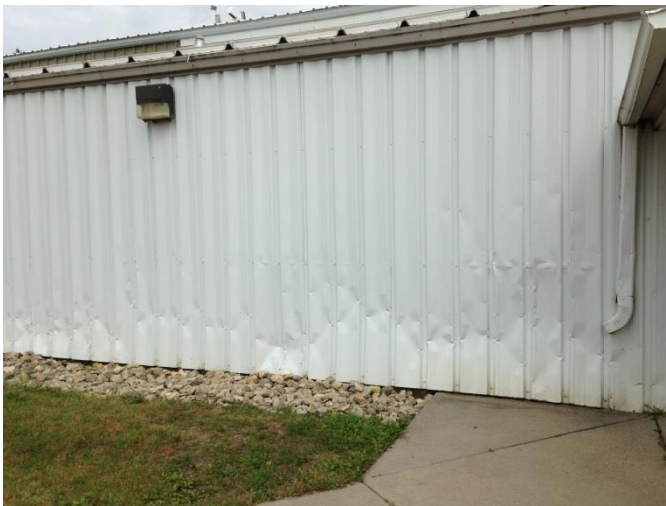
1. Dented exterior metal wall panels: the exterior metal wall panels, constructed of industry-standard “R” panels with ribs on 12” centers, are dented primarily along the west elevation of the original building and the addition, due to snow sliding off the metal roof and falling against the metal panel walls. There is also damage to miscellaneous panels around the perimeter of the building, likely cause by snow removal or mowing equipment. The dented panels are not a structural concern but are primarily an aesthetic issue. The estimated construction cost to replace the exterior metal panels along the entire west elevation is \$27,500.

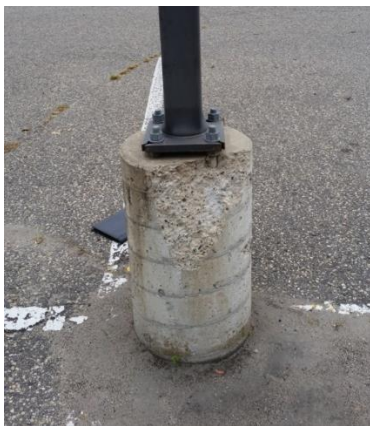
Parking lot lighting appeared to provide adequate light levels and was in good condition. It was observed that one concrete light pole base was damaged and is recommended to be replaced. The estimated construction cost to replace the light pole base is \$3,750.

Def Maint	3	23 00 00	M	Ice Refrigeration System - Replace compressors and increase electrical feeder	1	LS	\$140,000	x
Def Maint	3	26 00 00	E	Electric Service - replace original main service panel and distribution panels that are approaching the end of their useful life.	1	LS	\$125,000	x
Def Maint	2	26 00 00	E	Electrical Distribution - add 5 - 20 amp single phase circuits (to rink overhead grid and at scorer's table)	1	LS	\$10,000	x
Def Maint	2	26 00 00	E	Interior Lighting - Replace existing flourescent rink firtures with LED light fixtuers (45 thus)	1	LS	\$28,125	x
Code	0	26 00 00	E	Fire Alarm Systems - Provide fire alarm system throughout existing facility	1	LS	\$50,000	x
Code	1	26 00 00	E	Emergency Lighting -provide additional battery back-up emergency lights at spectator seating and locker room areas.	1	LS	\$7,500	x
Def Maint	3	26 00 00	E	Exterior Lighting - Replace damaged parking lot light pole base.	1	EA	\$3,750	x
