APPENDIX F

Original and Current Materials - Interior

1944 Interior Features Reversed to Pre-1944 (Period of significance: 1888 until 1944)

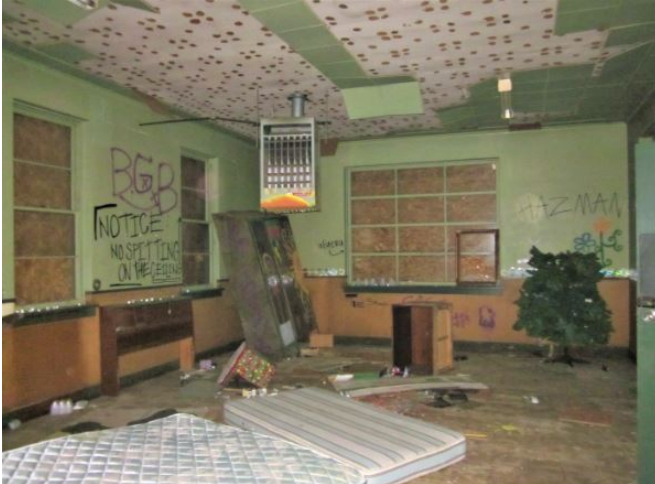
2016: Reflects 1944 changes: Ceiling lowered 2 ft.; acoustical tile used. Note also, all woodwork removed; 1” of plaster added over wood walls; windows replaced; concrete & tile added on top of wood floor.

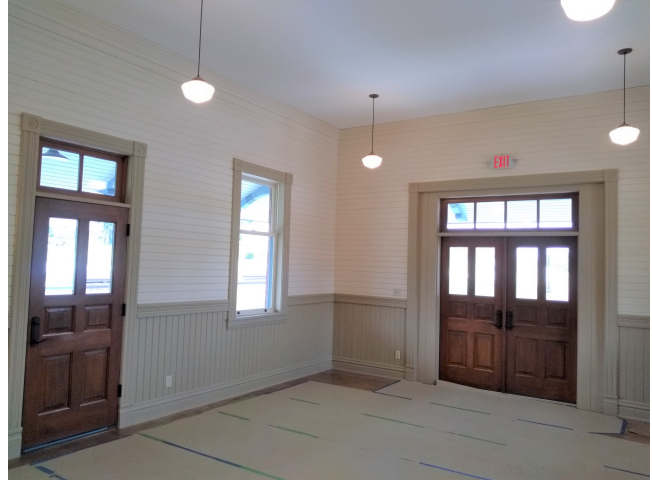
2018: Ceiling raised 2' to original position on original rafters.

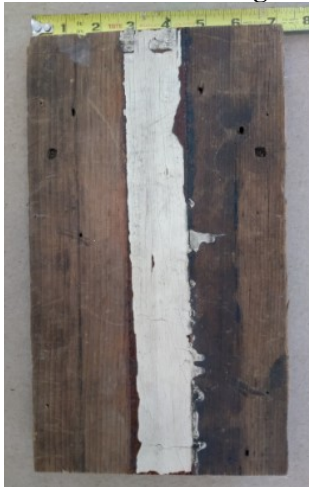
2016: Crown moulding component found in attic

Removal of the plaster revealed shadows of unpainted v-board at the top of the walls which indicated some type of a crown moulding was used originally. Stored in the rafters were long boards that were beveled on both sides (second photo above) with a painted strip down the center about 2” wide (first photo above) but unpainted strips about 1 ½ ” wide on both sides. The painted strip matched the paint color of the v-board on the original walls. When placed at a 45 degree angle at the point of the unpainted wall v-board, it fit perfectly against the restored 2019 ceiling installed on the original rafters. The board was clearly the major board for the crown moulding on which narrow 1 ½” wide moulding was nailed on both sides of the painted center strip (third photo above).

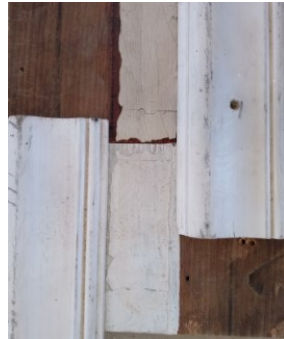
Mock up of crown moulding placing two pieces of moulding on each side of the 7” board.

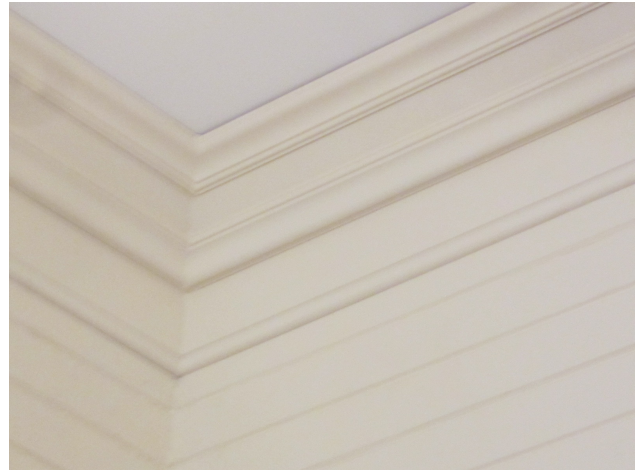
2019: New crown moulding using of same dimensions of original.

New crown moulding was installed with the same width as the main board and the two narrow side mouldings.

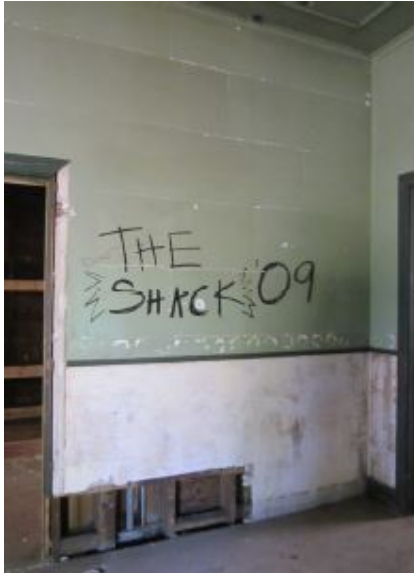
2016 (after move)

Left photo: Regularly spaced horizontal cracks appeared on the walls after the move – an indication that it was not likely to be lathe beneath.

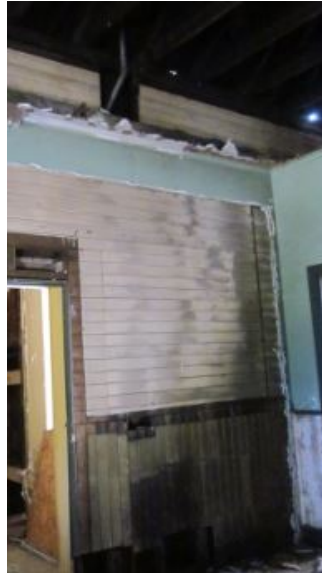
2016 (after plaster removal)

Center photo: Removal of the 1" of plaster and plaster board on all walls added in 1944 revealed the original v-board – horizontal on the upper wall and vertical on the lower wainscoting.

Note: This photo also shows the depth of the lowered ceiling, and shadows of the wainscoting trim, baseboard and crown moulding (dark shadow above lowered ceiling) providing valuable dimensions information for replacing the missing elements.

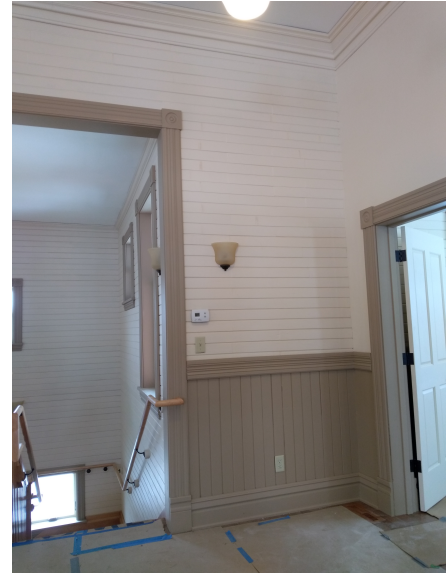
2019

Right photo: Reversals shown include original v-board, raised ceiling, crown moulding, window/door casing, wainscoting trim and baseboard.

Note: All walls of the main room and alcove consist of the original v-board, although some repairs and rearrangement of the boards was needed. The salvageable original v-boards removed from the walls of the baggage room/men's restroom (now the stairway) were used for the repairs and patching. These boards had been removed to gain access for repair of the south wall studs that had been damaged in a boiler room fire at an unknown date. Newly milled v-boards of the same width were then added to the stairway walls.

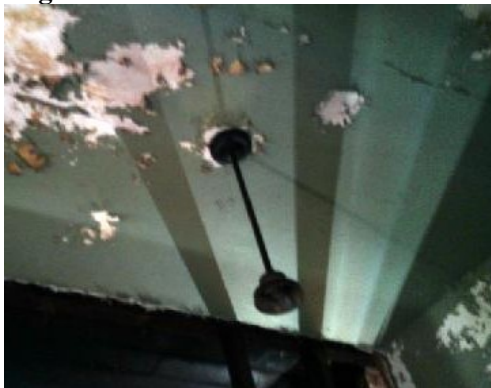
One pendant light fixture was found in the original ceiling of the baggage room area. The ceiling had never been removed and lowered, in contrast to the main room.

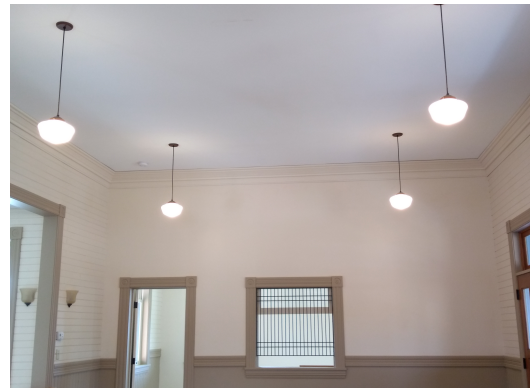
Recycled pendent light fixtures with school house style globes were installed in the main rooms and office area.

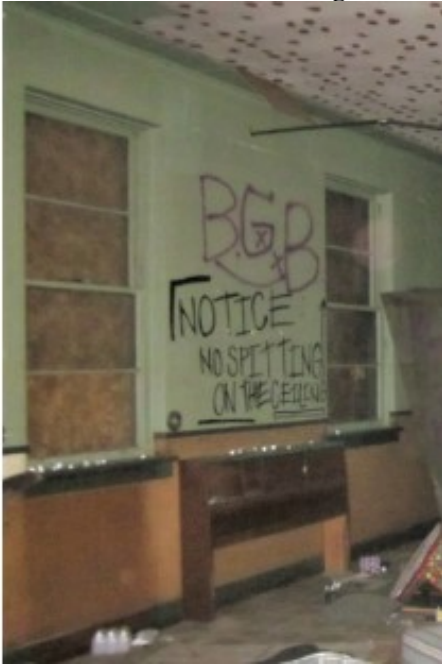
2016

Left photo: 1944 remodeling included removing all door and window casing and adding 1" of plaster and plaster board to the edge of the new window frames, covering all of the original v-board.

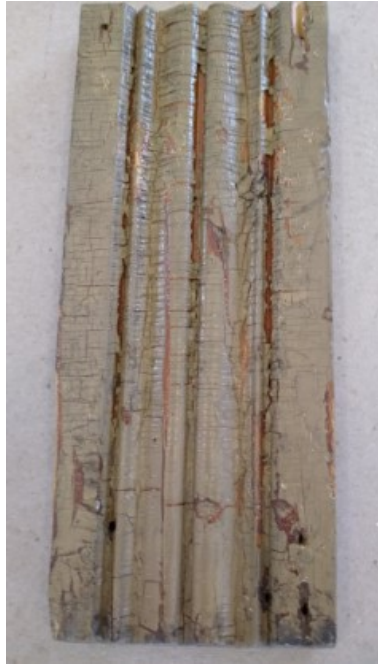
Center photo: One the boards used to suspend the 1944 ceiling; all were two foot pieces of painted window/door trim; that trim was the same width of the original trim (determined by the paint shadow on the original v-board around the windows and door openings) that had been removed for the installation of the plaster board.

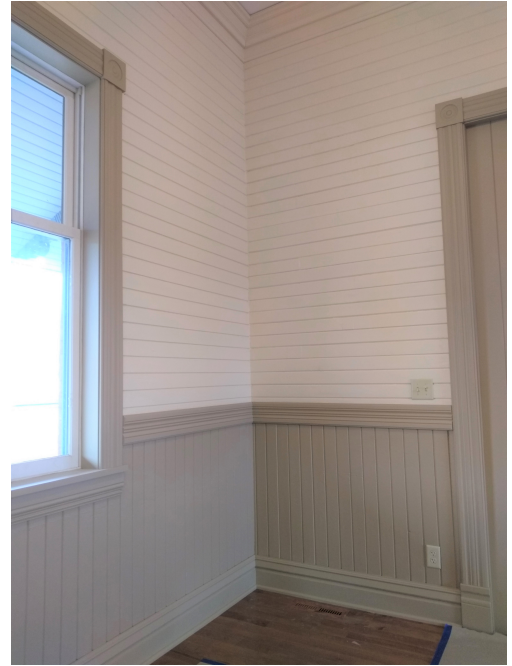
2019

Right photo: The profile of the old symmetrical casing used in the attic suspension of the 1944 ceiling was not available, but door and window casing was purchased that was symmetrical, and the same width and a similar profile as the pieces of casing found in the attic. The photo also includes the newly crafted rosettes, new cottage style windows (larger panes on bottom and smaller on top) and newly painted original v-board (see close-ups below).

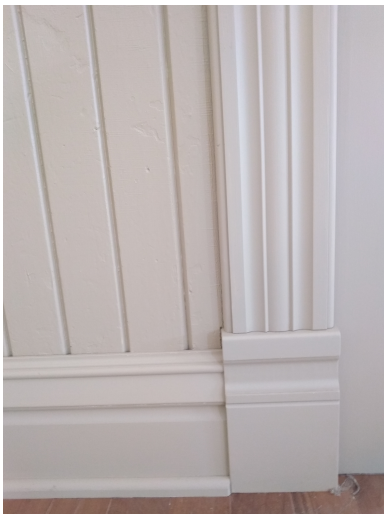
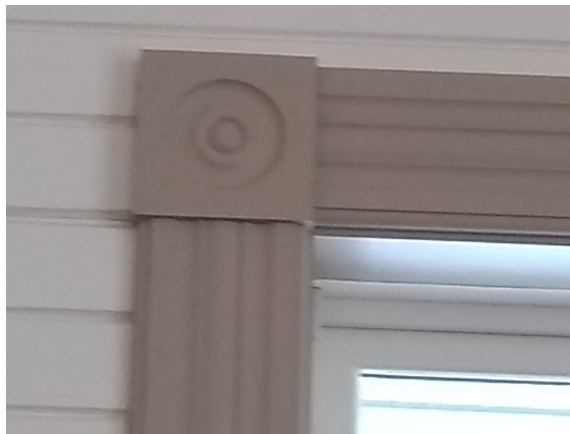
Above photos include original v-board, window and door casing, milled plinths and baseboard, and the newly crafted rosettes. Some of the elements were hand crafted because of the width needed for the casing. Fortunately, symmetrical casing of the width needed was available for purchase and being discontinued, and there was enough for the depot work. The width of all elements was consistent with the width of the shadows of the original.

As noted above, the plinths and baseboard were newly milled. All baseboards were removed in 1944; the original height was determined by the shadow on the unpainted v-board above the concrete floor. About 1 ½" was added to that shadow measurement since the 1" concrete had been laid on top of the original wood flooring and the new wood flooring was about one-half inch on top of the concrete (see milled plinth and baseboard photo above).

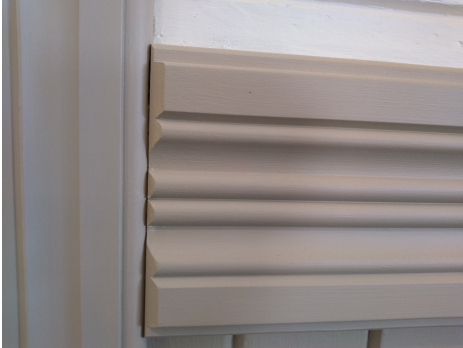
The wainscoting trim was milled to the width of the unpainted shadow found on the v-board wall. The profile used is very similar to that of the pieces of original casing found in the attic.

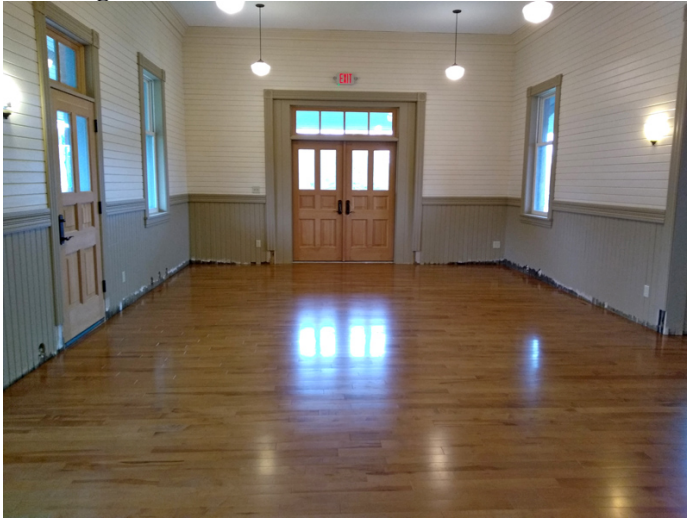
The 1888 maple flooring was covered with concrete and rubber tile in the 1944 remodeling. That work included the removal of the dividing walls around which the original flooring had likely been laid.

By the time the building was acquired, the rubber tile had disappeared and the move had resulted in no cracks in the concrete.

In the 2019 renovation, small areas of wood on the edge of the concrete was exposed and determined to be maple. Manufactured maple flooring was then installed on the stable concrete running the same direction. Doors were stained to match.

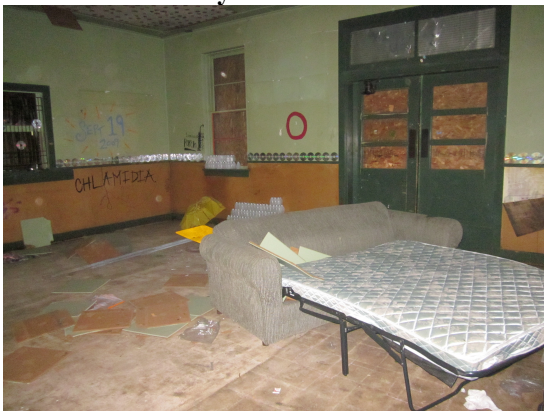
2016. 1944 remodeling converted a door into the window (left); removed the station master bay and replaced with a double door.

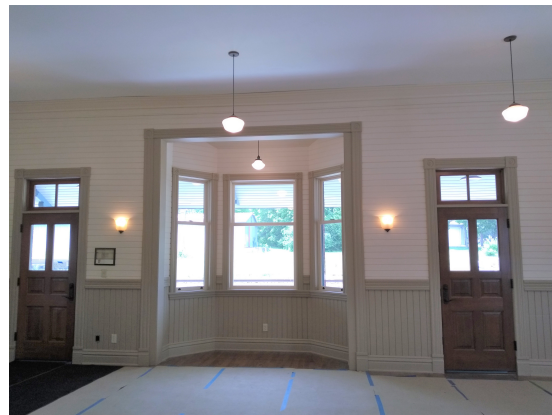
2019. Turned the two 1944 windows back into doors as in 1888; restored the 1888 station master bay and installed cottage windows.
