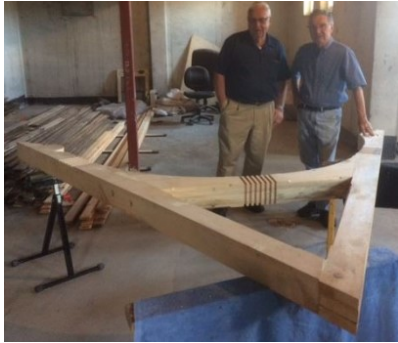
2014 Three-piece brackets crafted and assembled.

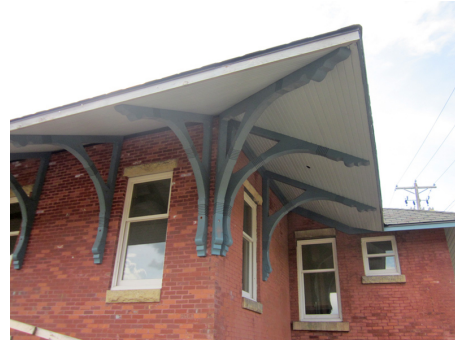
2019 Four new brackets on south(left) and two original on east (right).

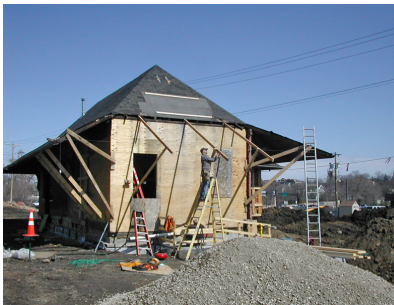
2016 South reconstructed wall

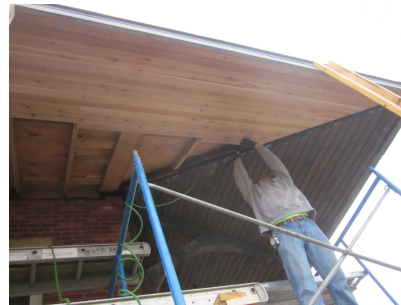
New milled v-board added.

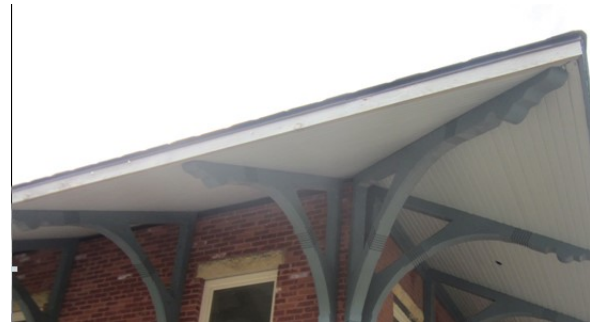
2019 New soffit on left; original on right

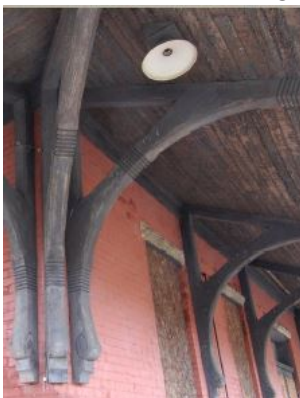
2016 A remaining light.

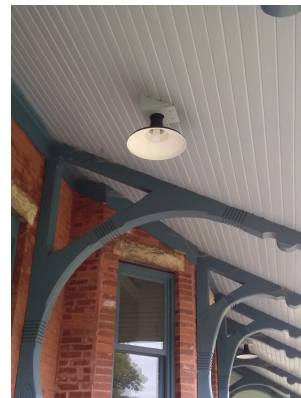
2019 One of six recycled lights installed.

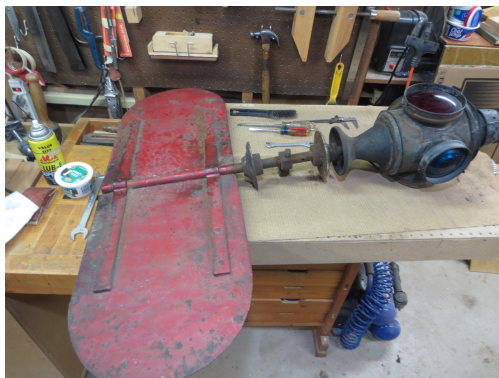
2017 Mechanism needing cleaning

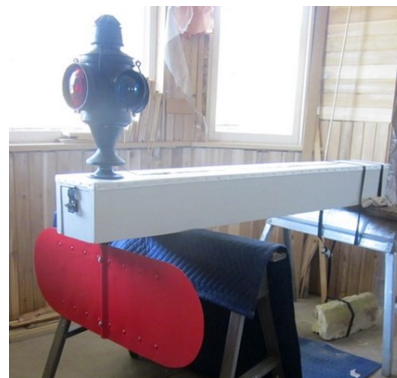
2019 Repaired (not yet mounted)

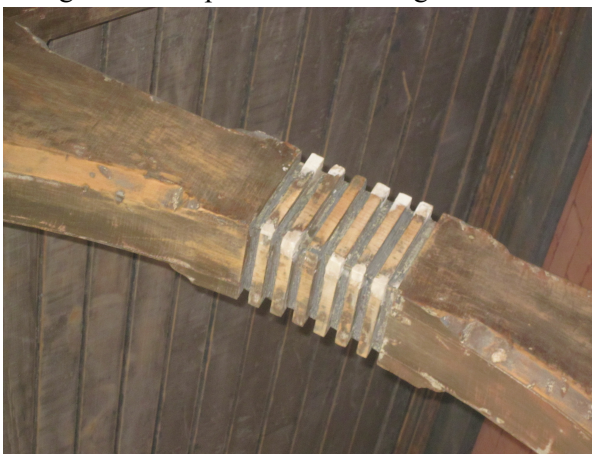
Repair: Some corners of bracket slots were missing, but repaired. Nail holes were filled. Wood in excellent condition.

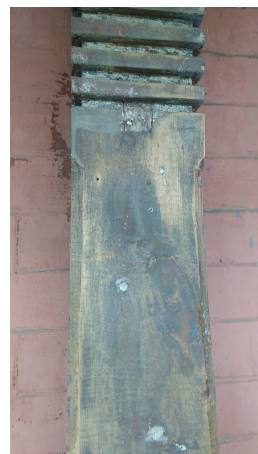
Removal of paint revealed original color.

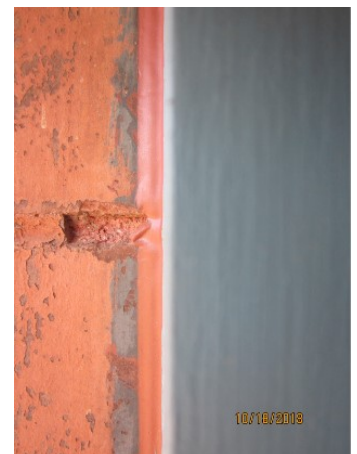
Narrow strip of paint on left, original brick. New paint on door frame is on right.

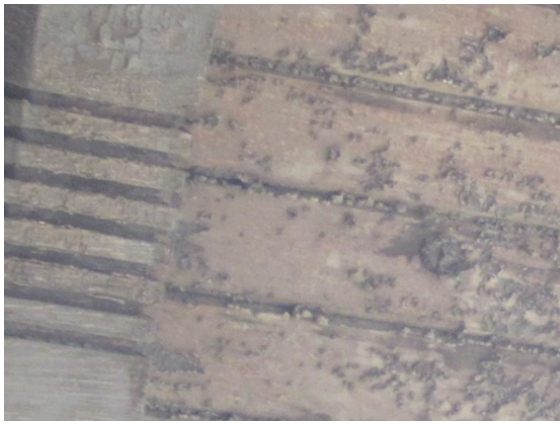
No color could be discerned on the old soffit paint crumbles in the v-board joints and board.

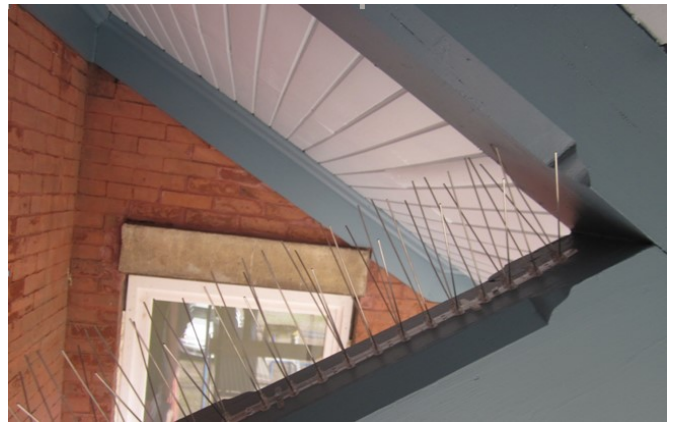
All old paint removed from original soffit v-board; painted with a very light shade of the gray-blue found under light mounting.

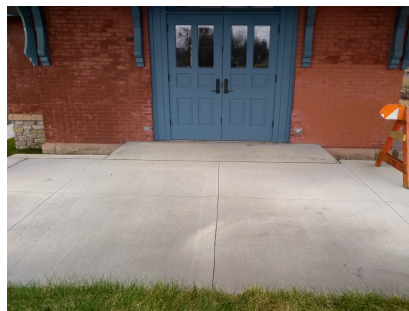
Top of water table visible in gap between platform and wall.

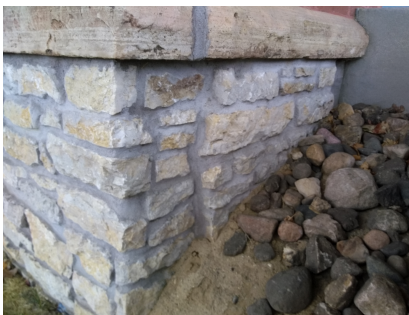
Exposed limestone in gap between wall and east side steps leading from the sidewalk to the platform. A similar gap is on the west side between the steps and platform.
