2026 MILL & OVERLAY AND MILL TOWNS STATE TRAIL IMPROVEMENTS PROJECT

Feasibility Report

2026 Mill & Overlay and Mill Towns State Trail Improvements Project

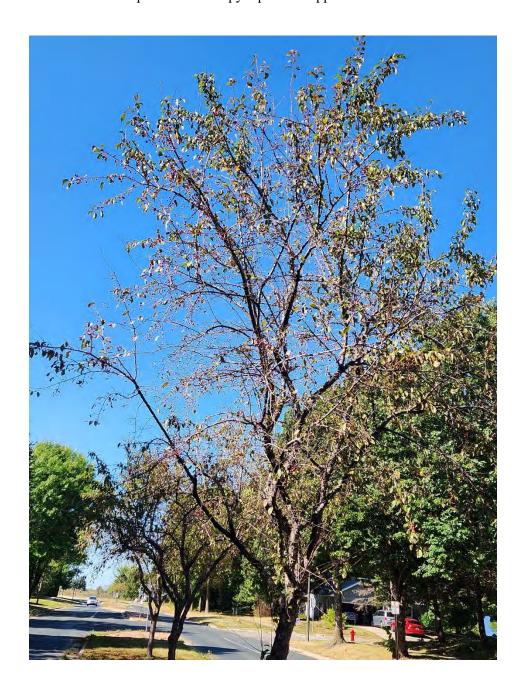
Example of thin canopy – possible apple scab as cause

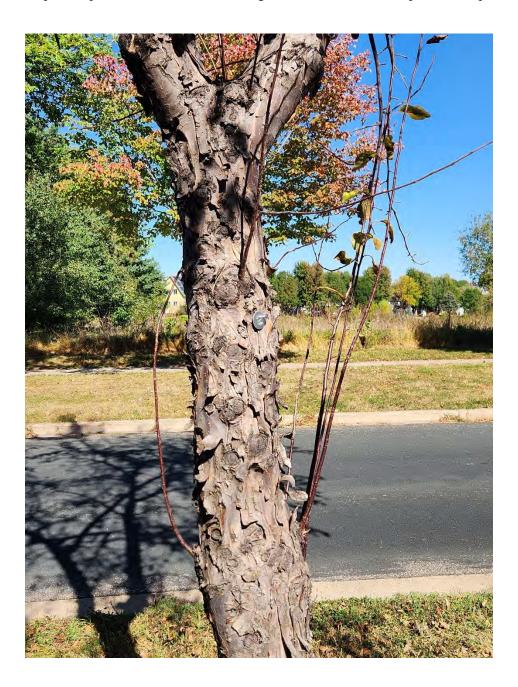
Example of Sprouts – these interfere with growth of more desirable parts of the plant

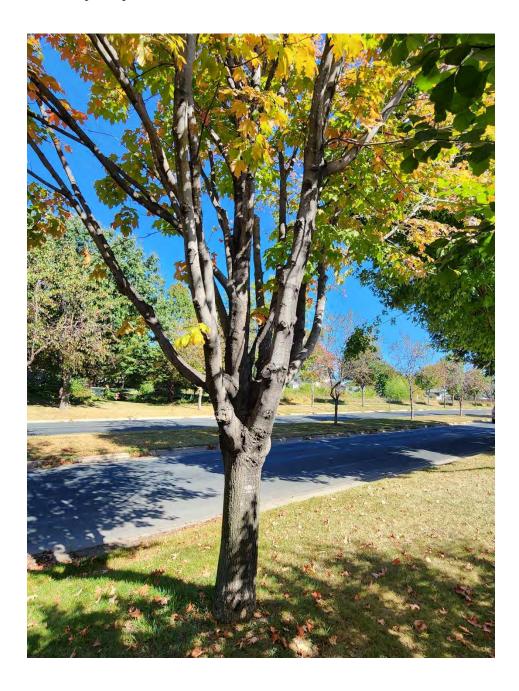
Example of poor form – trees should have one main leader in the center

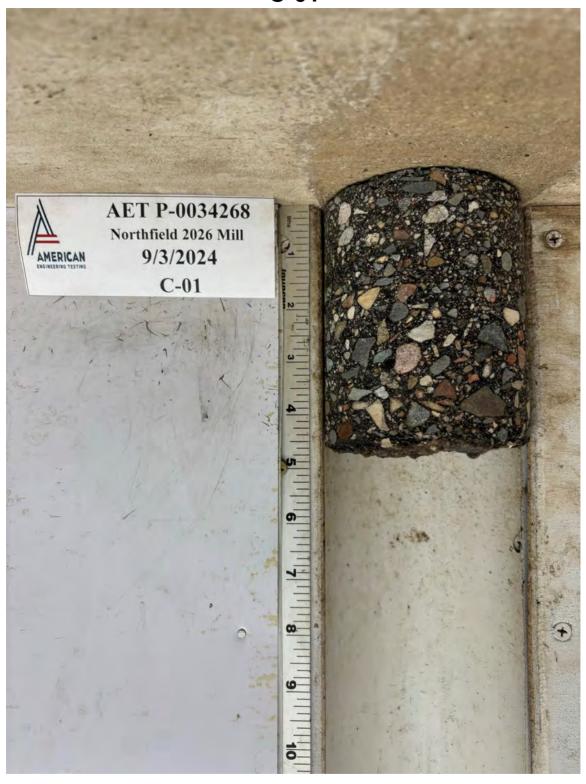
| Location | Core | Recovered Core Thickness (in) | Downhole Core Thickness (in) ^A | Material Condition | | | | |
|---|---|--|--|--|--|--|--|--|
| | C-01 | 4.6 | 4.75 | Good condition | | | | |

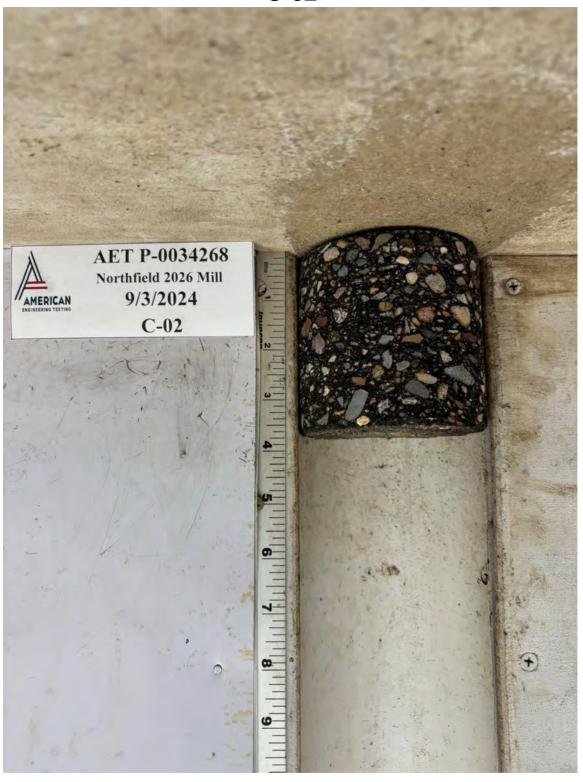
| Location | Core | Recovered Core Thickness (in) | Downhole Core Thickness (in) ^A | Material Condition | | | | |
|---|---|--|--|--|--|--|--|--|
| | C-02 | 3.6 | 3.75 | Good condition | | | | |

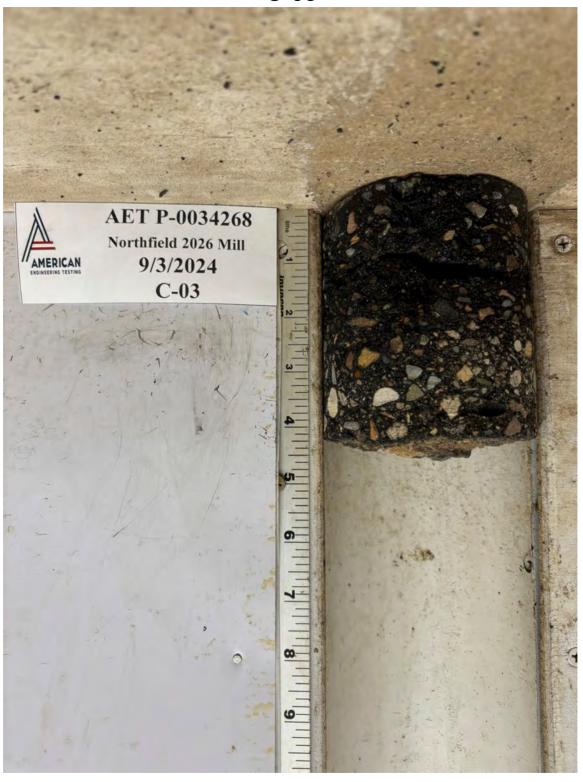
The core condition varied, but they were generally good or only included low severity stripping. Core C-03 was debonded near the surface, with some stripping present at the former bond.

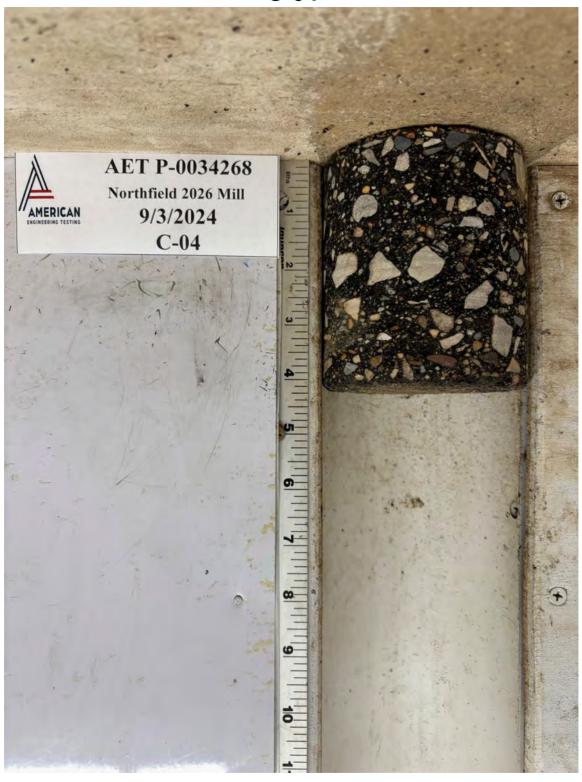
Core C-04

| Location | Core | Recovered Core Thickness (in) | Downhole Core Thickness (in) ^A | Material Condition | | | | |
|---|---|--|--|--|--|--|--|--|
| | C-04 | 4.1 4 | | Good condition | | | | |

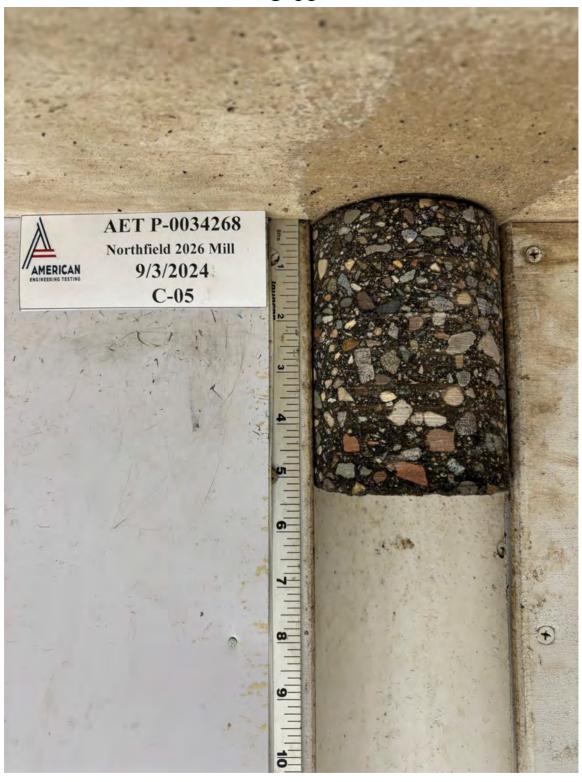
Core C-05

| Location | Core | Recovered Core Thickness (in) | Downhole Core Thickness (in) ^A | Material Condition | | | | |
|---|---|--|--|--|--|--|--|--|
| | C-05 | 5.2 | 5 | Good condition | | | | |

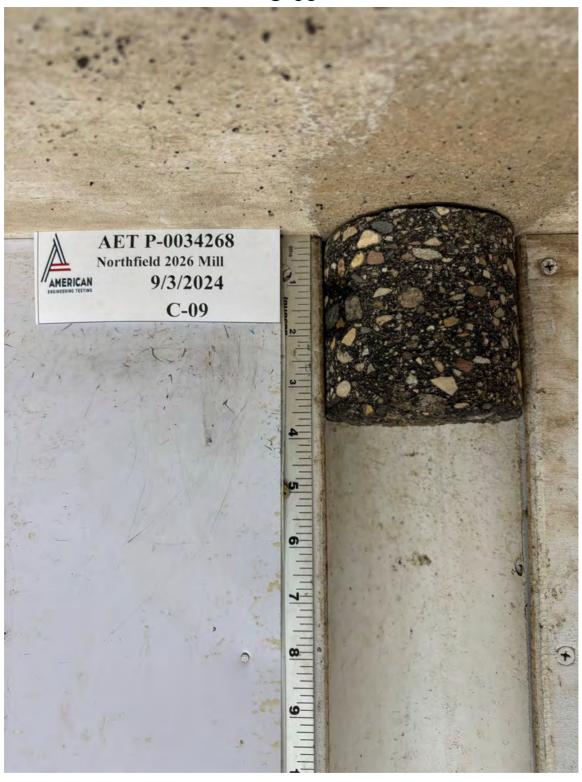
Core C-09

| Location | Core | Recovered Core Thickness (in) | Downhole Core Thickness (in) ^A | Material Condition | | | | |
|---|---|--|--|--|--|--|--|--|
| Prairie St | C-09 | 3.7 | 3.75 | Good condition | | | | |
