# NORTHFIELD LIBRARY

## Final Presentation

# 01 EXISTING ISSUES

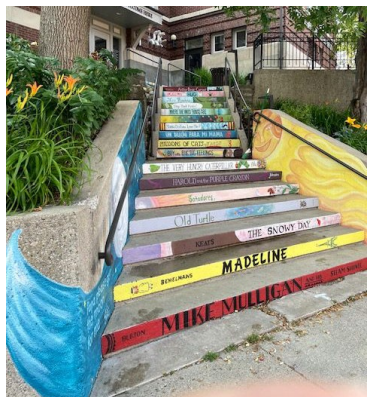
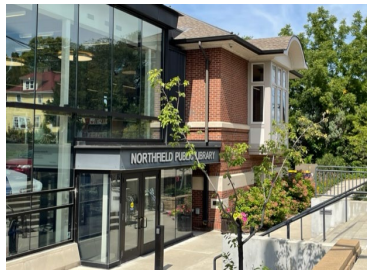
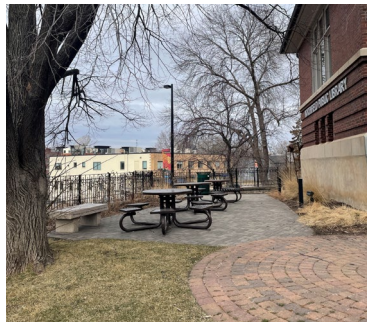
# Accessibility

- Property Line
- Library Building
- Entrance
- Wall
- Minor Contour
- Major Contour
- Ramp
- Stair
- ADA-Accessible Route

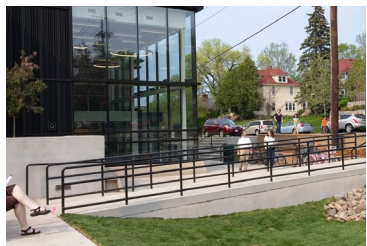
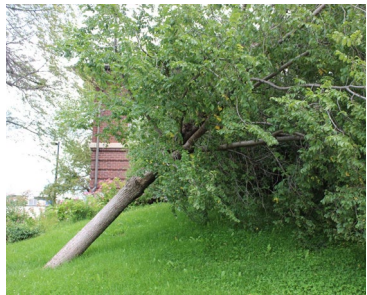
# Sustainability

- Property Line
- Library Building
- Entrance
- Wall
- Minor Contour
- Major Contour
- Areas with Drainage Issues
- 2024-25 Fallen Trees

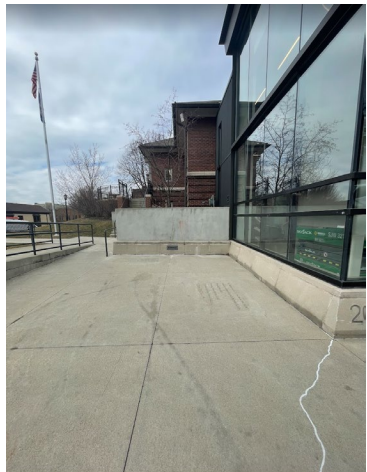
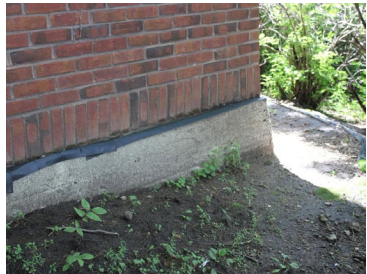
# Safety

- KEY**
- Property Line
  - Library Building
  - Entrance
  - Wall
  - Minor Contour
  - Major Contour
  - Area with Slopes above 1:3
  - Areas of Erosion Issues
  - Areas with Steep Steps

WALL GOES BELOW BUILDING FOUNDATION AND SHOULD NOT BE TOUCHED

MAJOR EROSION ISSUE ON WEST SIDE OF THE LIBRARY

SETTLING GROUND REVEALING FOUNDATION

SLIPPERY & STEEP ENTRY STEPS

RAMP TERMINATING WITH STAIRS, CREATING POTENTIAL SAFETY HAZARD

ADDRESS UPSTREAM DRAINAGE CAUSING EROSION ON THE NORTH SIDE

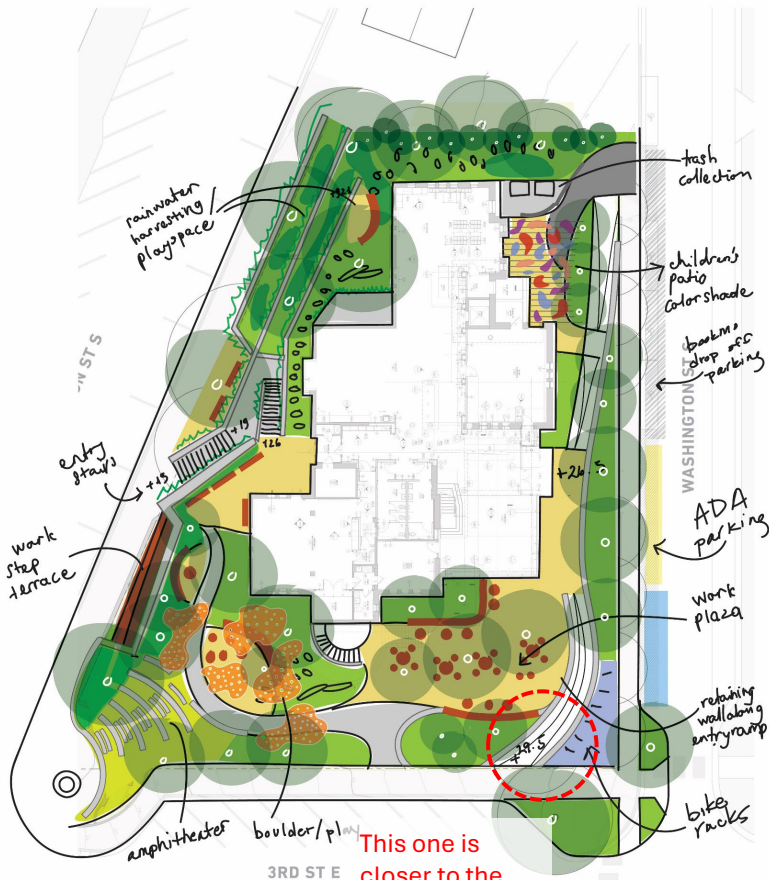
OPTION 1

This one is closer to the originals, but can't save the tree

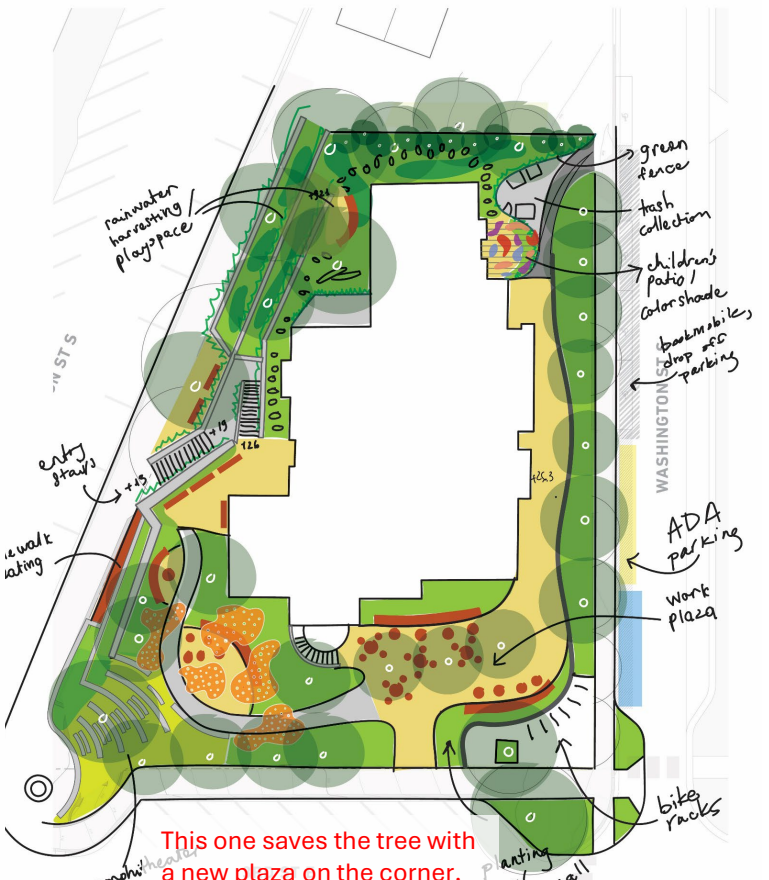
OPTION 2

This one saves the tree with a new plaza on the corner, but requires the path access to be further down the sidewalk in order to avoid the tree
