## **ORDINANCE NO.**

### **AN ORDINANCE OF THE CITY OF NORTHFIELD, MINNESOTA DESIGNATING A HERITAGE PRESERVATION SITE**

WHEREAS, the property proposed for heritage preservation site designation is known as the Chicago Milwaukee St. Paul & Pacific Railway Depot (Northfield Depot), located at 204 3<sup>rd</sup> Street W., and such location is depicted and legally described on Exhibit A, which is attached hereto and incorporated herein by reference; and

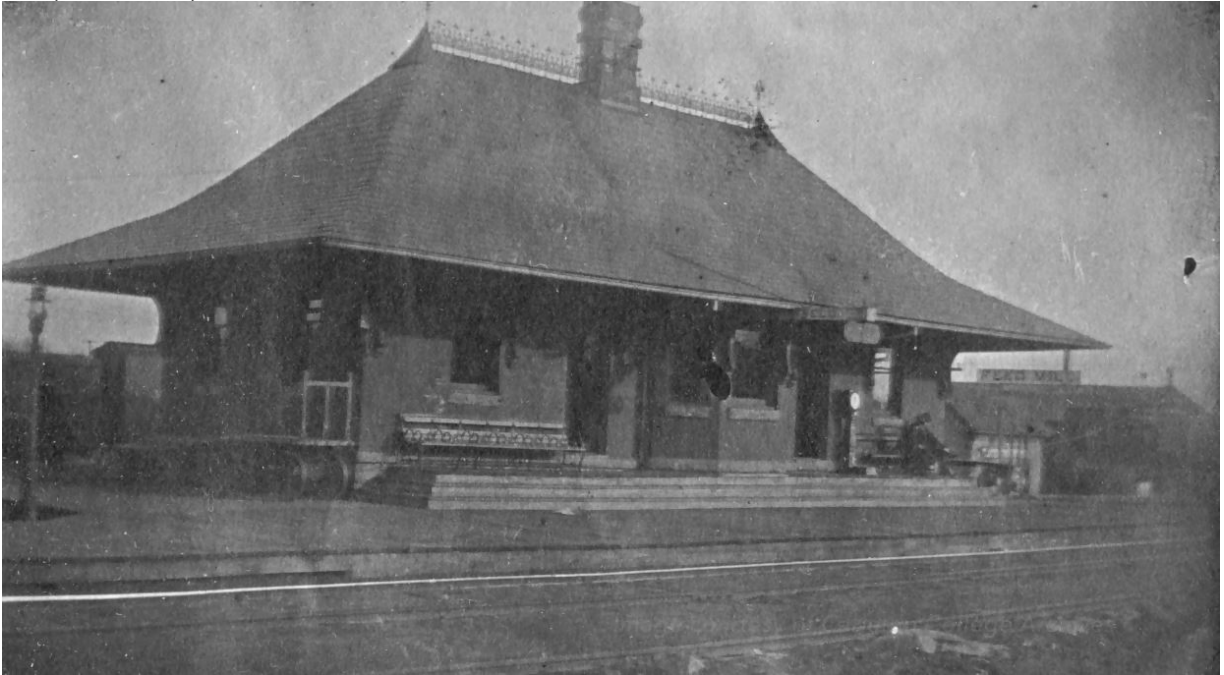
1896

Visible Features: Limestone foundation, water table, and window sill; steps spanning most of the wall; cottage style windows; large brackets; order board lamp signal; swooping, flared roof; roof cap, cresting and finials; detailed chimney.

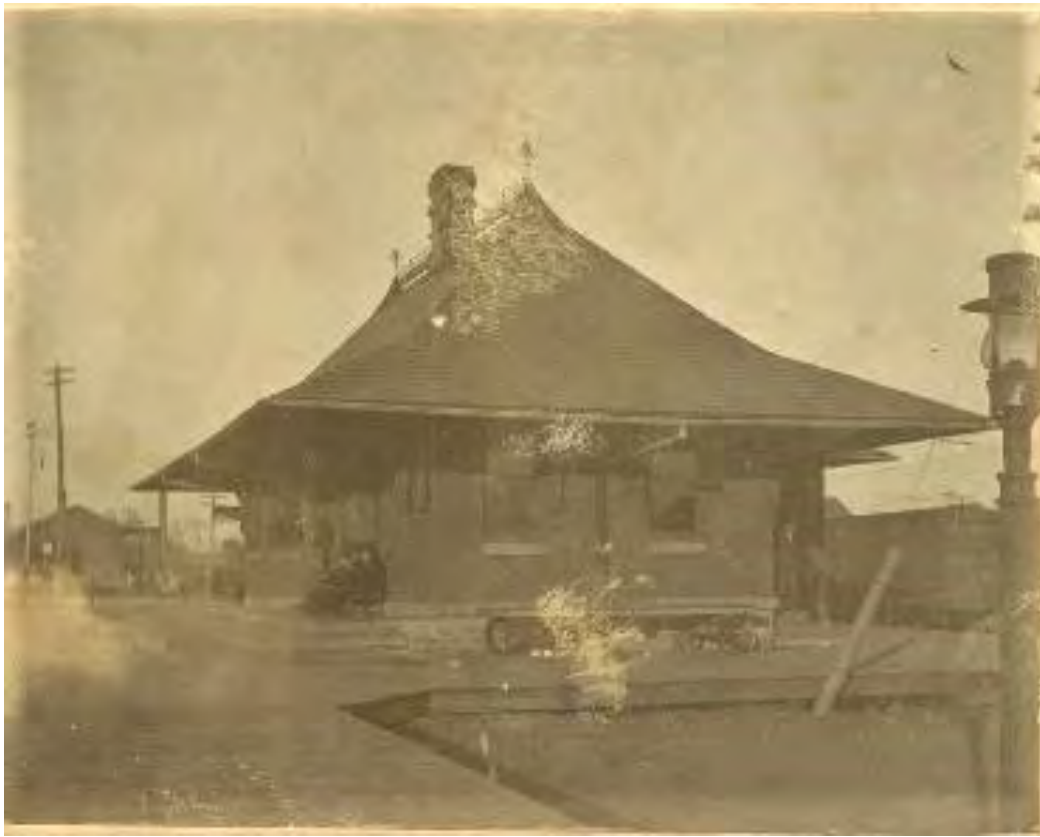
Before 1910

Visible Features: Limestone foundation, water table, and window sill; two windows in men's waiting room; swooping roof; roof cap and cresting; detailed chimney.

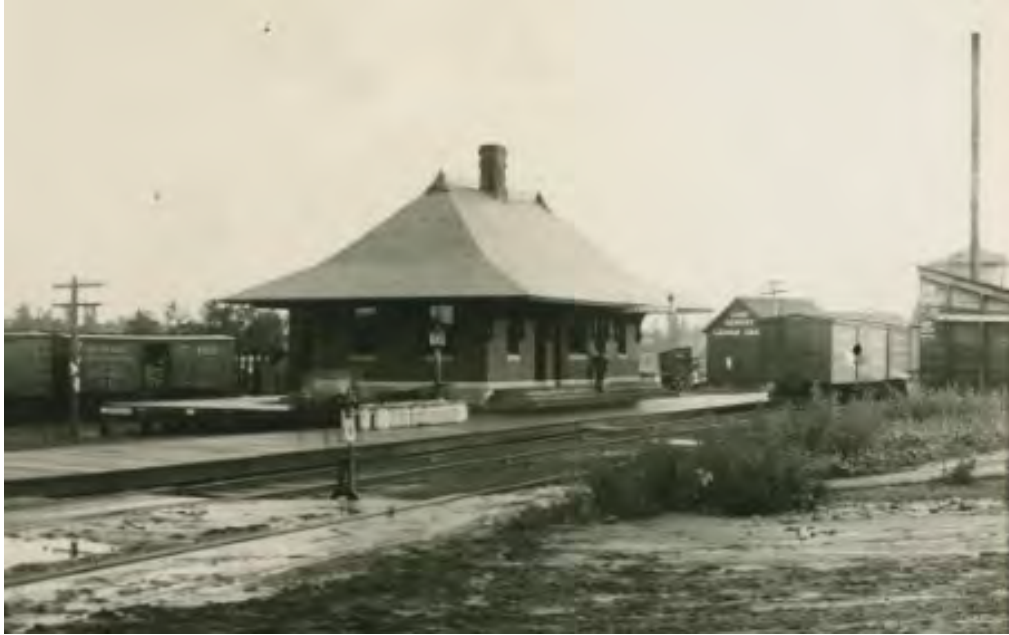
Before 1910

The above photo shows the depot west and north walls. It also shows the platform leading around to the east side baggage room door and the east side entrance to the main waiting room for women (see floor plan in Appendix A). The east wall would have included the platform on both the north end for women and on the south end for men. Photo also shows the outhouse for the depot (between depot and “*Lime, Cement, Lehigh Coal*” shed) used until the baggage room was converted in 1910 to two restrooms and a coal bin and boiler room.

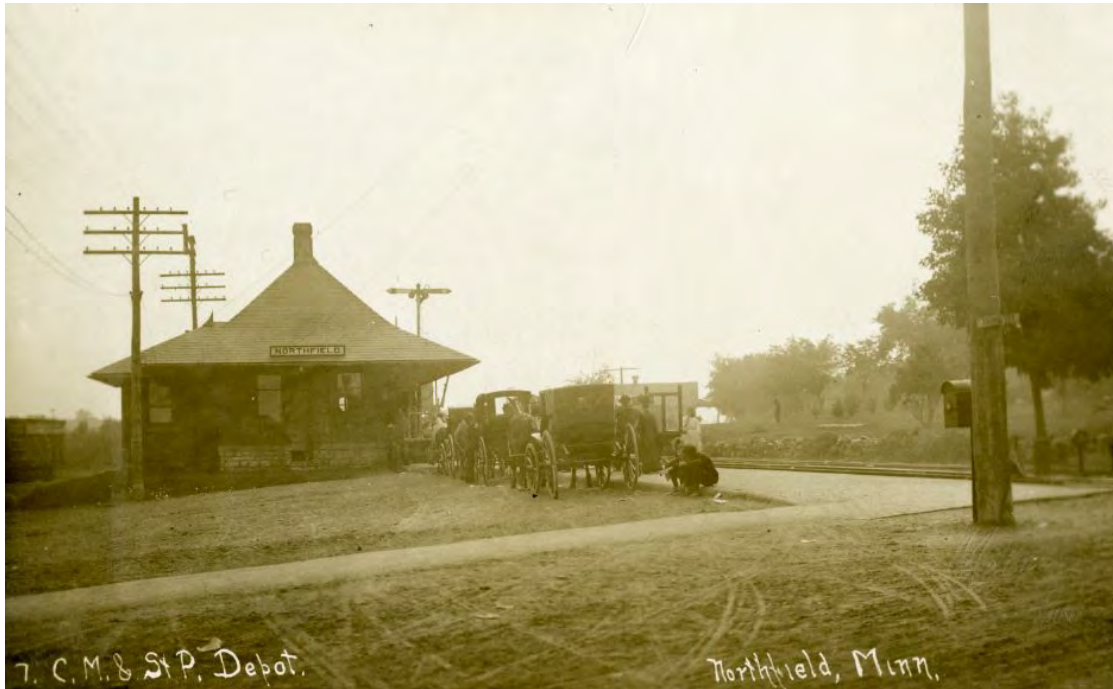
Before 1910

Visible Features: Limestone foundation, two windows in women's waiting room, swooping roof, roof cap on baggage room, Northfield sign, order blade signal, chimney (in center for heating stove in center serving both waiting rooms), baggage room door for women (far left).

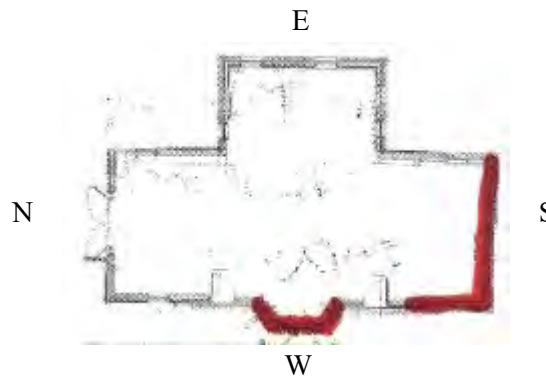
For clarity in the subsequent text, see the image below that identifies the three exterior wall areas that were removed in 1944, but were rebuilt 2019, i.e., station bay on west wall, southwest corner of west wall, and south wall.

= New 2019 exterior walls; reconstructed from 1888 plans.

**Major modifications.** Major 1944 exterior modifications in the depot play a role in many of the components below. They included 1) removal of the entire south wall and addition of an attached freight house; 2) removal of the original station master bay in the center of the west wall and installation of a double door entry in the opening; and 3) removal of the southwest corner of the west wall for the addition of a new, small station master bay (all of these modifications have been reversed in the 2019 work). The period of significance for the depot is the period up until 1944.

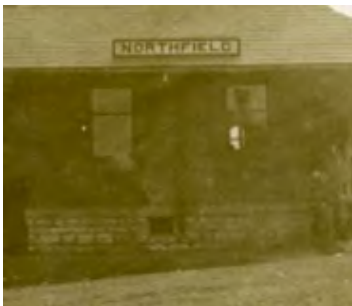
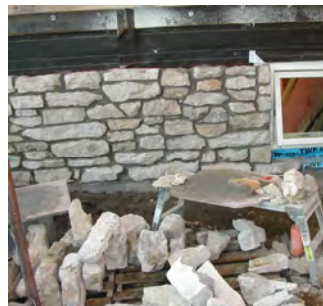
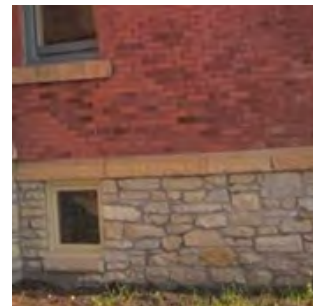
**Foundation:** The original blueprints and archival photos indicate the original foundation was limestone.

By 2015 when the property was acquired, it had been coated with concrete. Original limestone was salvaged and reused in 2016 as veneer on a new concrete foundation.

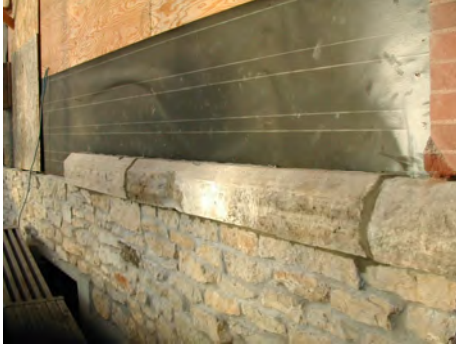
Original water table from baggage room bump-out added to new south wall.

To provide matching stone for the depot main room, those pieces were then used for the missing water table on the main building that had been removed in 1944, chiefly the south wall, and original bay area. Recycled, similar stone water table was then purchased for the baggage room bump-out. Thus, all sides of the main part of the building currently have the original stone water table, and the baggage room bump-out has the similar newly purchased recycled water table stone.

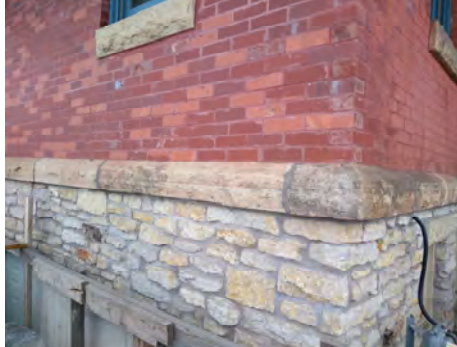
Original stone added to south wall (left) Original stone in place (right)

**Water table:** The limestone water table on the three sides of the baggage room was removed for the move.

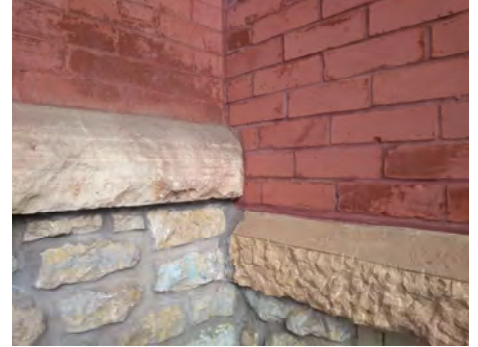
Original stone in place on main room (left) Recycled stone on baggage room bump-out (right)

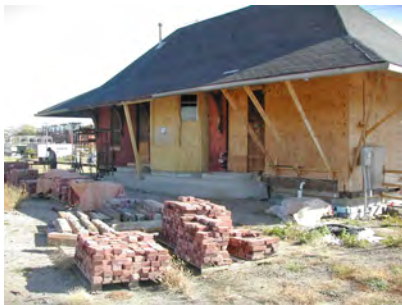
2017 New walls needing brick

**Brick:** All but three sections (the south wall, the southwest corner of the west wall and station master bay) contain original brick or brick added in modifications before 1944. The City donated bricks from a former local school house (Washington Elementary) that was built in the same late 1800s era. Those recycled bricks were used for the new south wall, southeast corner of west wall, and station master bay.

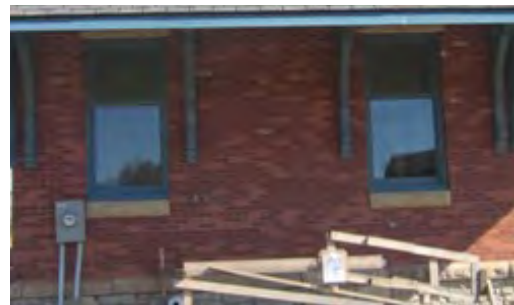
2019 South wall with added recycled brick

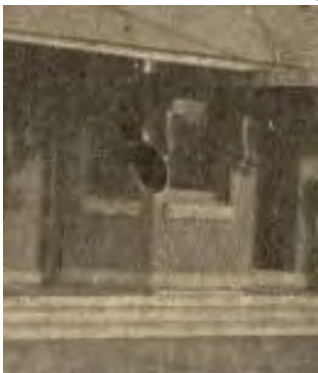
1896

**Station Master Bay:** The original station master bay was in the center of the track (west) side until 1944 when it was removed; a small bay was constructed on the southwest corner of the west wall; and a double door installed in the original bay opening. The original blueprints were used to reconstruct the station master bay.

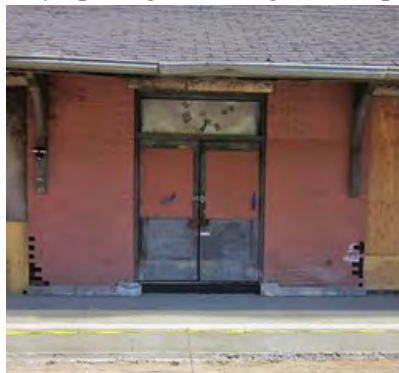
2015 Double door replaced bay

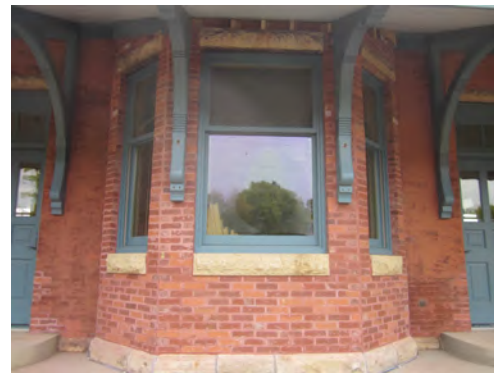
2019 Reconstructed station master bay

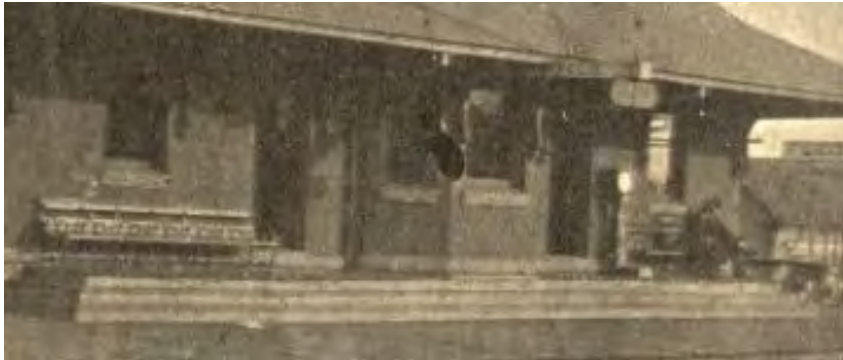
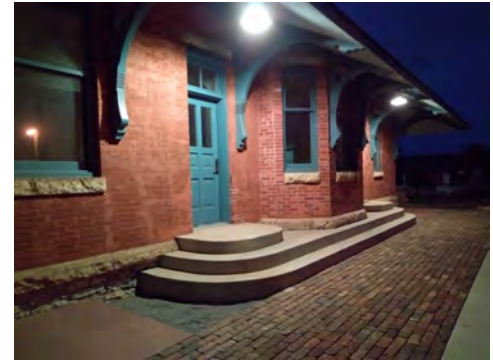
**Steps:** Archival photos are consistent with the 1888 blueprints regarding the track side steps. The original top step was lower than the floor of the depot (see photo). To comply with current building code, the 2019 top step is level with the interior floor. In order to maintain the reveal of the original water table, this top step does not extend the length of the depot. The remaining steps extend most of the length of the depot providing a similar profile as the original.

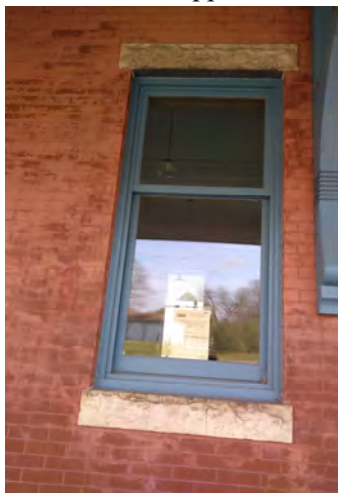
Original lintel and sill

**Door & Window Lintels, and Window Sills:** All of the window lintels and sills are the original rock-faced limestone or were added before 1944 (two windows with smooth concrete lintels were added in 1910 when two restrooms were created in some of the baggage room). The windows that were removed in 1944 (on the south end, the southwest corner of the depot, station master bay) have been rebuilt using the rock-faced limestone originally on the baggage room water table.

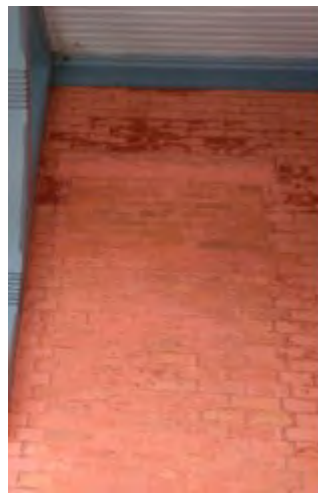
One of two lintels painted over when doors removed and openings bricked over in the 1910 addition of restrooms.

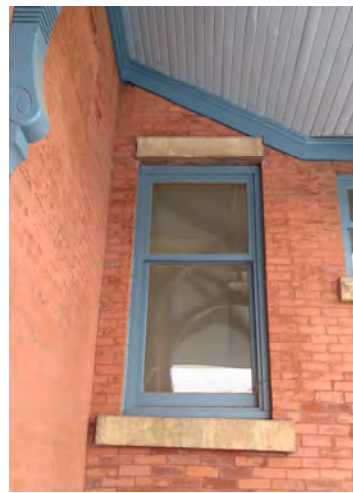
One of two 1910 windows with smooth concrete lintels and sills in the added restrooms in the former baggage room.

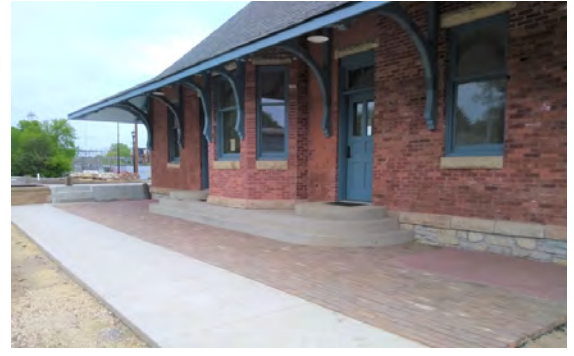
1896

2019

**Window Frames:** None of the windows are original. A report of the 1944 remodeling in the local newspaper in 1945, noted that there were “new window panes throughout”.<sup>1</sup> The blueprints did not include cottage style windows, but archival photos before 1944 indicate that the cottage style was used originally. The 2019 renovation installed all new wood, double hung, cottage style windows.

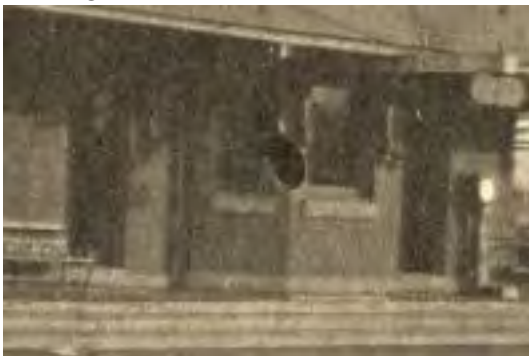
1896

**Exterior Doors:** None of the original exterior doors with transoms existed when the property was acquired in 2016. In 1944 the two original track-side (west) exit doors with transoms were converted to windows and the station master bay was replaced by a double door. That was reversed in 2019 when new, custom made doors with transoms were ordered using the 1888 blueprints (glass replaced the top panels). Double doors of the same design were added on the north wall for a handicapped access entrance replacing the 1944 picture window.

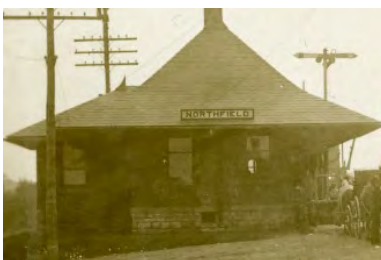
ca 1910  
Two north windows

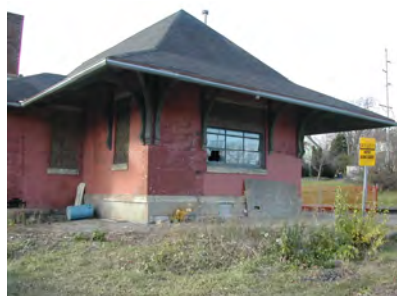
1944 Conversion: Two windows were replaced with one picture window

All door lintels are the original rock-faced limestone lintels; the lintel above the 1944 picture window (now the double doorway) on the north side was likely created from the lintels of the two windows that were replaced by the picture window in 1944. That picture window lintel remains in place for the new handicapped accessible double door.

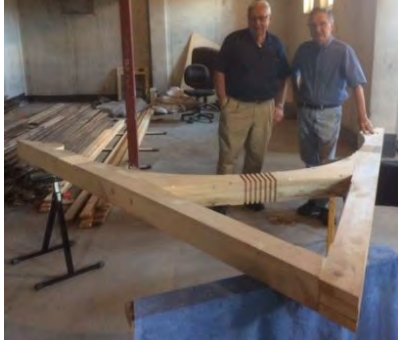
2014 Three-piece brackets crafted and assembled.

**Brackets:** All of the twelve large brackets on the west, north and east sides are original. Replacements for the eight large brackets and two smaller brackets removed in the 1944 work were crafted using the same type of wood as the original; clear pine from northern WI was harvested for this project and dried for a year. The craftsmen replicated the original three-piece bracket design and assembly using the same mortise and tenon technique. Some of the interior wall was opened temporarily to determine the technique used to anchor the brackets.

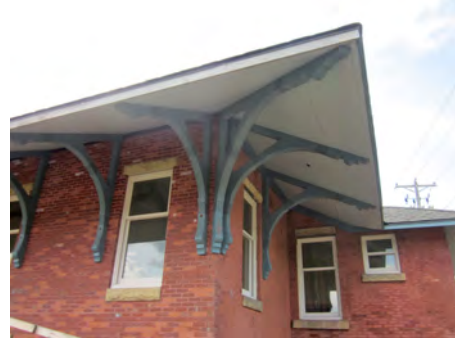
2019 Four new brackets on south(left) and two original on east (right).

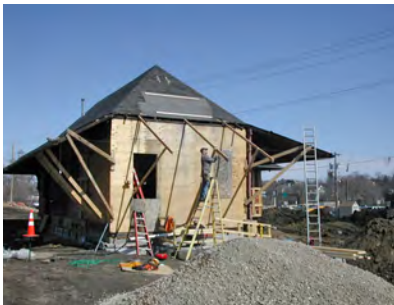
2016 South reconstructed wall

**Soffit:** On the west, north and east sides, all of the soffit v-board is original with only a few small repairs. In the 1944 work, the soffit was not removed above the station master bay or the southwest corner. For the missing roof on the south wall, new v-board was milled to match the width of the original soffit.

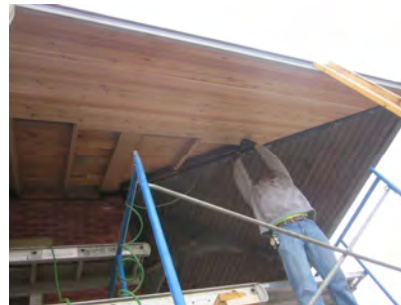
New milled v-board added.

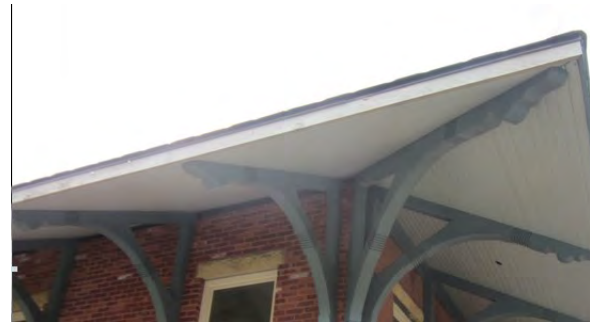
2019 New soffit on left; original on right

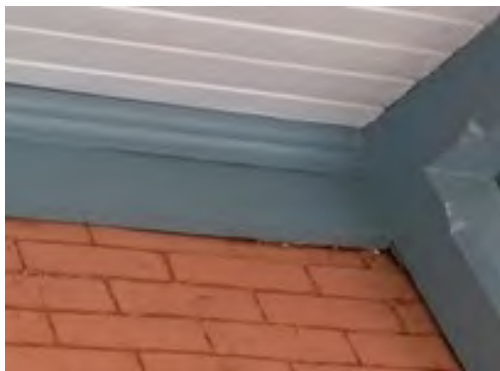
Original cornice board

**Cornice Board:** All existing cornice boards between the brick and the soffit v-board on the north, east and west walls appear to be original; the cornice boards on the restored south end of the west side and the new south wall were added in 2019.

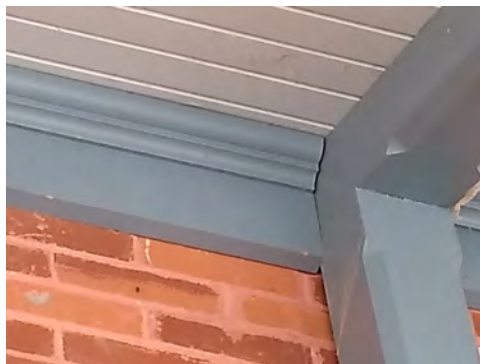
2019 New cornice board on south wall

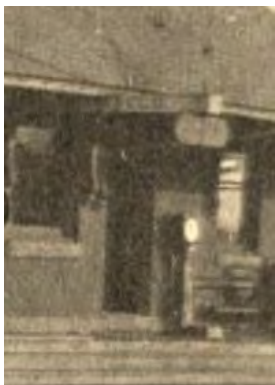
1896 In front of bay.

**Order Board** (yet to be mounted): The Midwest contact for the Milwaukee Road Historical Association donated an order board to the project since an archival photo (1896) indicated the depot did have one. A new mount was built and mechanism cleaned.

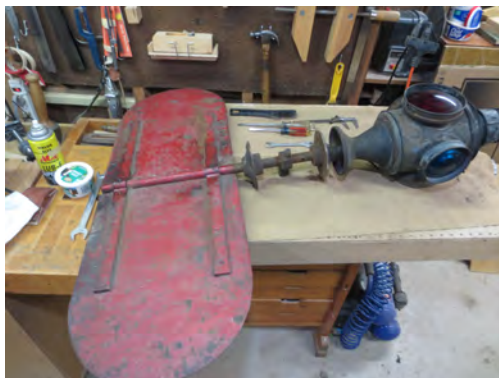
2017 Mechanism needing cleaning

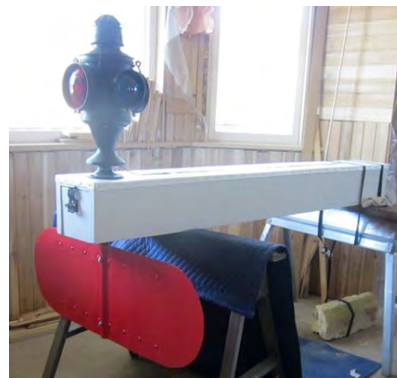
2019 Repaired (not yet mounted)

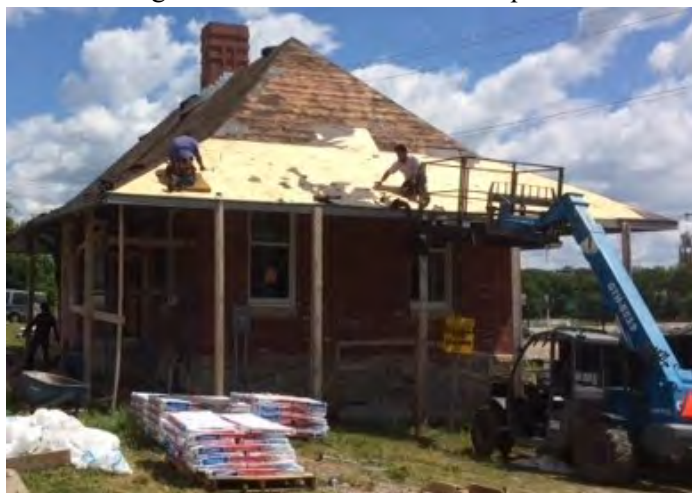
2016

**Roof:** Although the blueprints indicate a slate roof, there is no conclusive evidence of what was installed. Asphalt shingles were on the roof when acquired in 2015 and have been replaced with new asphalt shingles.

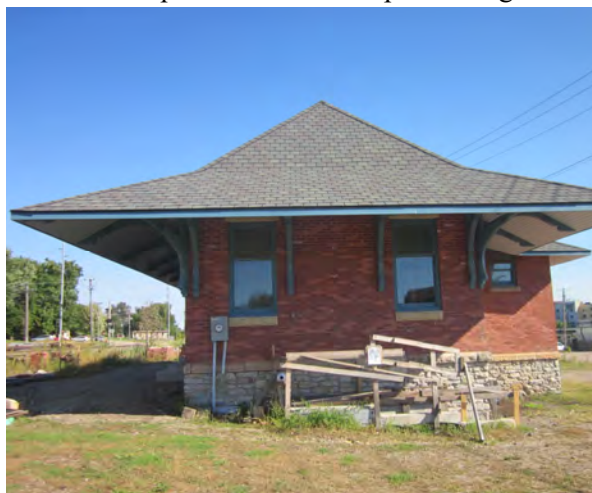
2019

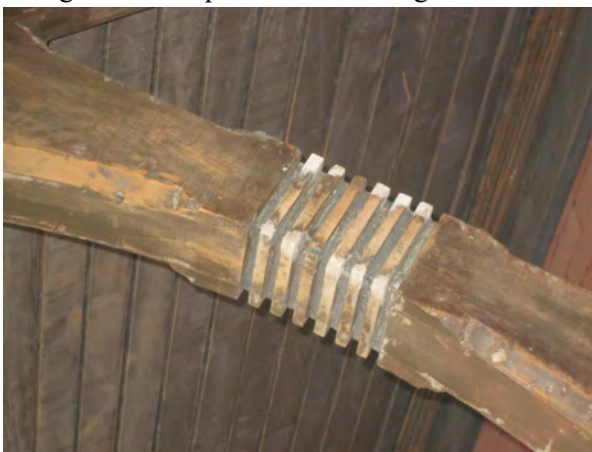
Repair: Some corners of bracket slots were missing, but repaired. Nail holes were filled. Wood in excellent condition.

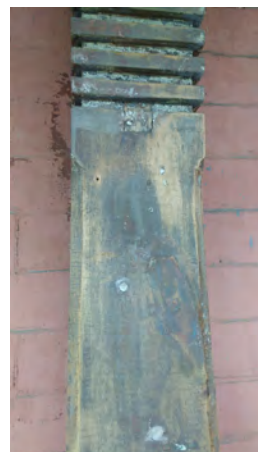
Removal of paint revealed original color.

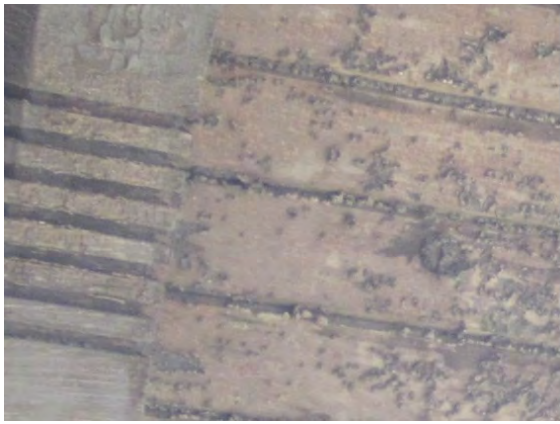
No color could be discerned on the old soffit paint crumbles in the v-board joints and board.

**Exterior Paint:** Although some of the bricks that had been painted in previous modifications, only graffiti spray paint was removed; a gel paint remover was used which did not affect the brick patina. All old paint was removed with a heat gun from the original wood elements on the three intact exterior walls: brackets, soffits, cornice board and fascia. A few minor repairs were made on the original wood. Many coats of thick, alligatored paint, sometimes of various colors, remained on most of the original brackets that are protected from the sun and much weather. The first coat of paint was a thin, white paint and the first colored, thicker paint was a gray-blue color. Paint chip samples were brought to the depot; a close match was identified, and used to paint the wood features noted above except the soffits. None of the original window frames and door jams remained but there was evidence that at least the door frames had been painted the same color (see image below of paint on brick).

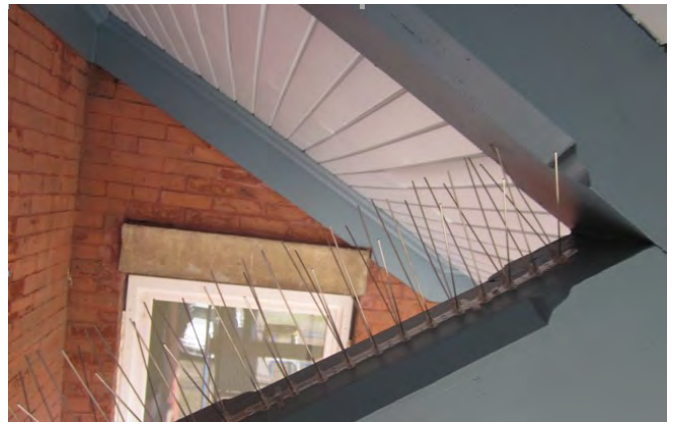
All old paint removed from original soffit v-board; painted with a very light shade of the gray-blue found under light mounting.

The soffits contained very little paint that remained in the form of dirty chips; the color could not be identified. However, when the remaining light fixtures were removed, a layer of a single color of paint was beneath that was a very light shade of the gray-blue of the brackets and other trim. Again, paint chips were brought to the depot and a matching color was selected for the soffit.

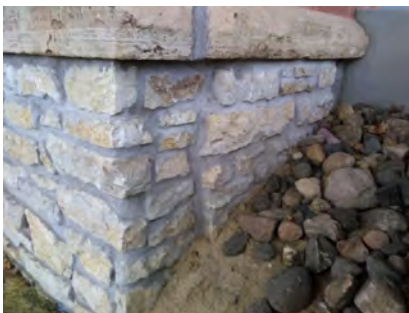
Exposed limestone in gap between wall and east side steps leading from the sidewalk to the platform. A similar gap is on the west side between the steps and platform.

As shown below, the door entrance is level with the depot platform that will be contiguous with the pavilion floor (see site plans below). The depot and the new pavilion, a separate structure and City project, will be connected only by the platform. The ramp will start near the transit hub and run south on the track side of the pavilion providing access to both the pavilion and the depot. That ramp placement allows minimal intrusion on the depot building. As shown below, the stairs on both sides are significantly distanced from the foundation; the only portion of the north foundation that is covered is the area immediately outside the doorway.

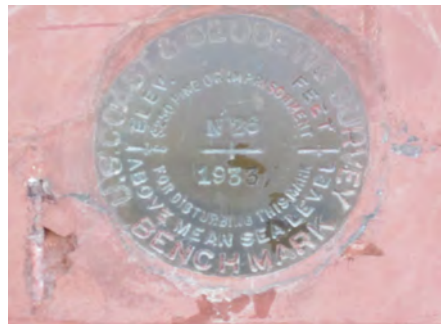
1933. Geodetic Elevation Disk installed in depot west wall, one of three in Northfield at the time to assist in planning developments. Decommissioned after depot move. National Geodetic Survey has requested to install a new, additional disk in current depot location.

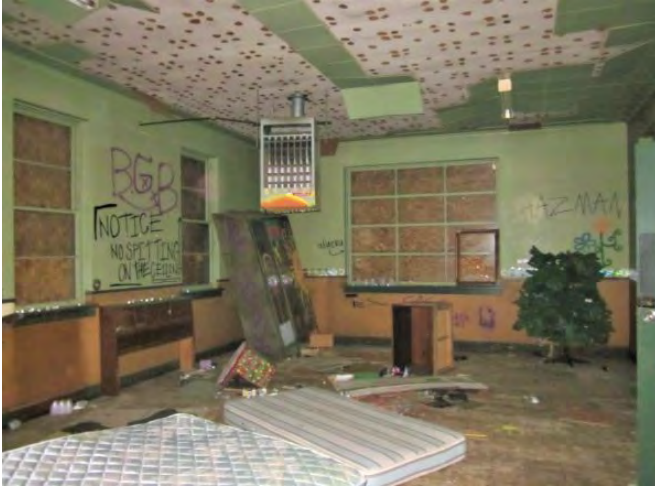
2016: Reflects 1944 changes: Ceiling lowered 2 ft.; acoustical tile used. Note also, all woodwork removed; 1” of plaster added over wood walls; windows replaced; concrete & tile added on top of wood floor.

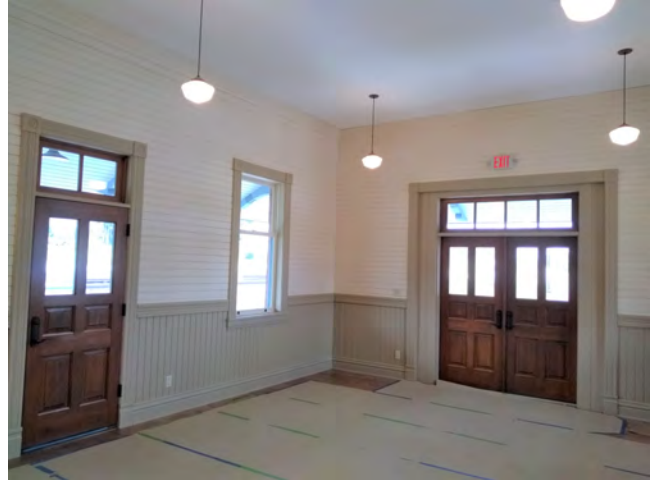
2018: Ceiling raised 2' to original position on original rafters.

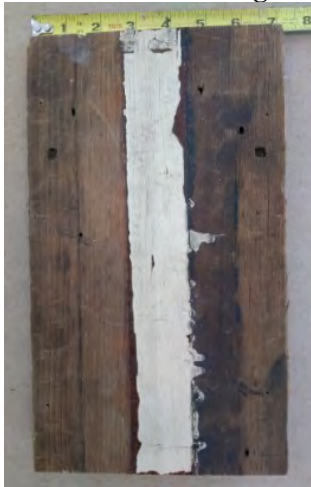
2016: Crown moulding component found in attic

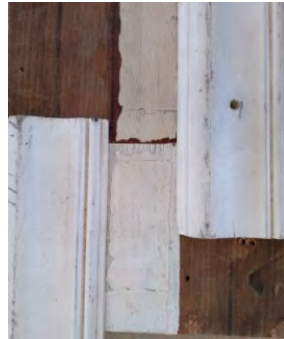
Mock up of crown moulding placing two pieces of moulding on each side of the 7” board.

New crown moulding was installed with the same width as the main board and the two narrow side mouldings.

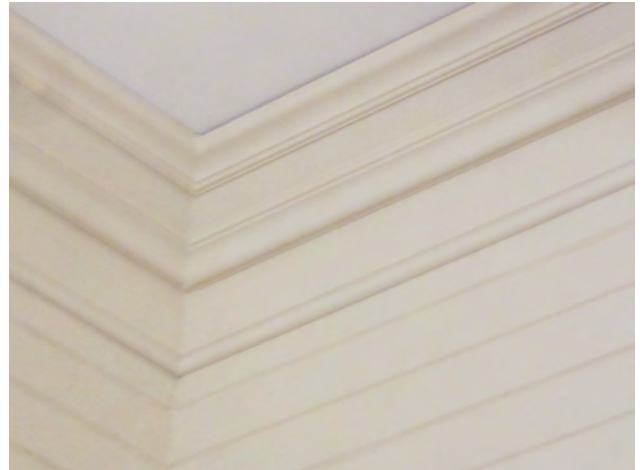
2019: New crown moulding using of same dimensions of original.

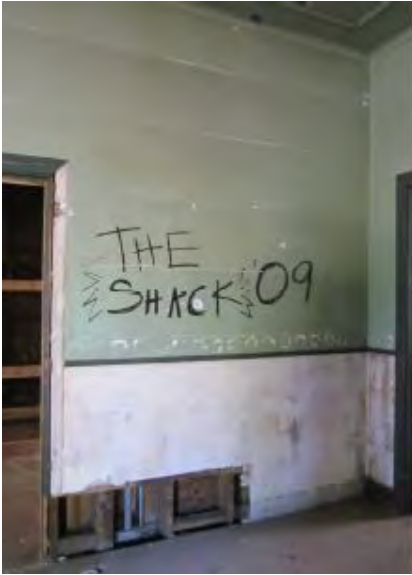
2016 (after move)

Left photo: Regularly spaced horizontal cracks appeared on the walls after the move – an indication that it was not likely to be lathe beneath.

Note: This photo also shows the depth of the lowered ceiling, and shadows of the wainscoting trim, baseboard and crown moulding (dark shadow above lowered ceiling) providing valuable dimensions information for replacing the missing elements.

Note: All walls of the main room and alcove consist of the original v-board, although some repairs and rearrangement of the boards was needed. The salvageable original v-boards removed from the walls of the baggage room/men’s restroom (now the stairway) were used for the repairs and patching. These boards had been removed to gain access for repair of the south wall studs that had been damaged in a boiler room fire at an unknown date. Newly milled v-boards of the same width were then added to the stairway walls.

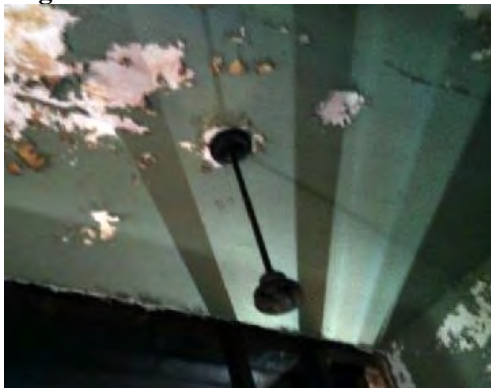
One pendant light fixture was found in the original ceiling of the baggage room area. The ceiling had never been removed and lowered, in contrast to the main room.

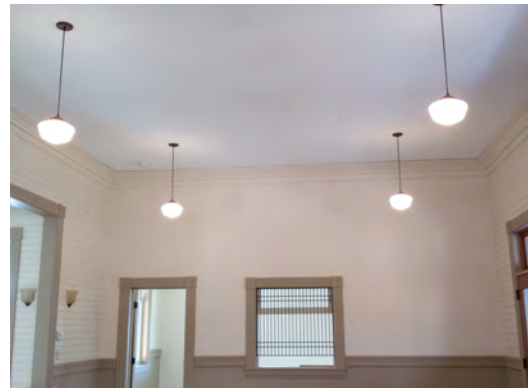
Recycled pendent light fixtures with school house style globes were installed in the main rooms and office area.

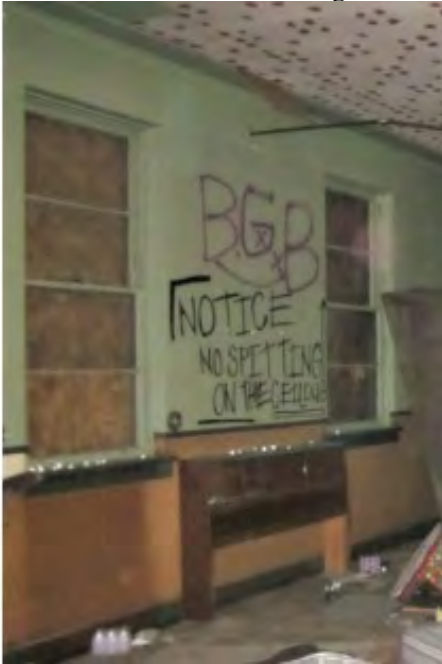
2016

Left photo: 1944 remodeling included removing all door and window casing and adding 1" of plaster and plaster board to the edge of the new window frames, covering all of the original v-board.

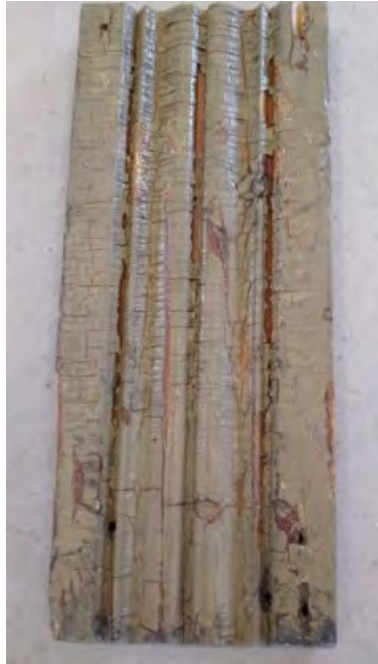
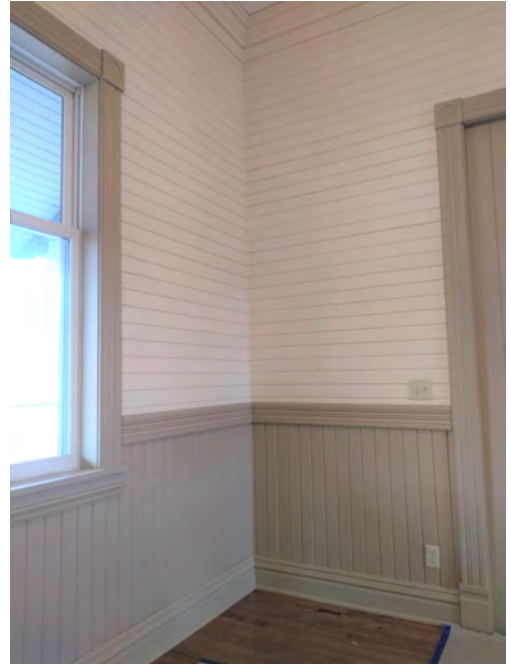
2019

Right photo: The profile of the old symmetrical casing used in the attic suspension of the 1944 ceiling was not available, but door and window casing was purchased that was symmetrical, and the same width and a similar profile as the pieces of casing found in the attic. The photo also includes the newly crafted rosettes, new cottage style windows (larger panes on bottom and smaller on top) and newly painted original v-board (see close-ups below).

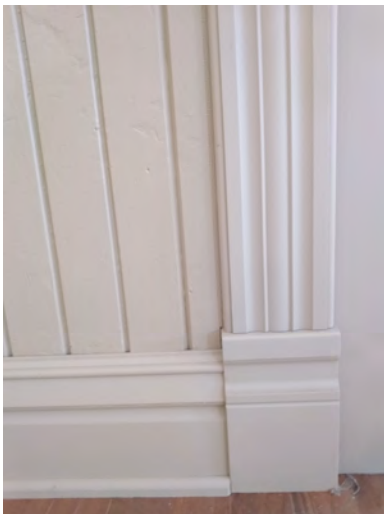
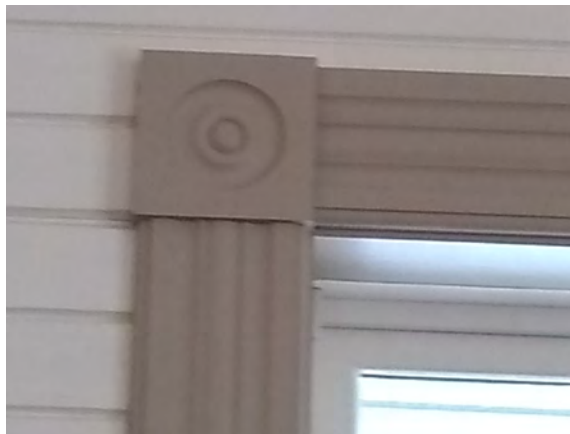
Above photos include original v-board, window and door casing, milled plinths and baseboard, and the newly crafted rosettes. Some of the elements were hand crafted because of the width needed for the casing. Fortunately, symmetrical casing of the width needed was available for purchase and being discontinued, and there was enough for the depot work. The width of all elements was consistent with the width of the shadows of the original.

As noted above, the plinths and baseboard were newly milled. All baseboards were removed in 1944; the original height was determined by the shadow on the unpainted v-board above the concrete floor. About 1 ½" was added to that shadow measurement since the 1" concrete had been laid on top of the original wood flooring and the new wood flooring was about one-half inch on top of the concrete (see milled plinth and baseboard photo above).

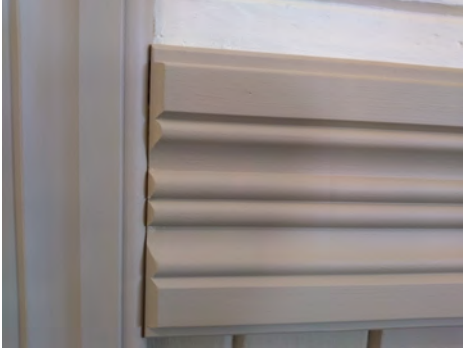
The wainscoting trim was milled to the width of the unpainted shadow found on the v-board wall. The profile used is very similar to that of the pieces of original casing found in the attic.

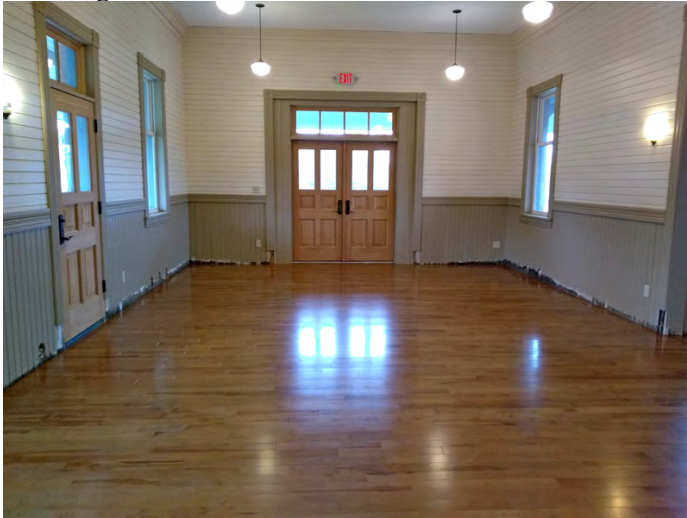
The 1888 maple flooring was covered with concrete and rubber tile in the 1944 remodeling. That work included the removal of the dividing walls around which the original flooring had likely been laid.

In the 2019 renovation, small areas of wood on the edge of the concrete was exposed and determined to be maple. Manufactured maple flooring was then installed on the stable concrete running the same direction. Doors were stained to match.

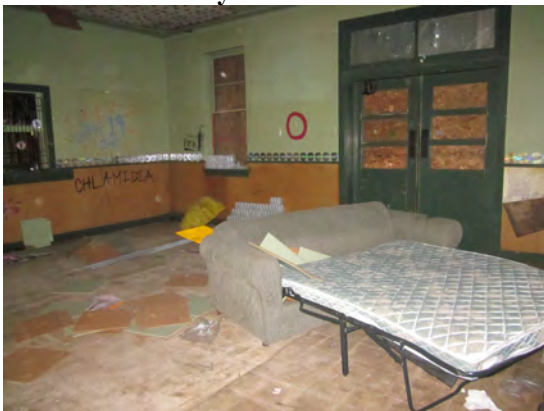
2016. 1944 remodeling converted a door into the window (left); removed the station master bay and replaced with a double door.

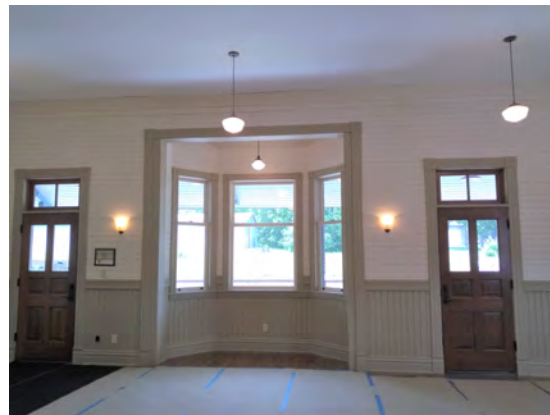
2019. Turned the two 1944 windows back into doors as in 1888; restored the 1888 station master bay and installed cottage windows.

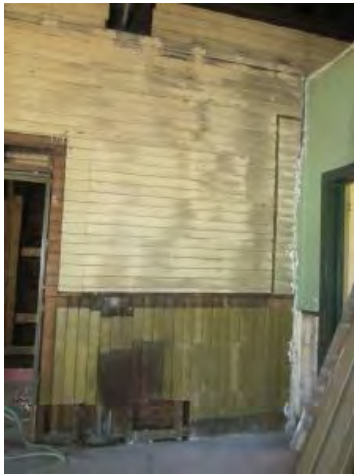
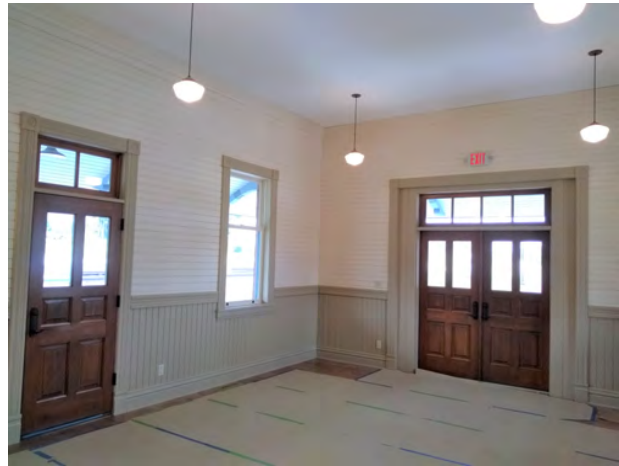
Evidence of the colors used in the interior were gathered from the original existing v-boards (chipped paint and nail holes from the plaster board) and pieces of the casing found in the attic.

1888. The first coat of finish on the v-board and the casing found in the attic indicated a varnished surface, similar in color to the finish used on the 2019 newly installed doors and flooring. Within the picture frame below (added in 2018 to preserve signature), the original v-board with cream paint can be seen. The signature area in the center is darker because it was not scrubbed. The dark spots of varnish are visible where the paint chipped off.

2019. The paint on the upper part of the wall is a similar cream color as the pre-1944 paint. A darker shade in the same hue was used for the wainscoting and trim giving a similar feeling for the rooms before 1944.

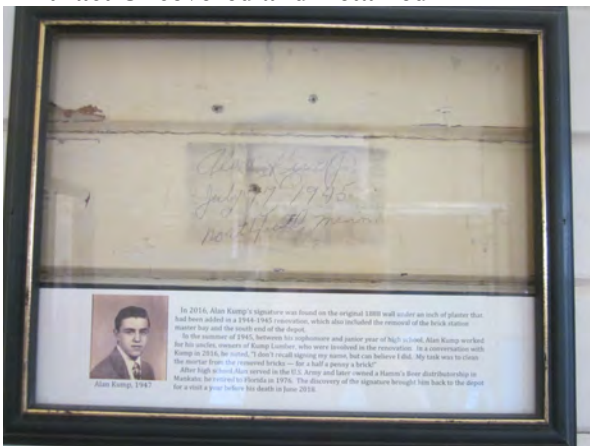
Framed 1945 signature on west wall v-board of Alan Kump with his 1947 high school photo. Caption reads:

*In 2016, Alan Kump's signature was found on the original 1888 wall under an inch of plaster that had been added in a 1944-1945 renovation, which also included the removal of the brick station master bay and the brick south end of the depot.*

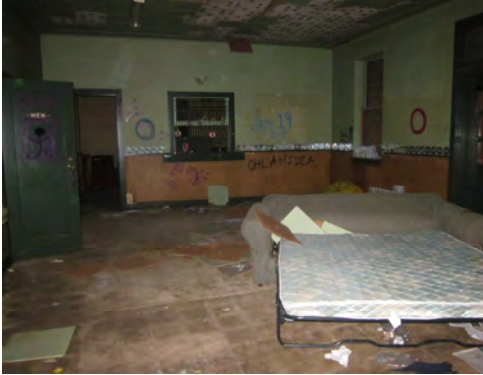
2016

Left photo: The current plaster wall on the south end of the main room was installed in 1944 to create an office with one ticket counter (instead of two), and a bay in the west side of that office; the new office space had been the south end of the men's waiting room. The south wall of the depot was removed and opened up to the newly attached freight house.

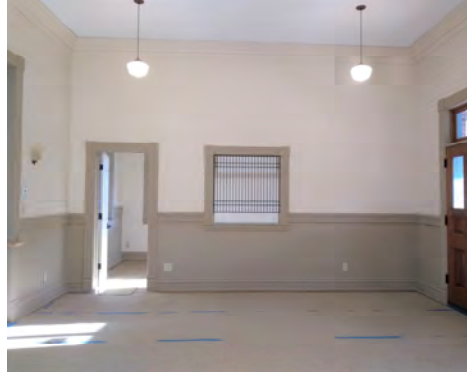
2019

Center photo: The 1944 wall contains the ticket window grille and ticket counter accessible to the main room and the office area. The current work required that the wall be extended up two feet to match the rest of the ceiling. The ticket window wall still contains the sash weight mechanism to lower and raise the ticket window. The sash weight mechanism was retained for the window usage. The dark green ticket grille was retained; the broken ticket window of wavy, translucent glass was replaced with the same type of glass.

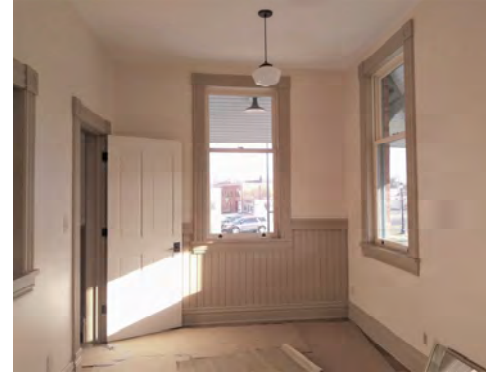
2019 Office area

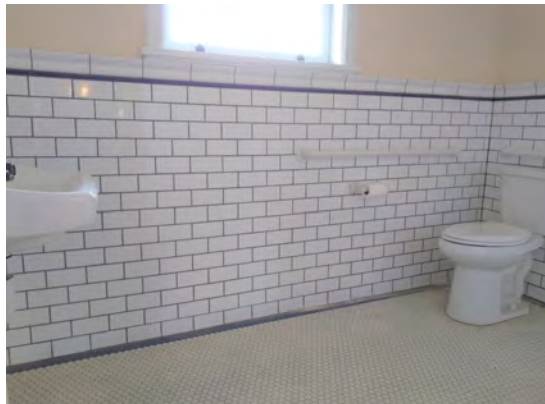
Coal bin – 2019 Conversion to handicapped accessible bathroom

The coal door opening used for window; thick coal dust provided evidence of the former use of room as a coal bin.

Subway tile was added to the walls and small hexagon tiles were used on the floor.

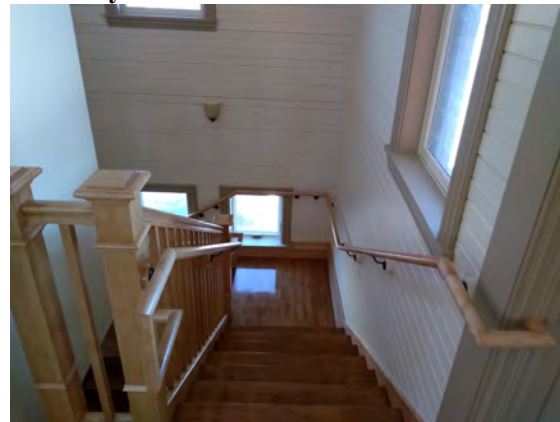
Boiler room – 2019 Conversion to Stairway to basement

The boiler room (on ground level) was in the eastern half of this stairway. The men's restroom was in the western half.

The area on the south (right) was opened for a stairway to the basement. V-board was custom crafted for stairway walls. Much of the original had been badly damaged by a fire in the boiler room. Several of the studs and rafters in the stairway south wall were sistered due to fire damaged areas.

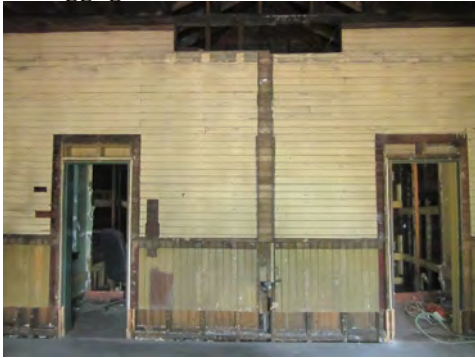
2016

The two interior door openings on the east wall were added in 1910 when the western half of the former baggage room was converted into a woman's and a men's restrooms.

The vertical shadow was the location of the wall that divided the waiting rooms for the women (left) and men (right).

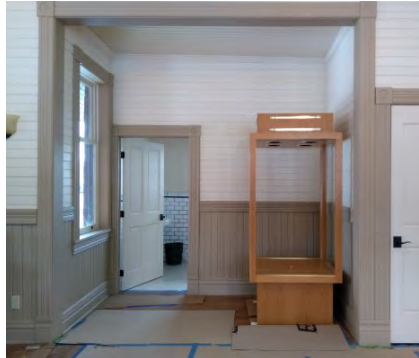
2019

The opening on the north (left) was enlarged to create an alcove entrance to the adjacent handicapped bathroom. Some of the alcove space can be used for a possible future lift to the basement. Some v-board was replaced with undamaged original v-board salvaged from the stairway walls and from the extended openings.
