# 16 PRESERVATION BRIEFS

## The Use of Substitute Materials on Historic Building Exteriors

John Sandor, David Trayte, and Amy Elizabeth Uebel

National Park Service  
U.S. Department of the Interior  
Technical Preservation Services

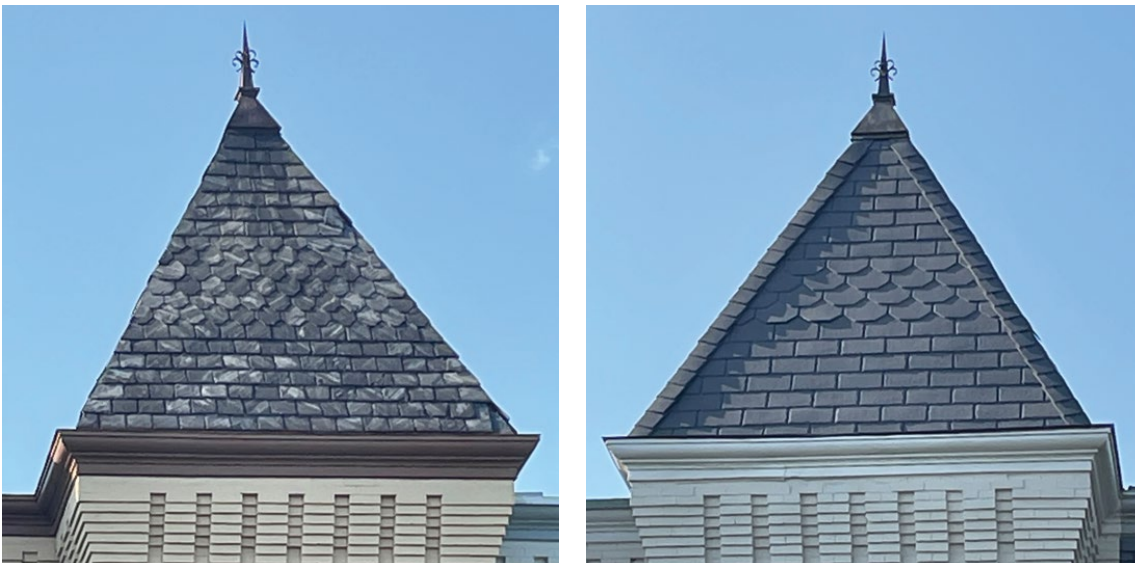
*Figure 10. Polymer slates offer a choice of shapes but not sizes, limiting their ability to achieve a good visual match for some historic slate. With the size of the polymer slates (right) being nearly twice that of the historic slates (left), the scale of the entire feature is incompatibly altered. The molded edges of this material, which contribute to its ability to replicate slate, would be lost if each shingle was resized by cutting. Photo: John Sandor, NPS.*

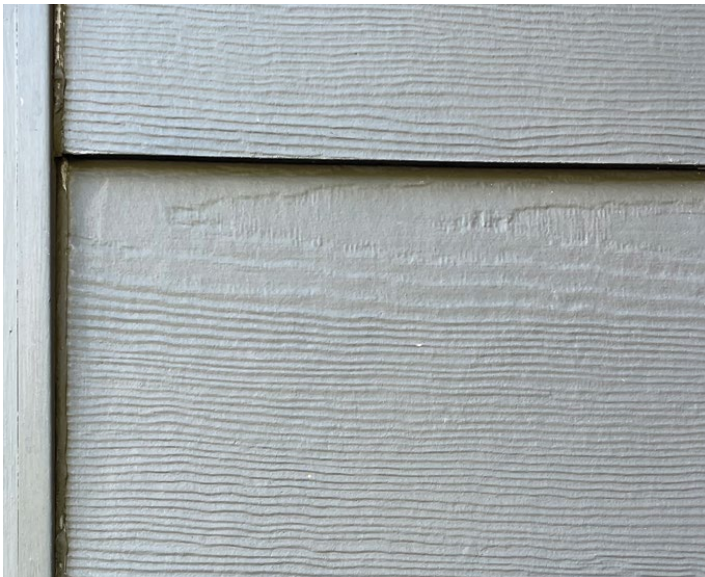
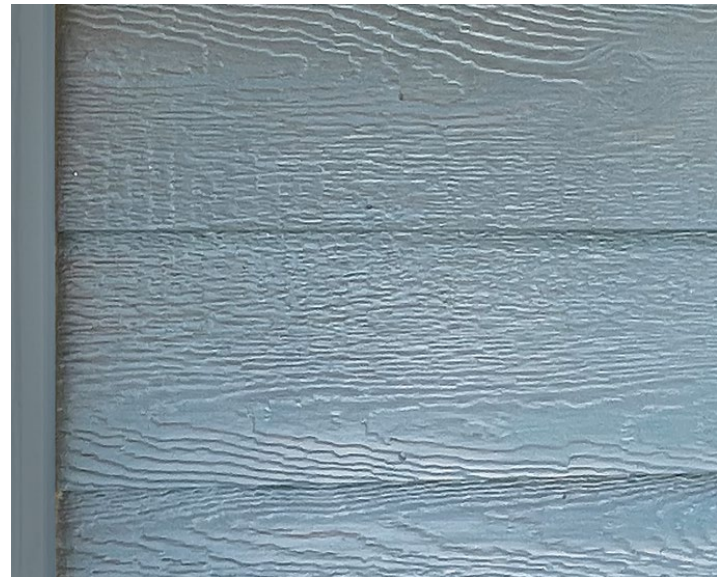
Figure 14. Surface texture is an important aspect in matching the appearance of a historic material, especially when a material is viewed at close range. As seen in these two images, many of the substitute materials produced for siding and trim have an embossed wood grain, making them incompatible for replacing historic wood that was typically planed to a smooth surface. Some substitute products are available with a smooth surface as well. Photos: John Sandor, NPS.

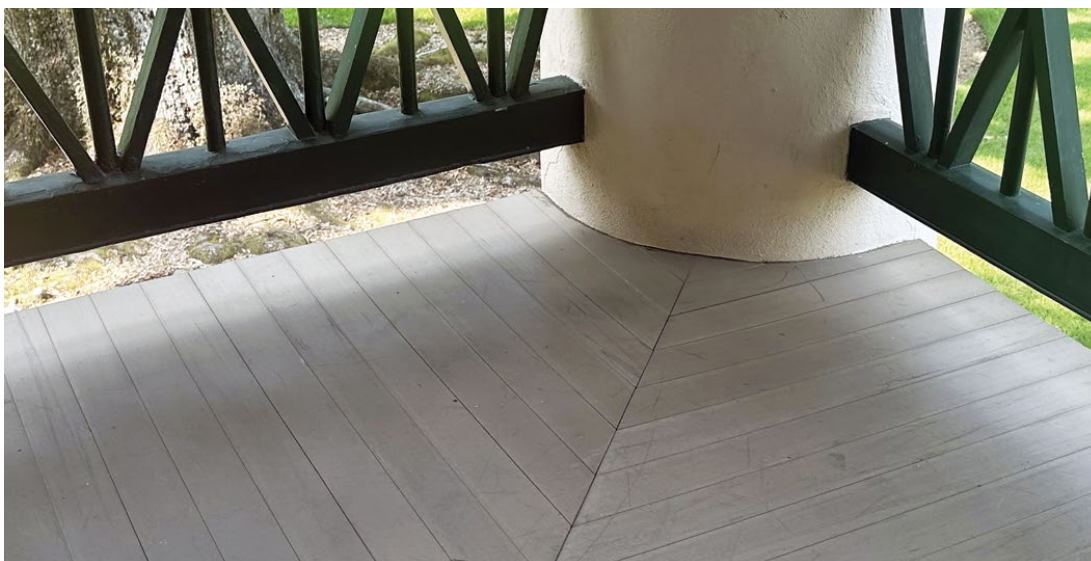
*Figure 15. Tongue-and-groove porch flooring is manufactured in several different substitute materials. Each type has different properties, though most are more moisture-resistant than wood. The prefinished product shown can be painted when worn, but repainting is not recommended for some product choices. Photo: Oak Alley Foundation.*

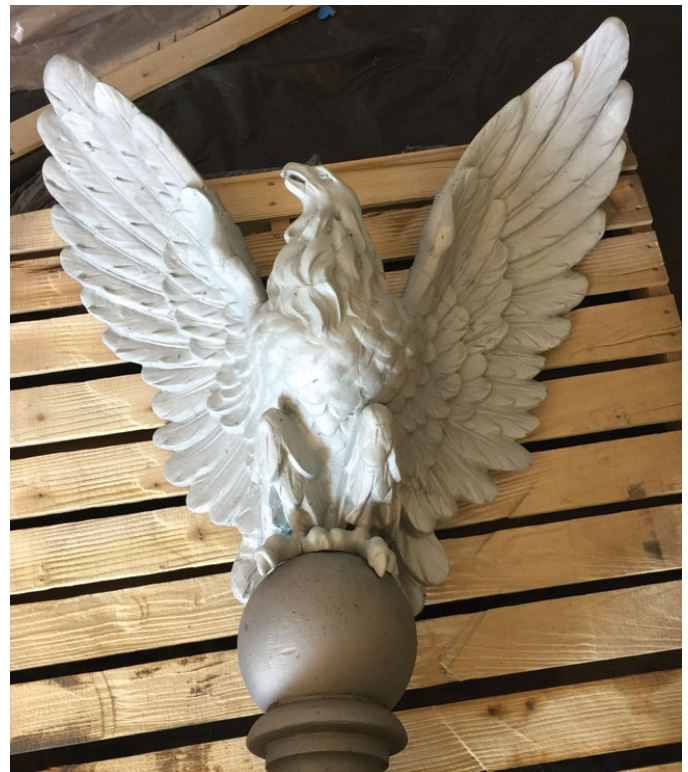
*Figure 16. Aluminum is a highly corrosion-resistant metal that is commonly used as a substitute material for cast iron. Aluminum can be a more affordable and lightweight alternative to cast iron that retains a similar texture, shape, and maintenance cycle. Photo: NPS.*

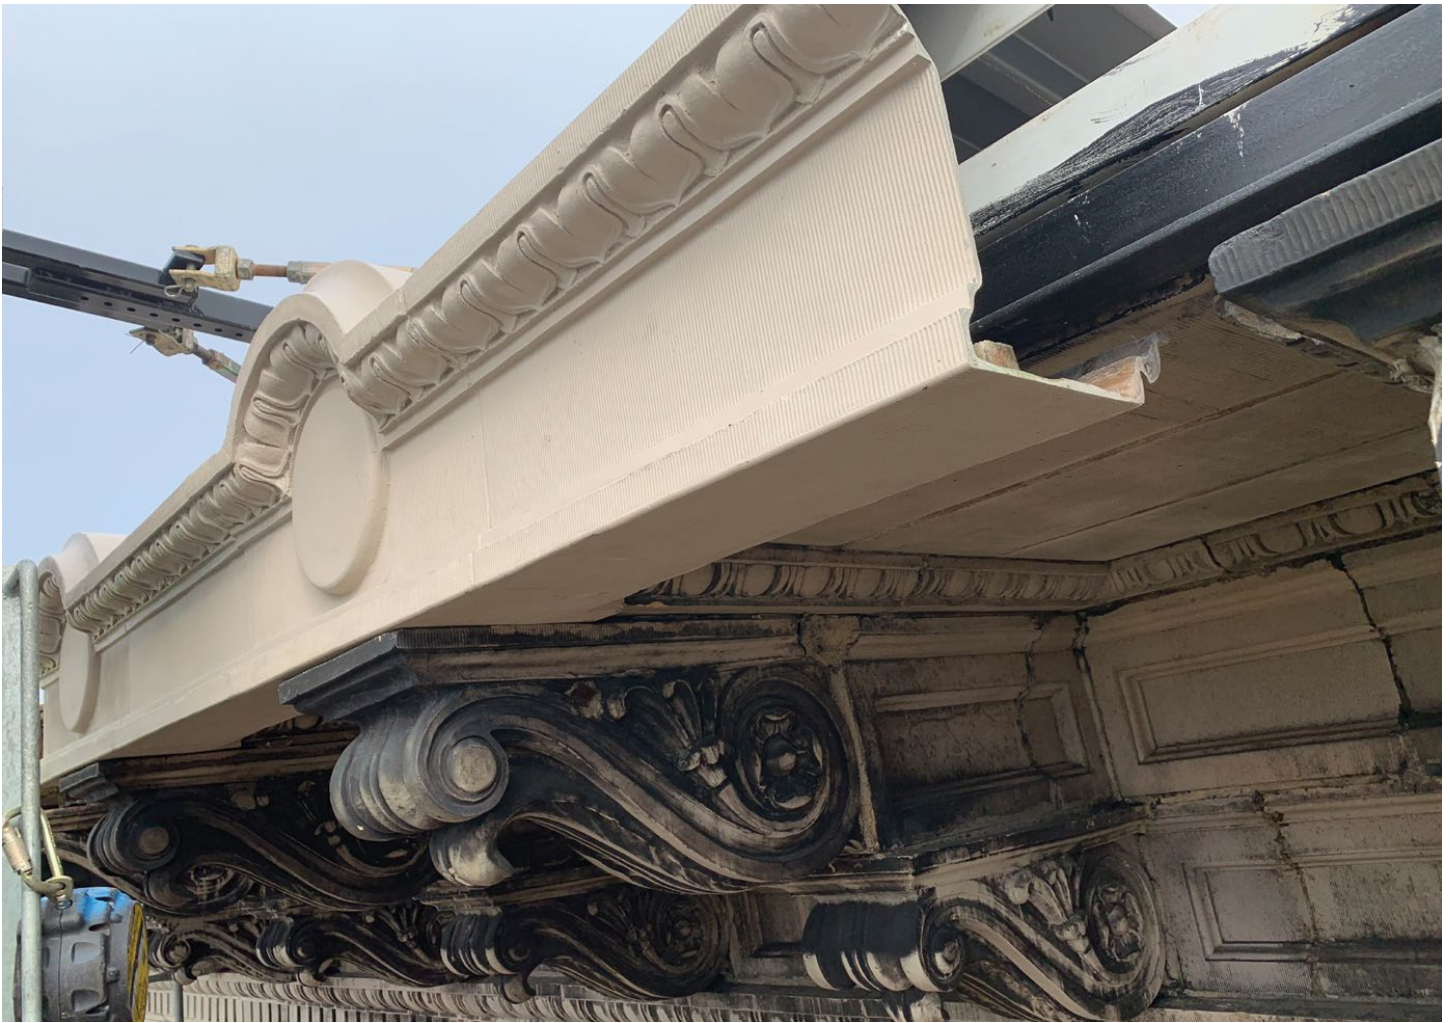
Figure 19. A new, lightweight fiber reinforced polymer is attached to a new metal armature to replicate damaged and missing elements of a terra cotta cornice. Photo: Quinn Evans.
