THE SECRETARY  
OF THE INTERIOR'S  
**STANDARDS FOR  
THE TREATMENT  
OF HISTORIC  
PROPERTIES**

WITH  
**GUIDELINES FOR  
PRESERVING,  
REHABILITATING,  
RESTORING &  
RECONSTRUCTING  
HISTORIC  
BUILDINGS**

U.S. Department of the Interior  
National Park Service  
Technical Preservation Services

2017

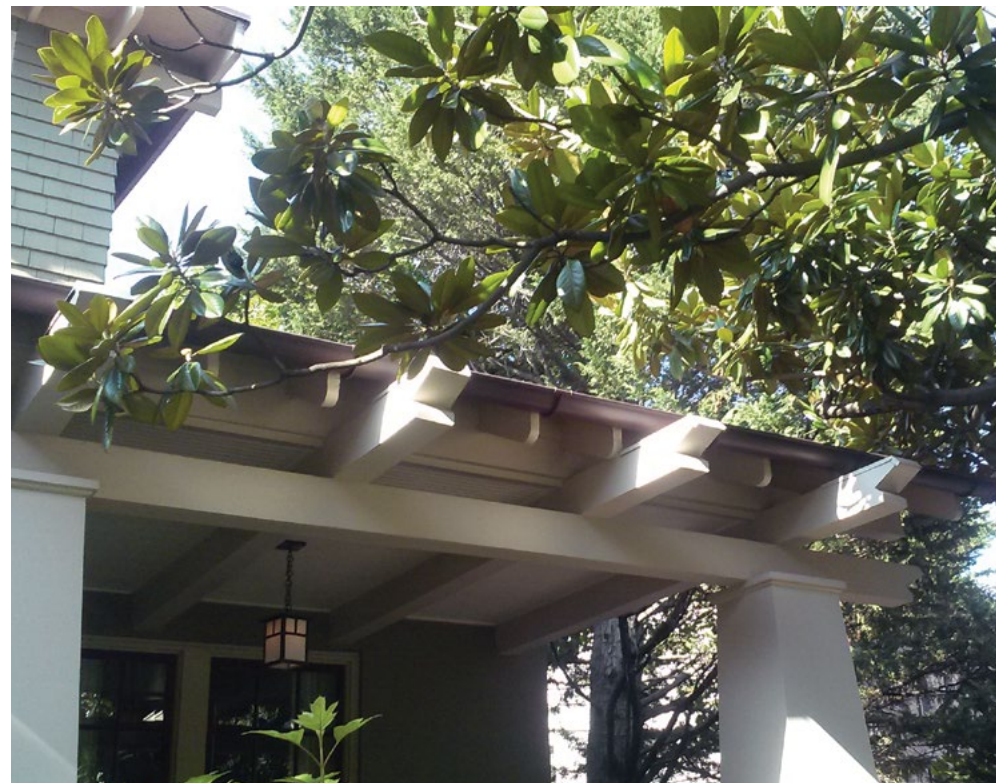
[12] Repair and limited replacement in kind to match deteriorated wood porch features is always a recommended preservation treatment.

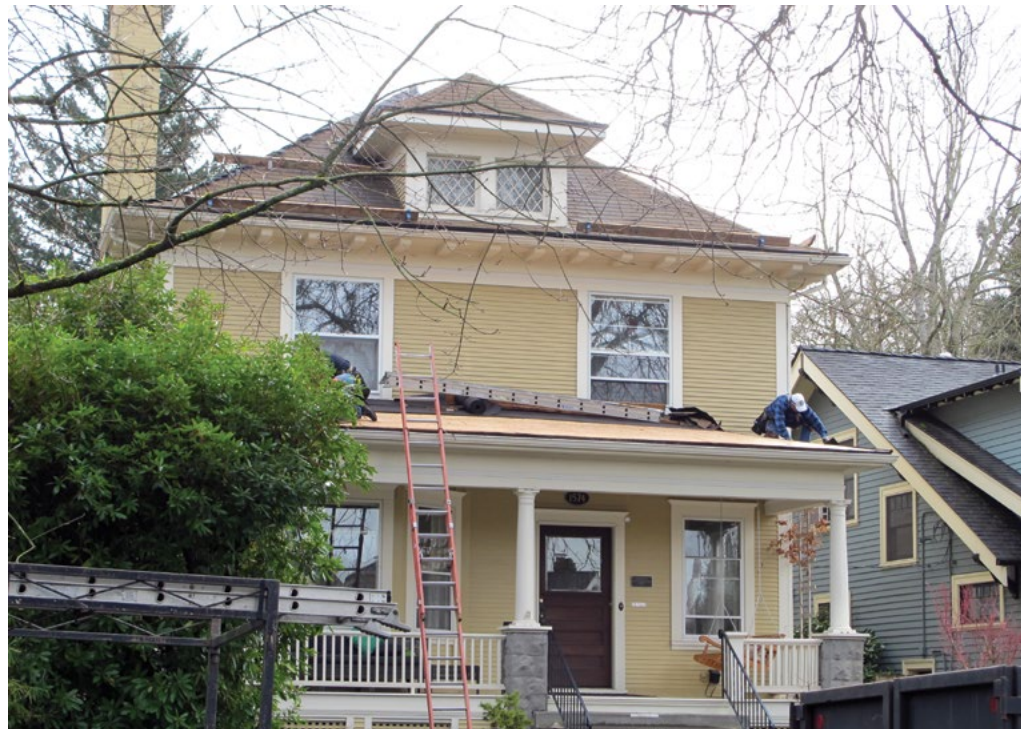
[16] The deteriorated asphalt shingles of this porch roof are being replaced in kind with matching shingles.

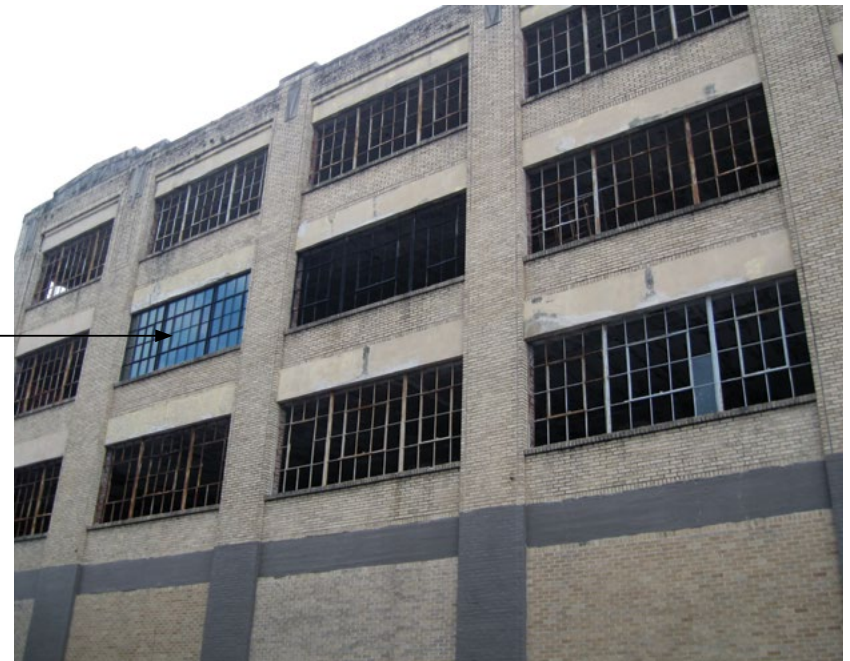
[19] Installing a mockup of a proposed replacement window can be helpful to evaluate how well the new windows will match the historic windows that are missing or too deteriorated to repair.

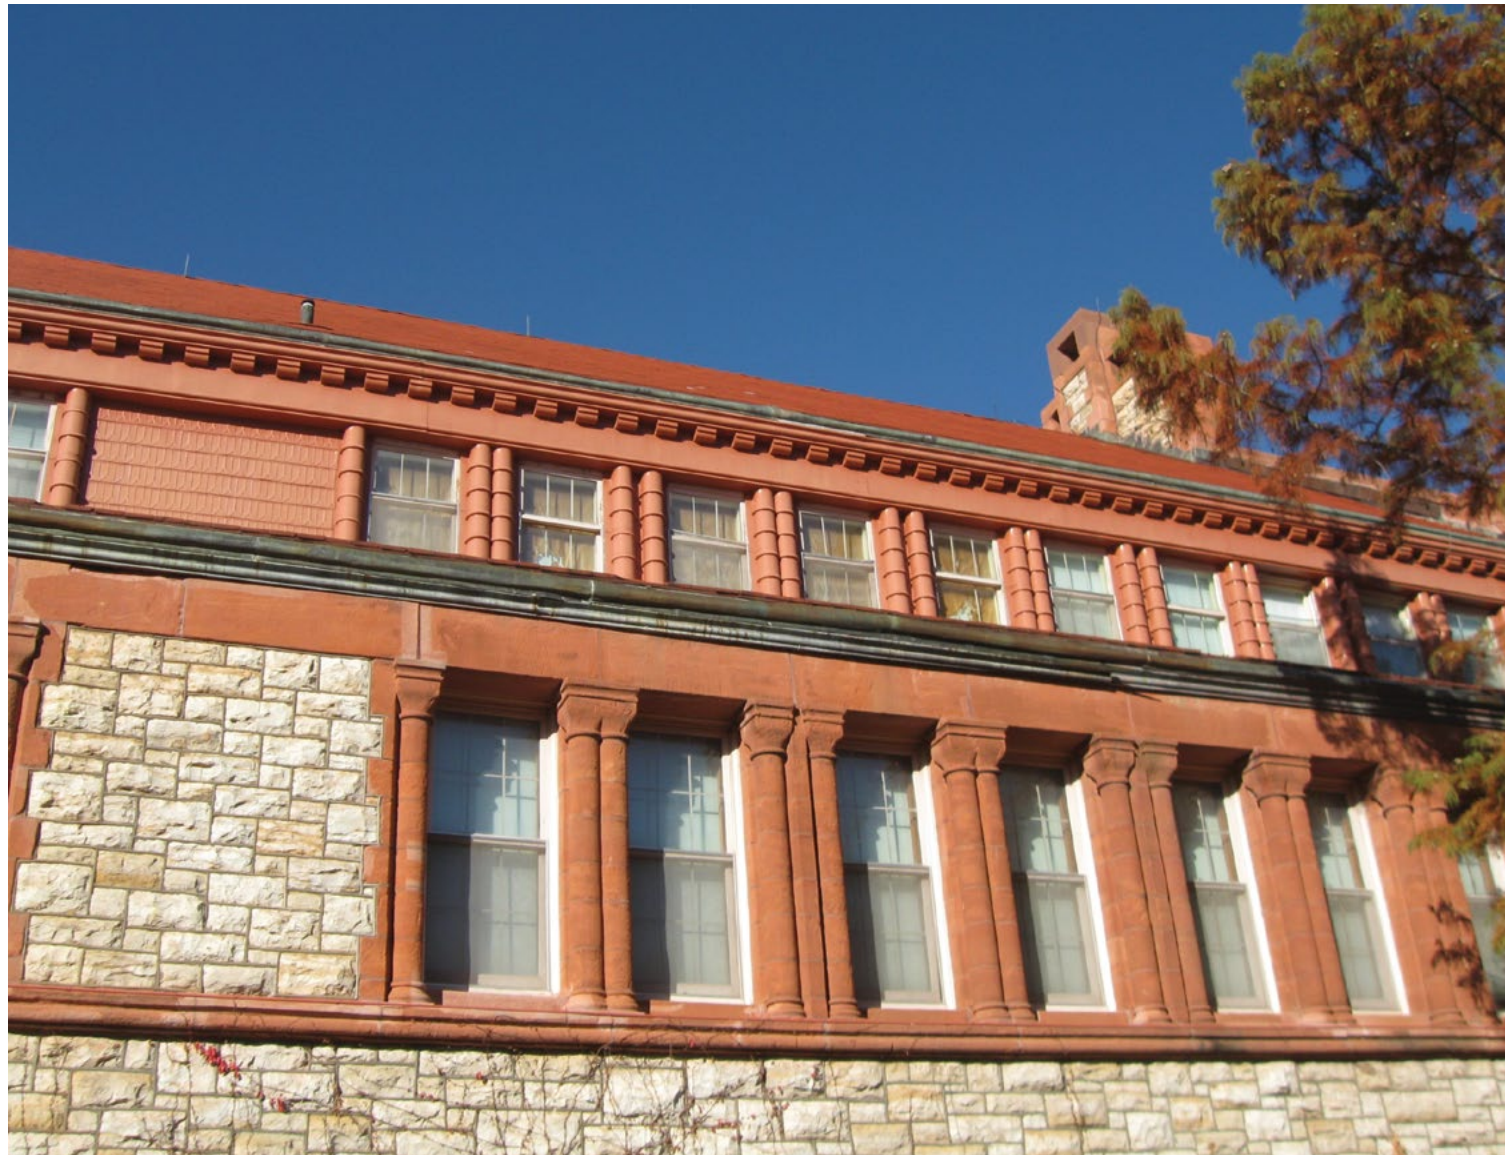
[6] Preliminary work before starting restoration revealed that the columns and the decorative shingles ornamenting the top floor of this historic building were fabricated of metal to imitate the red sandstone used elsewhere on the building.
