The Secretary  
of the Interior's  
Standards for  
Rehabilitation &

**I**llustrated  
Guidelines  
for  
Rehabilitating  
Historic  
Buildings

U.S. Department of the Interior  
National Park Service  
Cultural Resources  
Heritage Preservation Services

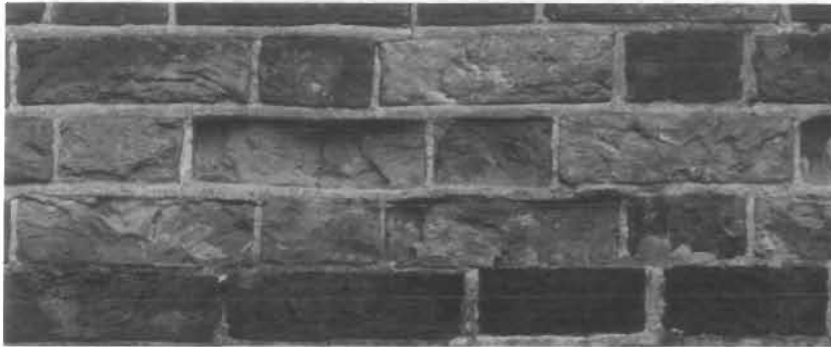
*Too hard and inflexible a mortar has caused this soft, 18th century brick to spall.*

Repointing with mortar of high portland cement content (unless it is the content of the historic mortar). This can often create a bond that is stronger than the historic material and can cause damage as a result of the differing coefficient of expansion and the differing porosity of the material and the mortar.

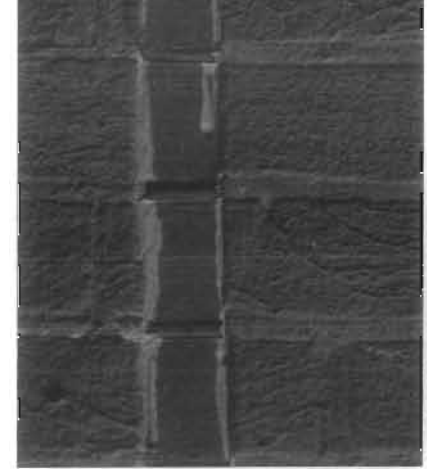
*When this brick wall was sandblasted, a downspout (since removed) protected the original smooth surface of the center strip from damage.*

Sandblasting brick or stone surfaces using dry or wet grit or other abrasives. These methods of cleaning permanently erode the surface of the material and accelerate deterioration.

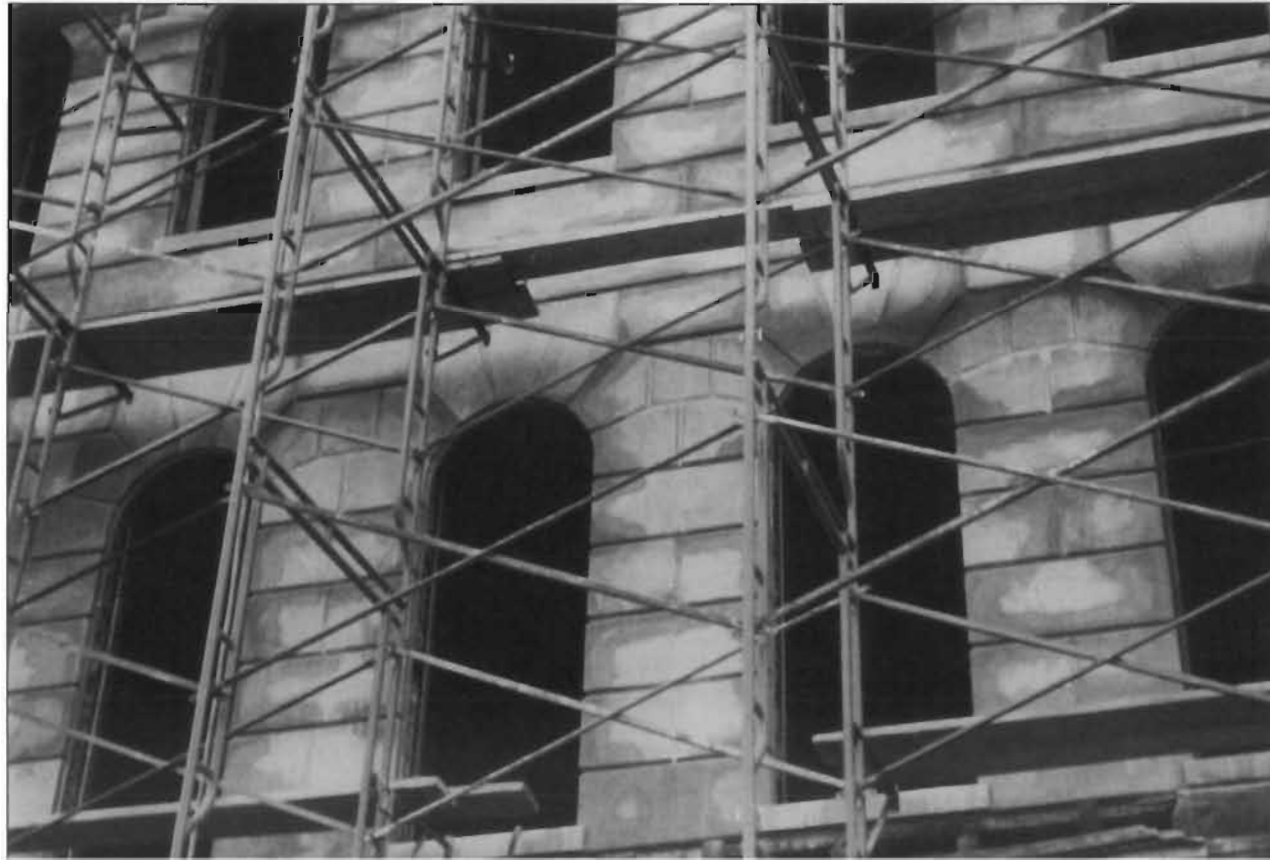
*Composite patching with a cementitious mixture is being used to repair eroded areas of this sandstone facade.*

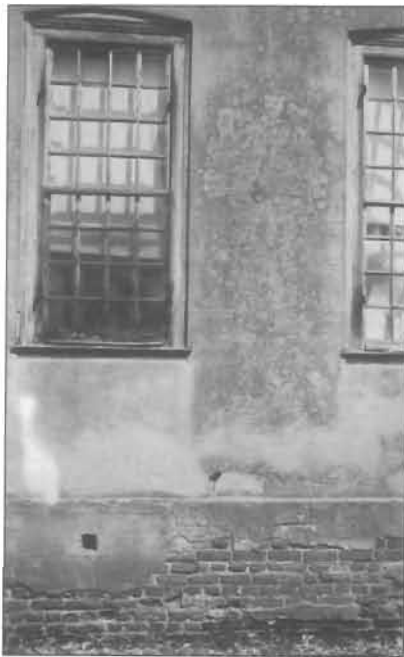
*Excessive moisture has damaged not only the stuccoed wall surface, but also the brick substrate.*

*Moisture from a faulty roof and drainage system has been trapped inside this limestone cornice by a waterproof coating, causing severe damage to the stone.*

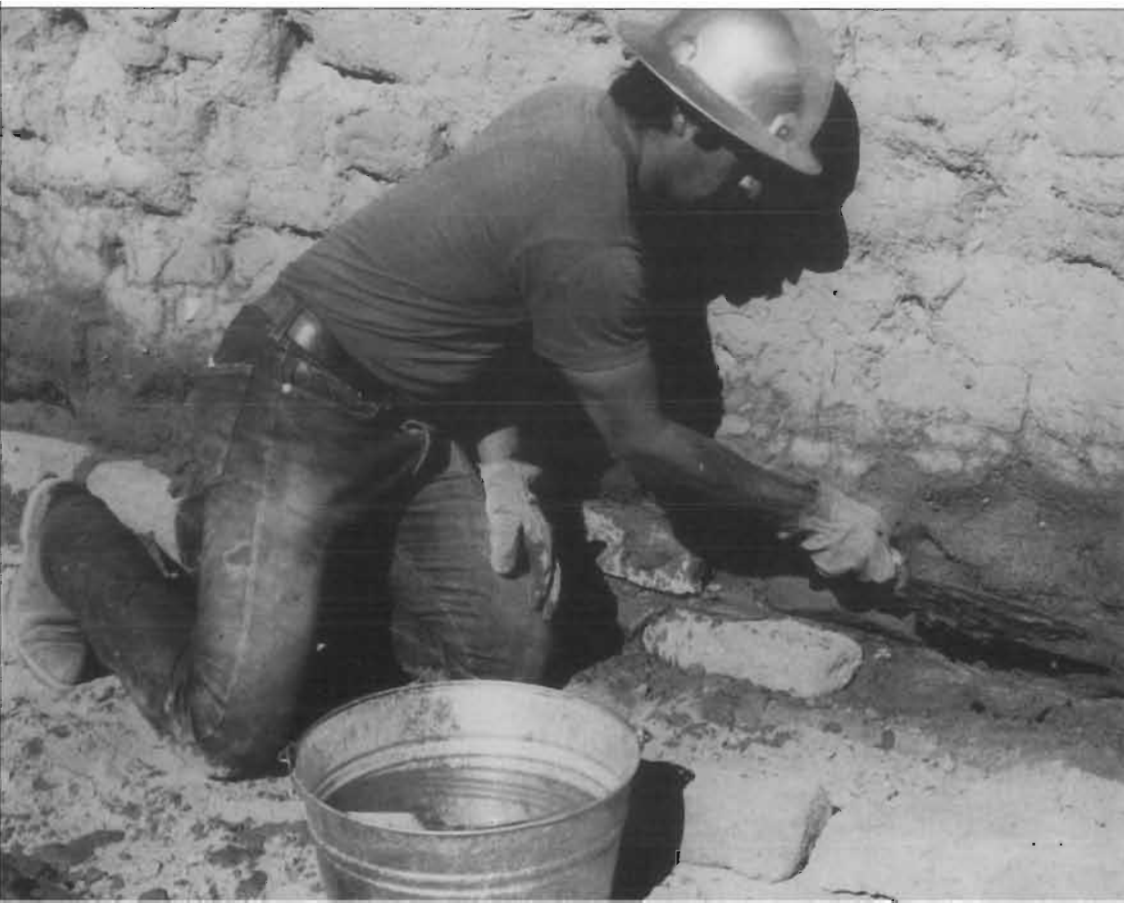
*Coving—the hollowing out of an adobe wall just above grade—may be caused by standing rainwater, rainwater splash-up from the ground, or by salts deposited in the adobe by moisture evaporation. This adobe wall is being patched in the traditional manner with adobe mud.*

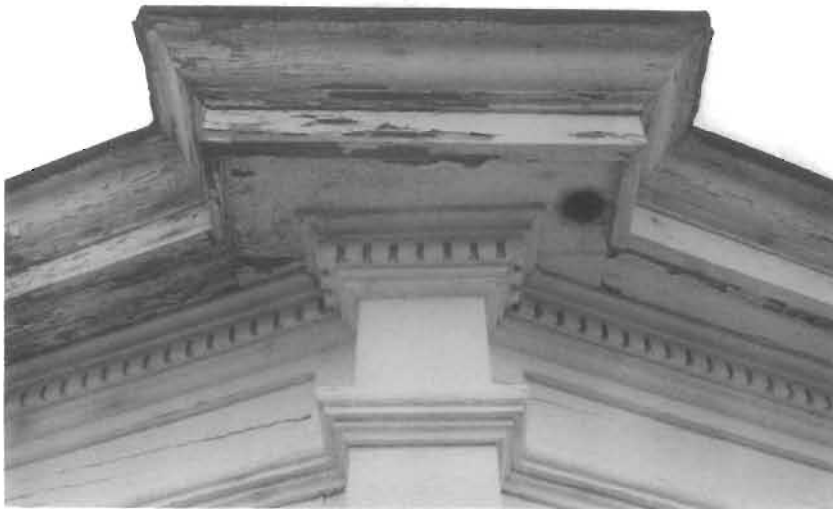
*Due to lack of maintenance, the paint has peeled to bare wood. In order to survive, this cornice will need to be scraped, sanded, and re-painted together with other essential repairs.*

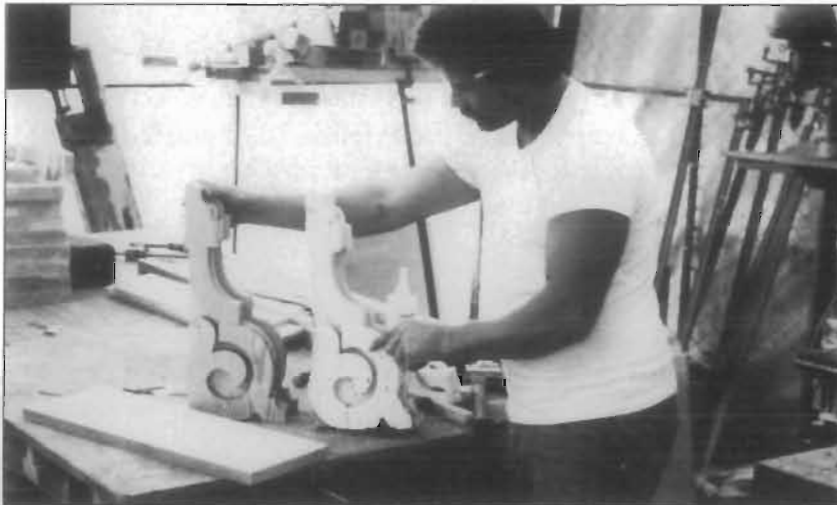
*If a character-defining feature is missing, it should be replaced with a matching feature. This shop artisan used traditional tools to replicate a missing porch bracket; after the new bracket is painted, both original and duplicate will be installed on-site.*

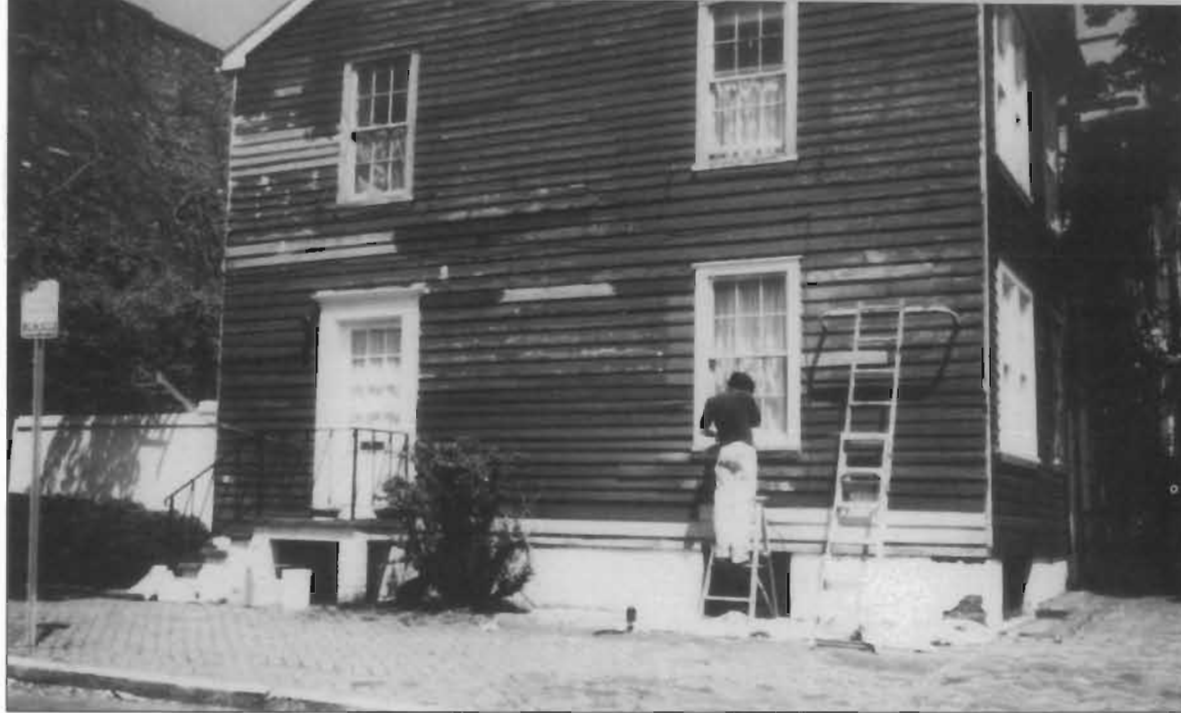
*Deteriorated clapboards are being selectively replaced, thereby maximizing retention of the historic siding.*

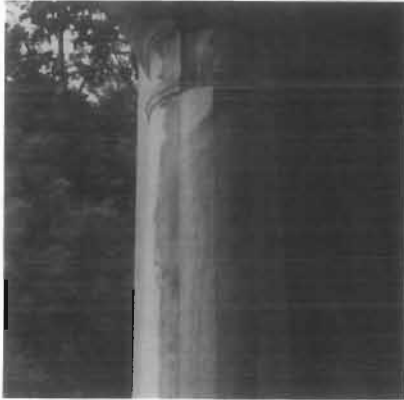
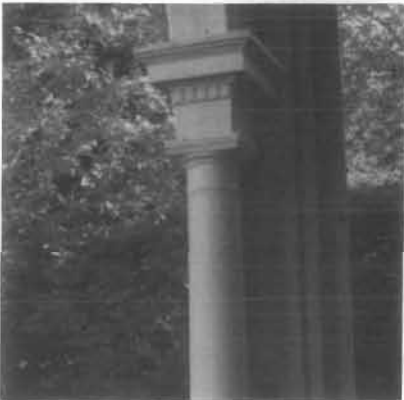
*To replace deteriorated portions of the column, strips of new wood were milled to conform to the shape and appearance of the old column framework, glued in place, then back-primed and painted.*

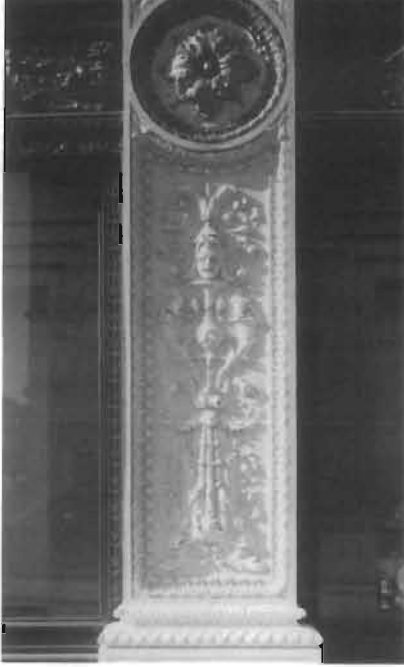
*The decorative cast-iron storefront column was sandblasted in order to remove flaking paint and rust prior to repainting. Unlike soft metals such as copper and tin, which are damaged by abrasive cleaning, sandblasting is an appropriate method for cleaning cast iron, a very hard metal.*

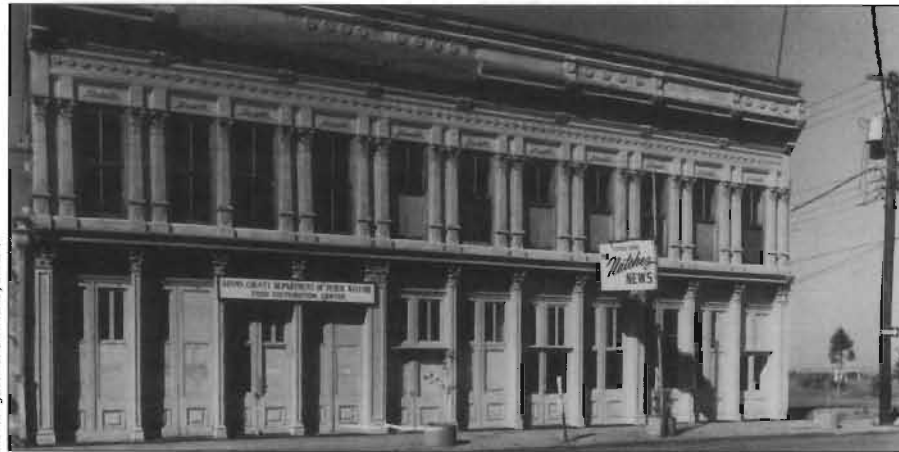
*Deteriorated portions of the decorative pressed metal cornice have been inappropriately replaced with non-matching, plain metal sheets, adversely affecting the historic character of this building.*

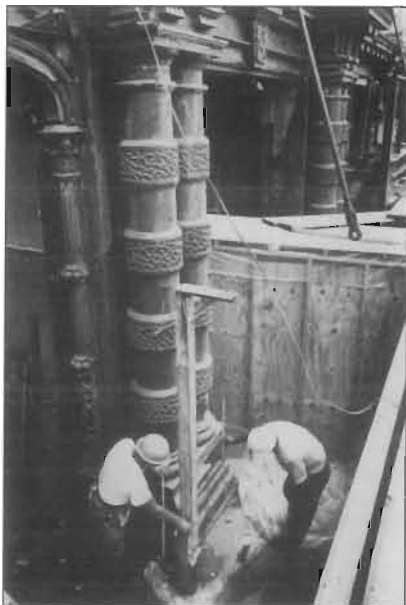
*The cast-iron columns of this theater are being repaired during rehabilitation. Some of the cast iron elements such as the smaller, non-structural columns missing from the bay on the right will be replaced with a lightweight substitute material such as cast aluminum, an acceptable alternative according to the Standards.*

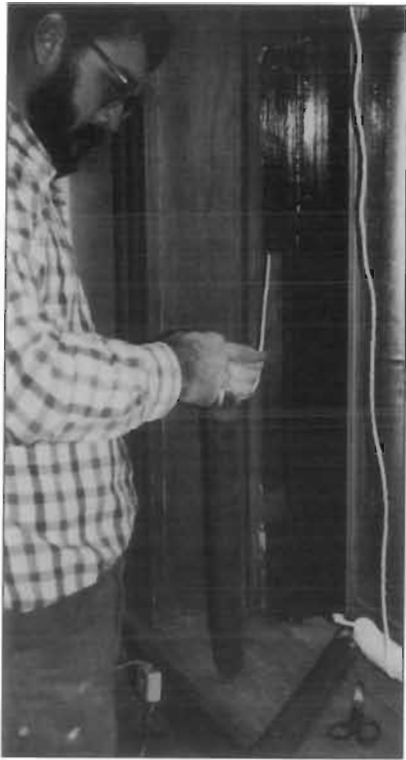
Maintaining a historic window may include work as basic as replacing a sash cord.

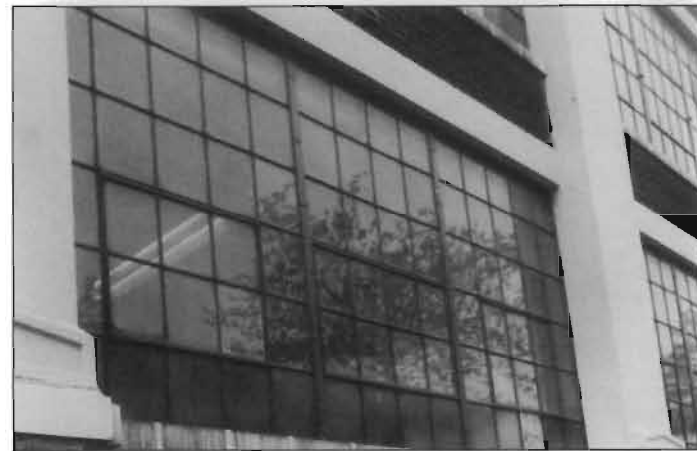
*The steel pivot windows in this historic manufacturing building were replaced with new windows which matched the multi-lighted originals.*

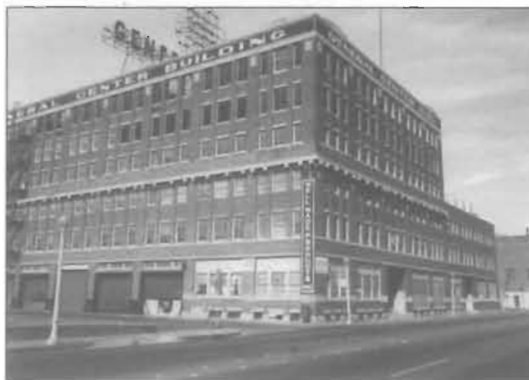
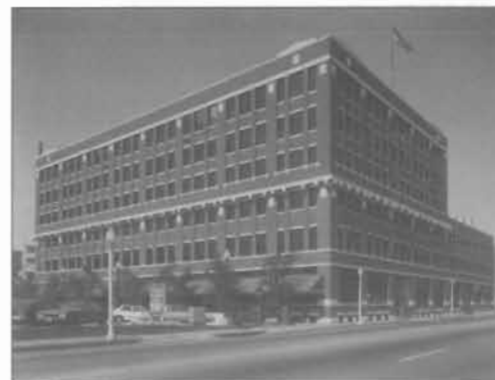
*When the six-over-six windows were replaced with inappropriate single sheets of tinted glass, the historic industrial character of this building was lost.*

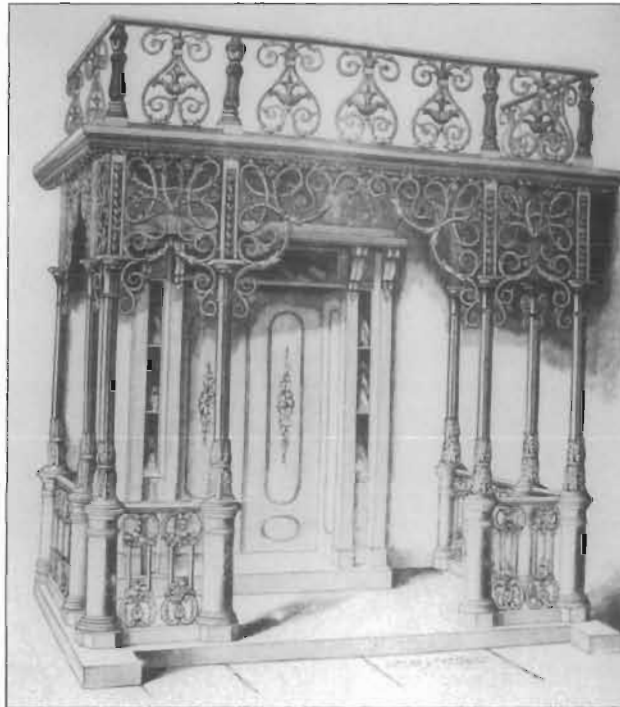
*In the 19th century some cast-iron porches could be purchased by mail, such as this made-to-order veranda which was featured in an 1870 foundry catalog.*

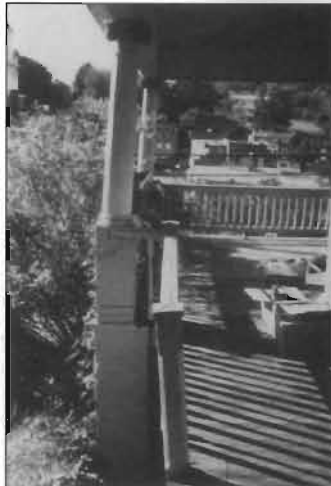
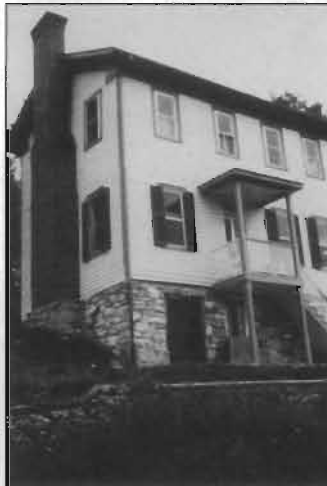
*A 1910 wrap-around porch was removed from this 1830 house during rehabilitation. Although a later addition, the porch should not have been removed because it had acquired significance over time and was thus an important feature in defining the character of this historic structure.*

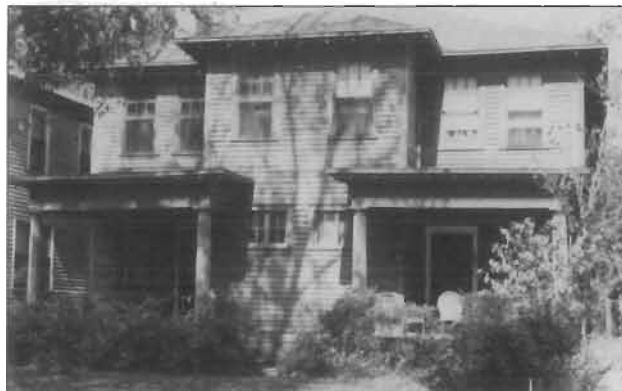
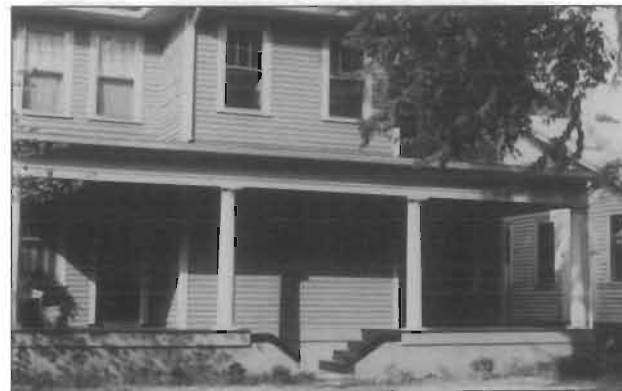
*This rehabilitation connected two separate porches, resulting in the creation of a large continuous porch that obscures the historic twin porch design; it is thus incompatible with the historic character of the house.*

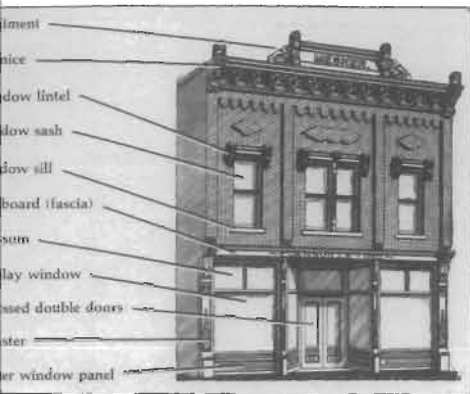
*These architectural details are typical of historic commercial buildings (this particular one is No. 4016 in the George L. Mesker and Company catalog of 1905). The design utilized both cast and galvanized iron.*

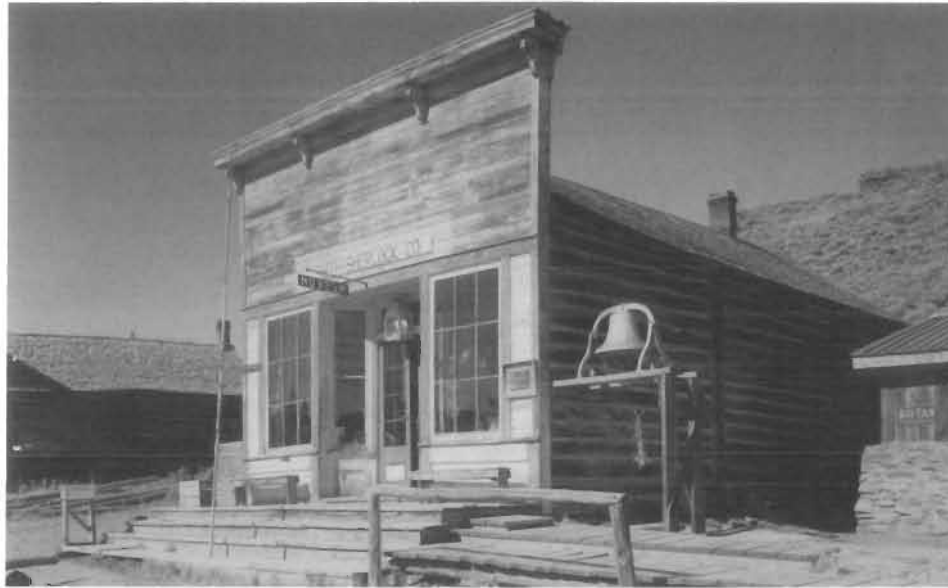
*A false-fronted wood store is now used as a museum. Although the weathered wood is part of its charm, repainting is recommended as a good maintenance practice to protect the wood.*

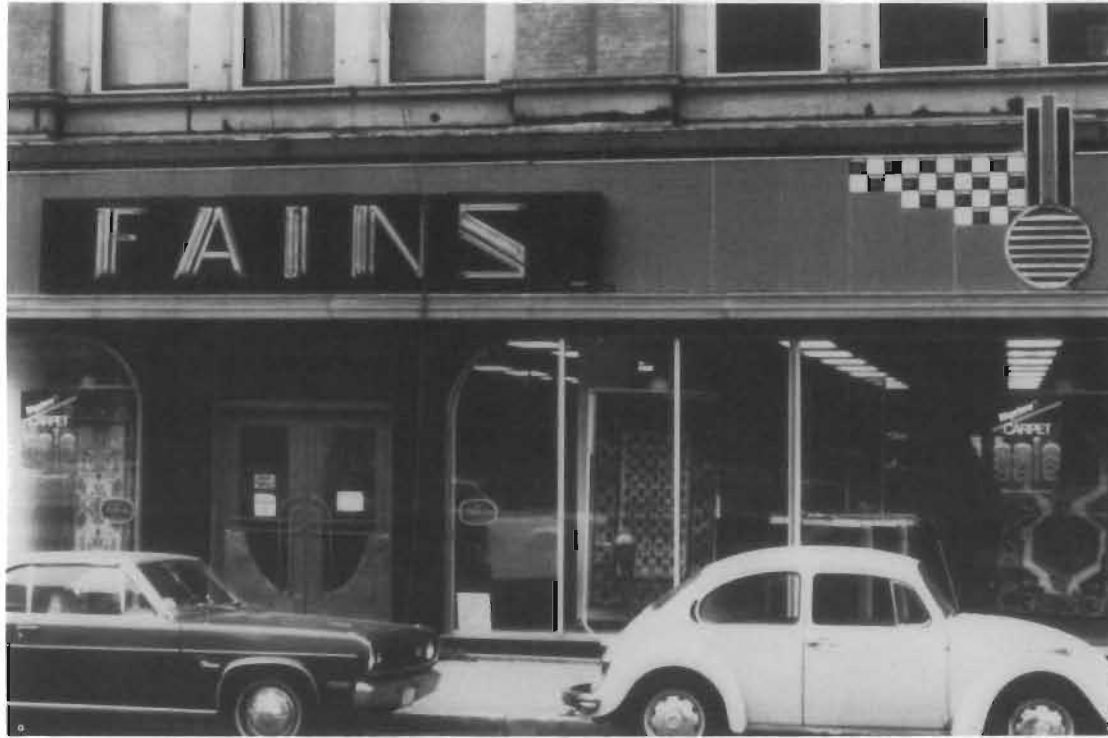
*This sleek red and black Moderne storefront was added to a more staid late-19th century commercial building in the 1930s—both are now in need of repair. According to the Standards, later storefronts that have acquired significance over time should generally be retained in rehabilitation.*

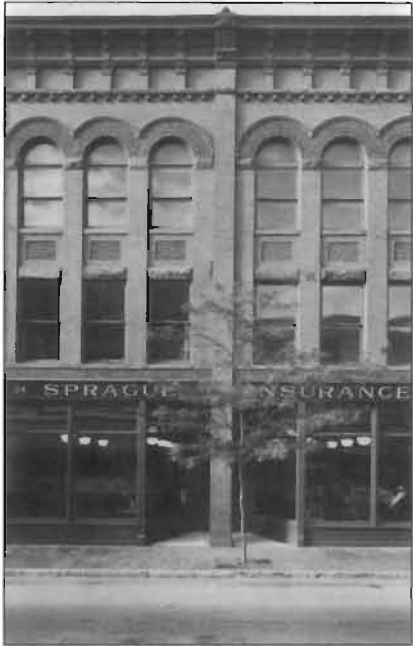
*This appropriate new storefront replaces an old one that was too deteriorated to save. It features a recessed doorway based on the historic design and respects the scale and proportion of the existing building.*

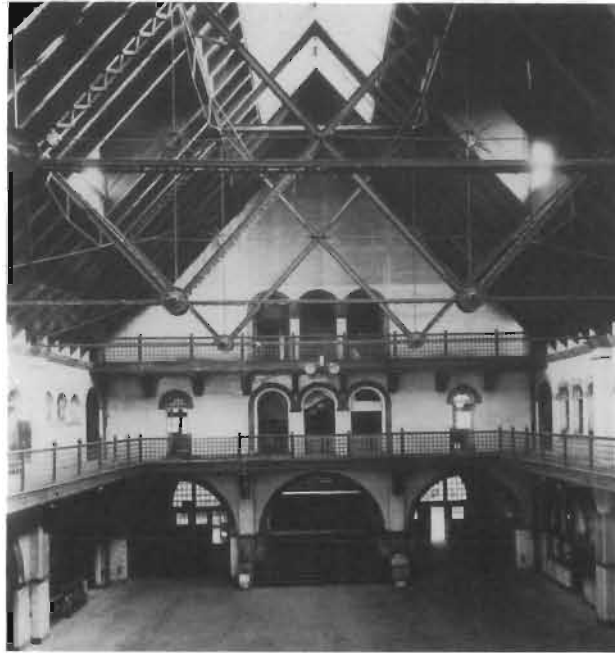
*The exposed metal roof-truss system of this waiting room not only provides structural support, but is also important in defining the interior character of the train station.*

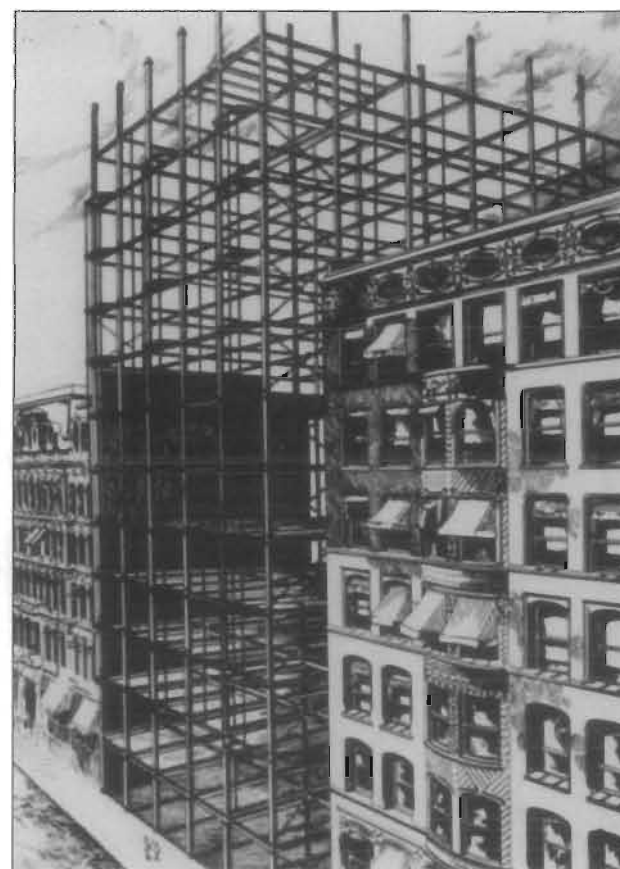
Iron and Steel Skeleton Frame, Unity Building, Chicago, Illinois, 1891-1892 (Clinton J. Warren, architect). *The development of the skeleton frame was pioneered by architects of the "Chicago School" in the late-19th century. With this method the weight of the building is carried on the frame, not the walls, allowing the construction of taller buildings without increasing the wall thickness.*

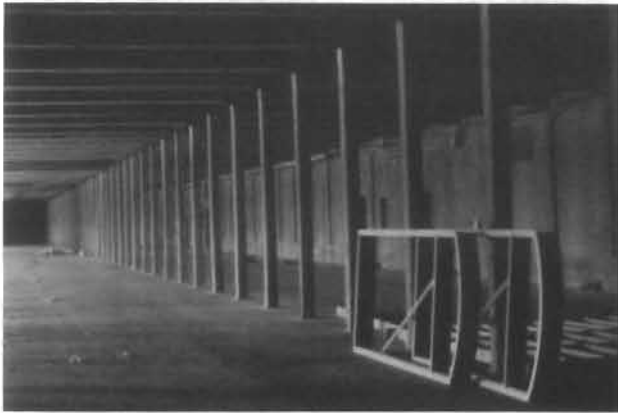
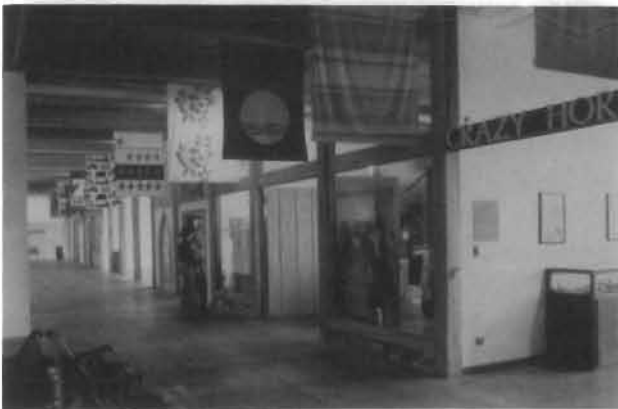
*These before and after rehabilitation photographs offer a good example of a project that took into account, and respected, the unique industrial structural character of this mill building in its conversion to a shopping mall.*

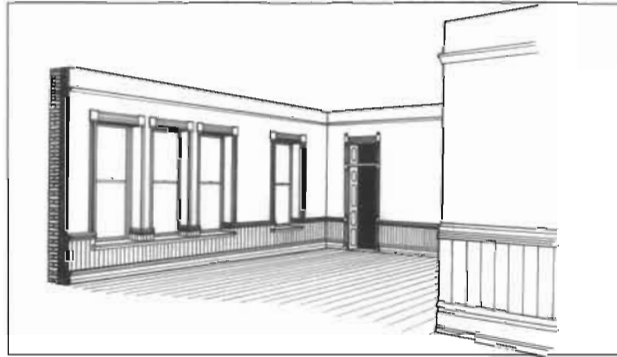
*Furring out exterior walls to add insulation and suspending new ceilings to hide ductwork and wiring can change a room's proportions and can also destroy or obscure significant decorative detailing.*

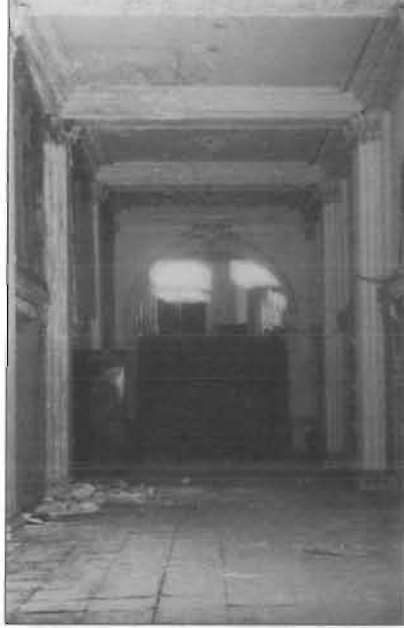
*Before and after: Prior to rehabilitation of this hotel, water intrusion and freeze-thaw cycles had caused extensive efflorescence and plaster failure. The ornamental plaster was almost fully re-manufactured, then gilded. Light fixtures and other detailing were also carefully replicated.*

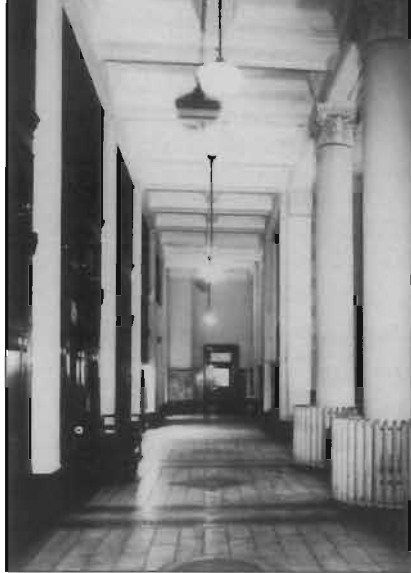
*The visible features of historic mechanical systems, such as heating, lighting, and plumbing, may sometimes help define the overall character of an interior.*

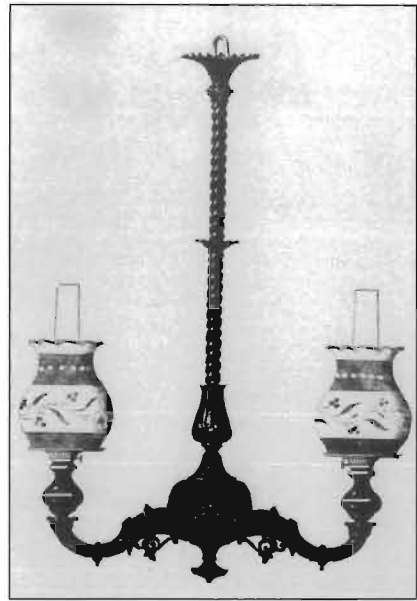
*A gaslight may be converted for electrical use to extend its functional and decorative life.*

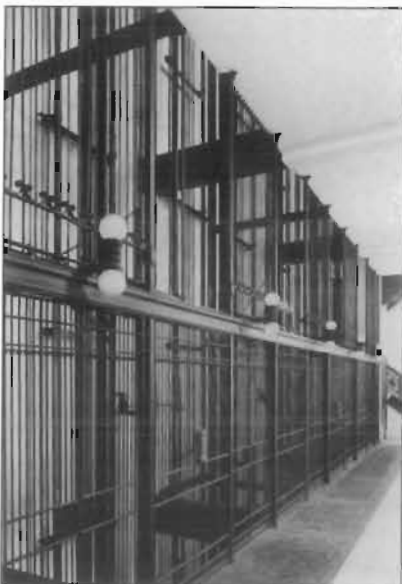
*Both function and design elegance are evident in this row of cast iron elevator cages and light fixtures adorning an early-20th century commercial building.*

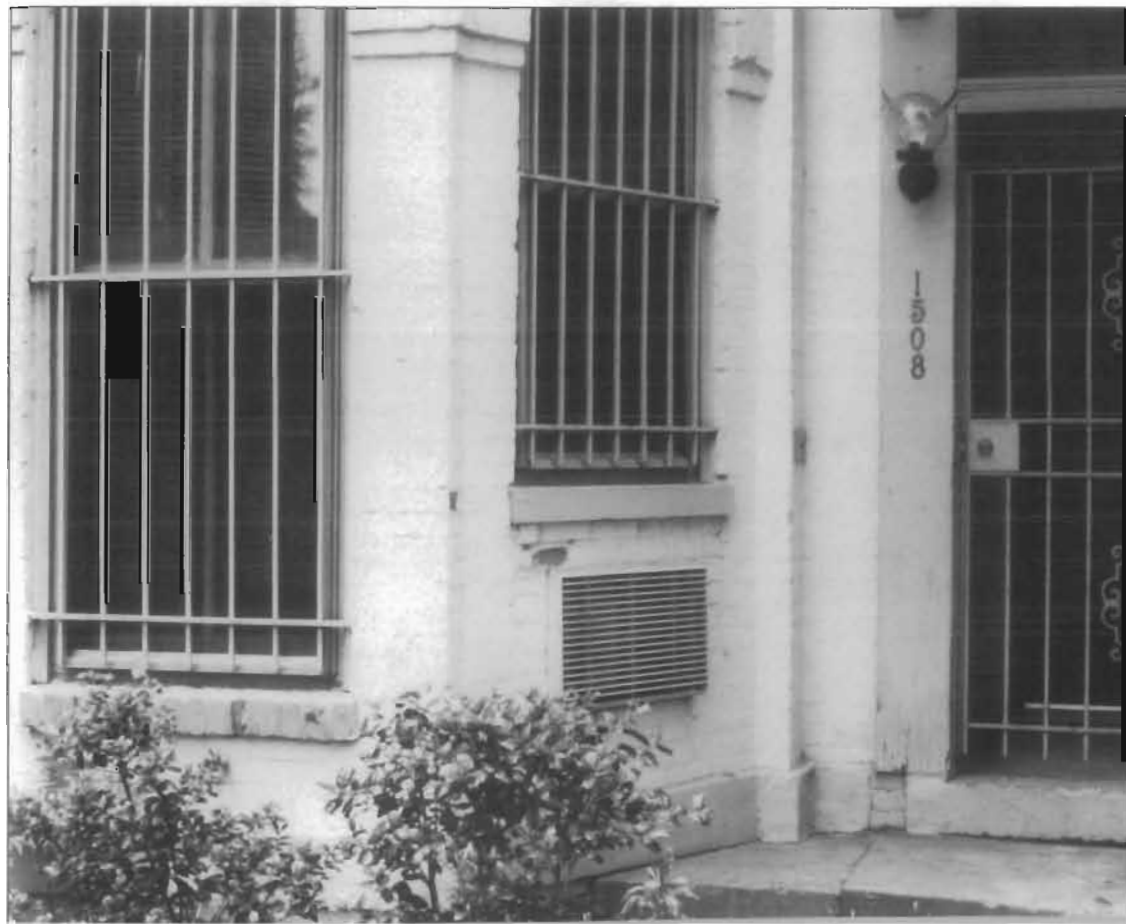
*The historic window on a primary facade has been shortened and the area below it filled in with brick in order to install a through-the-wall air conditioning unit. In addition to changing the window size and destroying the sill, the unit itself is visually obtrusive.*

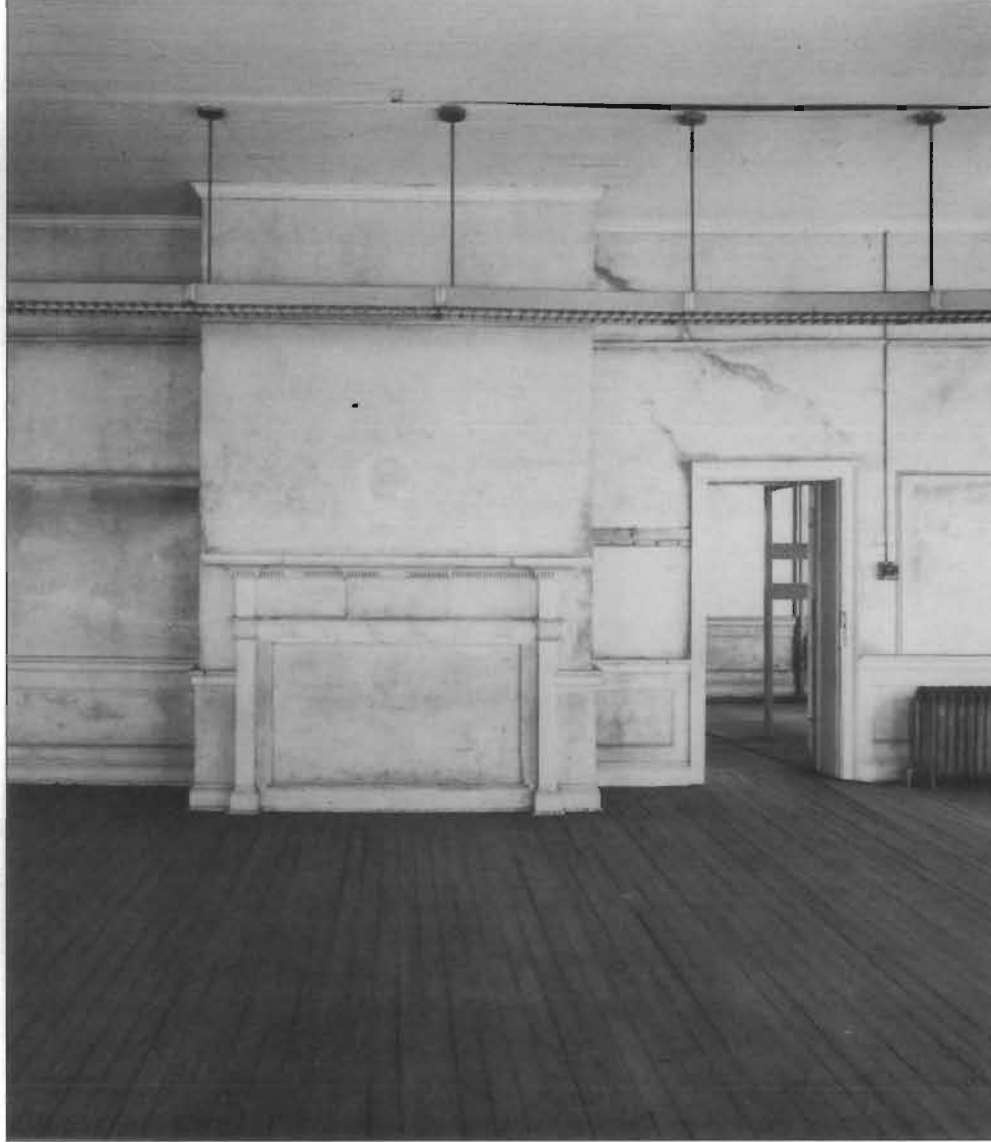
*This row of hanging fluorescent lights installed in an earlier renovation mars an otherwise classically detailed interior. They have also caused the historic beaded ceiling to pull away from the joists.*

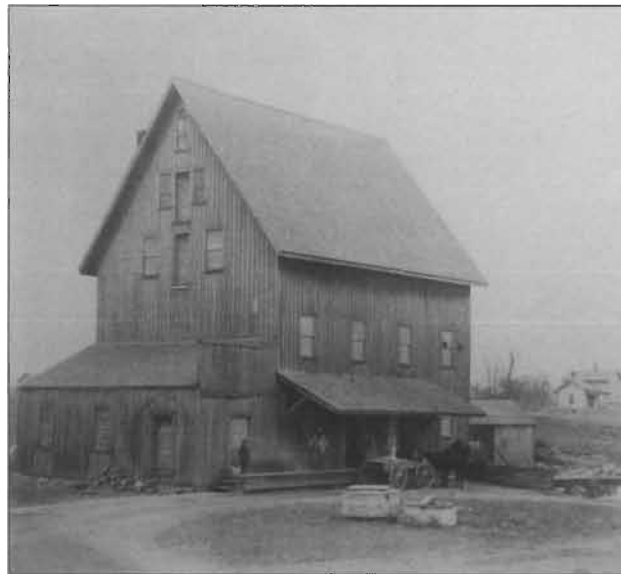
*The stream and circular wagon approach are important features of this historic mill site.*

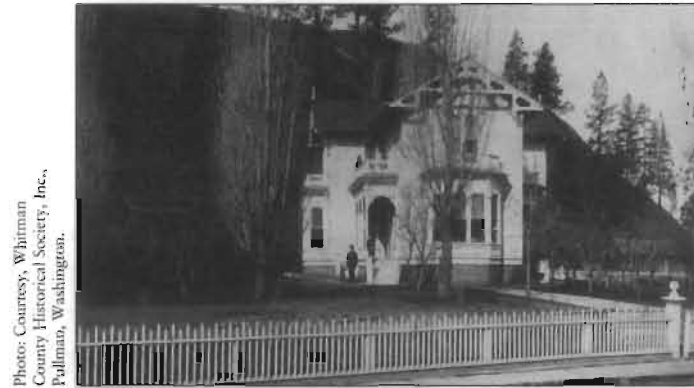
*Landscape features that are important in defining the historic character of a building site may include fences, walks, and small outbuildings, as well as trees, bushes and topography that may be unique, such as the hill behind the house.*

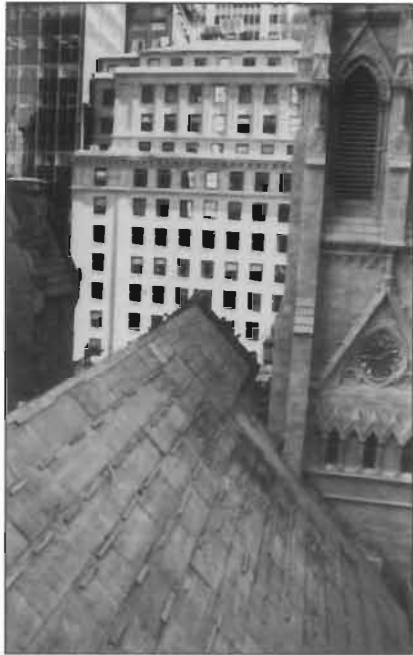
▲► The roof and stained glass windows of this historic church have been appropriately covered with plywood as a protective measure during construction of a new building on an adjacent lot.

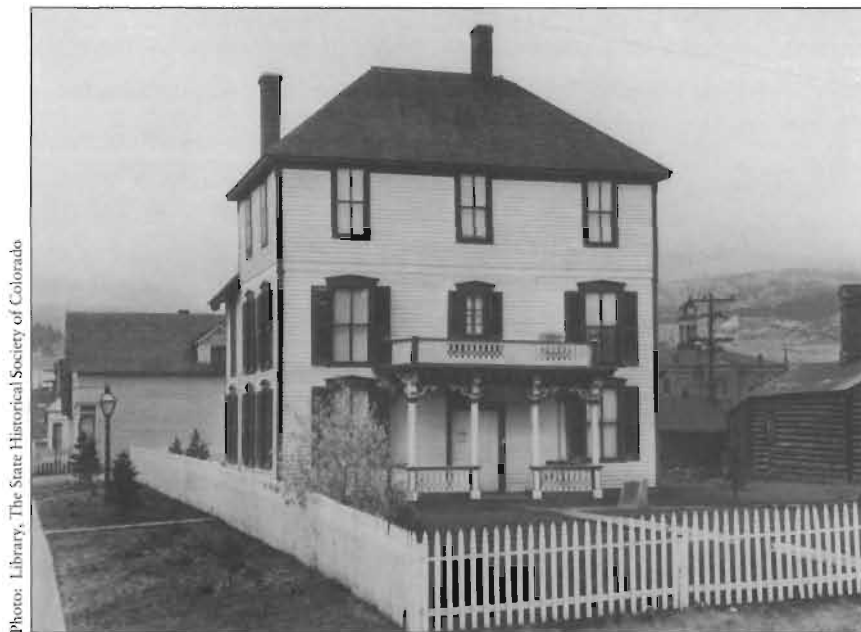
*This wood picket fence is as important to the site as the shutters, porch detailing, and clapboards are to the house. As such, the fence was carefully repaired and painted as part of an overall project to preserve the historic residence.*

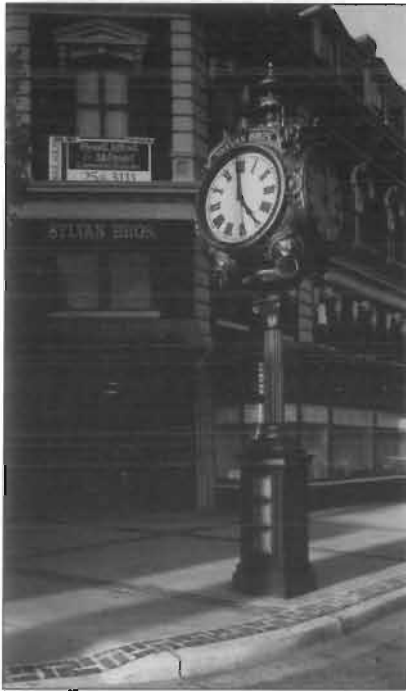
*Street furniture such as this historic clock helps define an urban district's character and thus should be retained in a rehabilitation.*

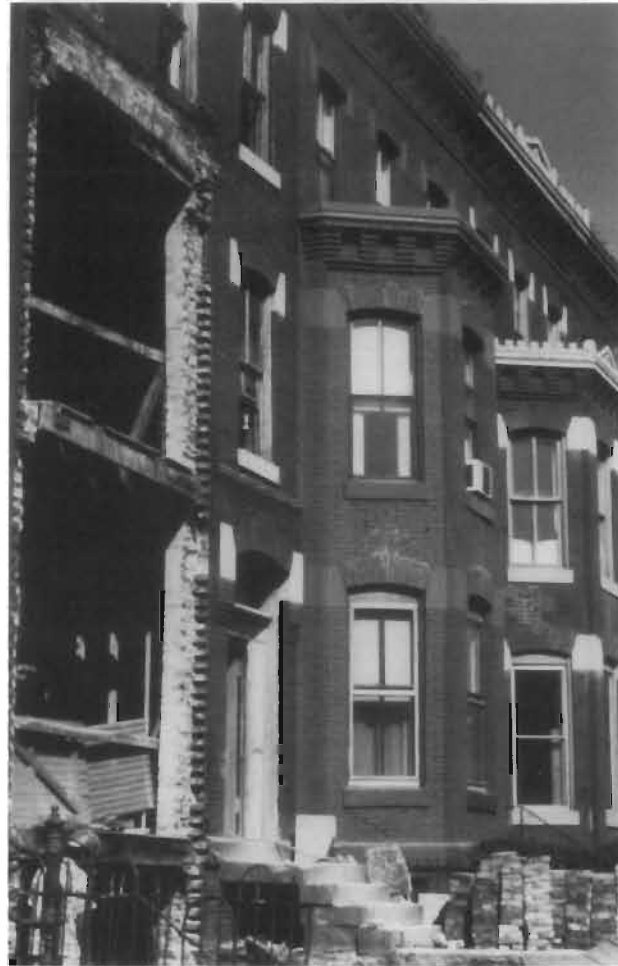
*This late-19th century residential historic district is characterized by brick row-houses with two-storied bays. A streetscape's visual continuity can be marred by an insensitive rehabilitation such as the one shown here. The original two-story brick bay of one of the houses was removed and replaced with a three-story bay that is incompatible in size, materials, and detailing.*

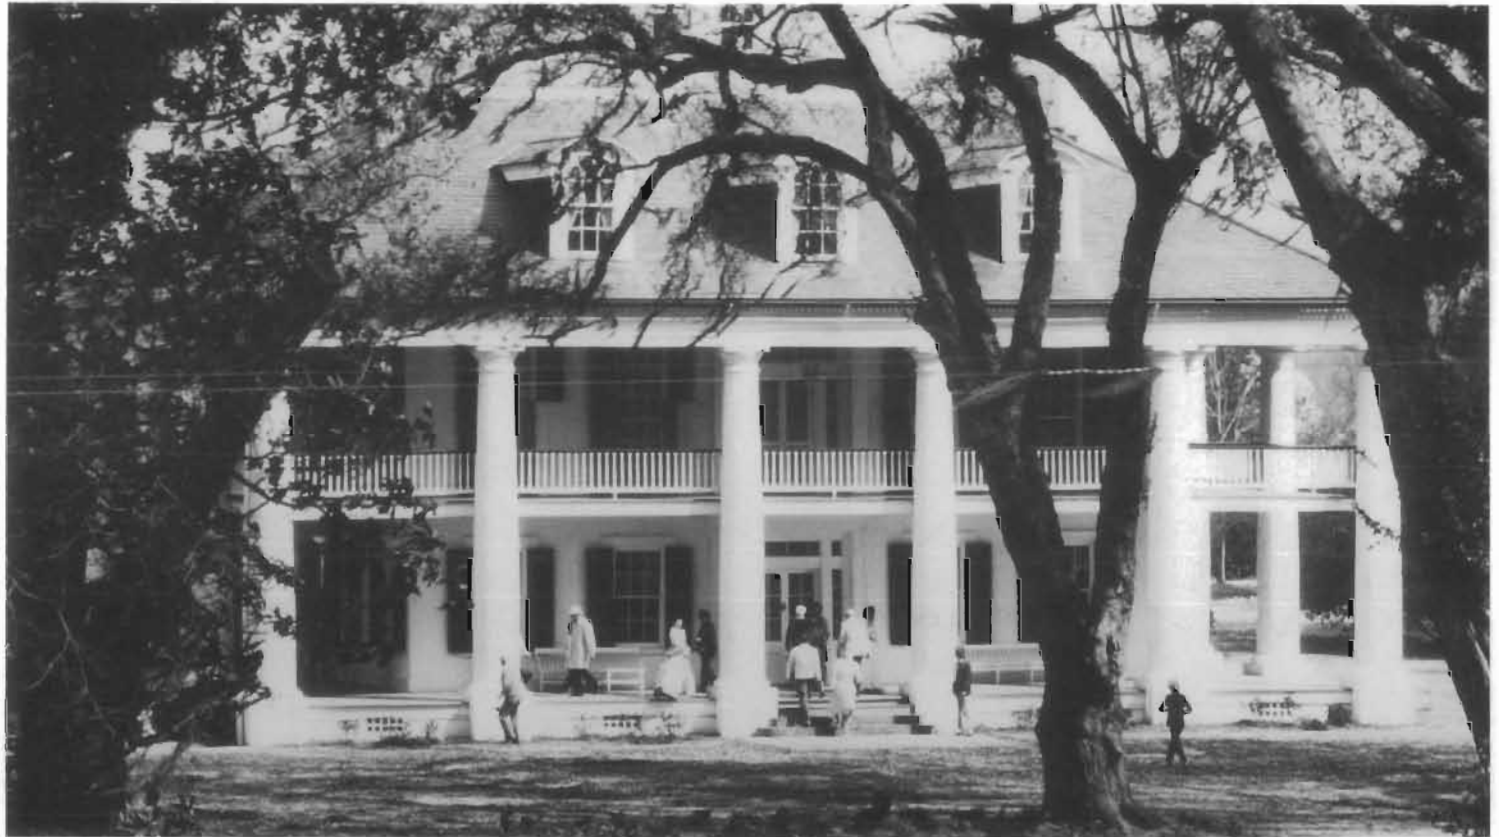
*In hot climates, buildings were historically designed to minimize the heat gain from the summer sun. The wide roof overhangs, exterior porches, shutters, shade trees, and heavy masonry walls (painted white) are all energy saving characteristics.*

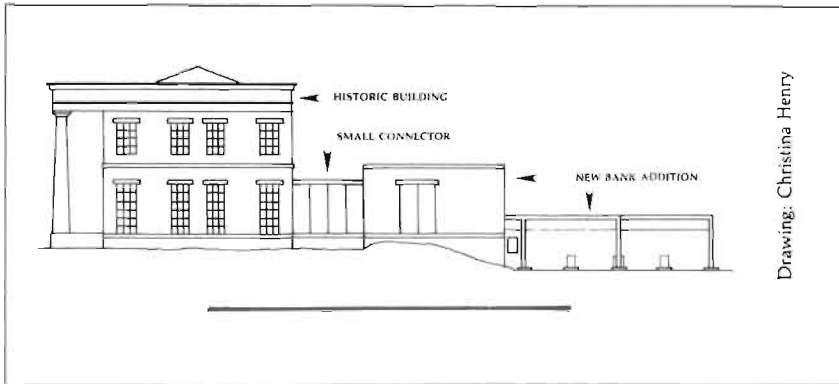
*An 1847 residence was successfully converted into a bank, with the construction of a low-scale addition. The drawing shows how the three-unit addition has been stepped down the hill, each unit set further back from the historic structure as it extends horizontally. As a result, the new addition is only partially visible from the historic "approach." The small connector was sensitively designed to minimize loss of historic building materials.*

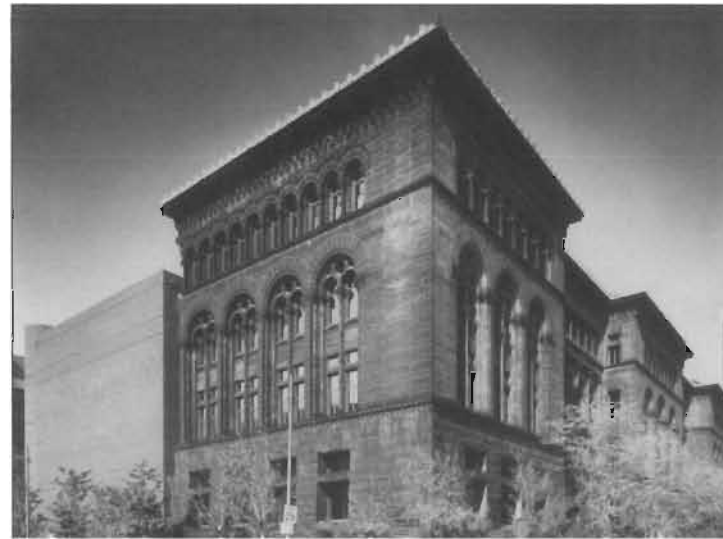
*A new 10-story wing added to the back of a historic library constitutes major expansion, yet is compatible because it reads as a subsidiary unit to the much larger historic building.*

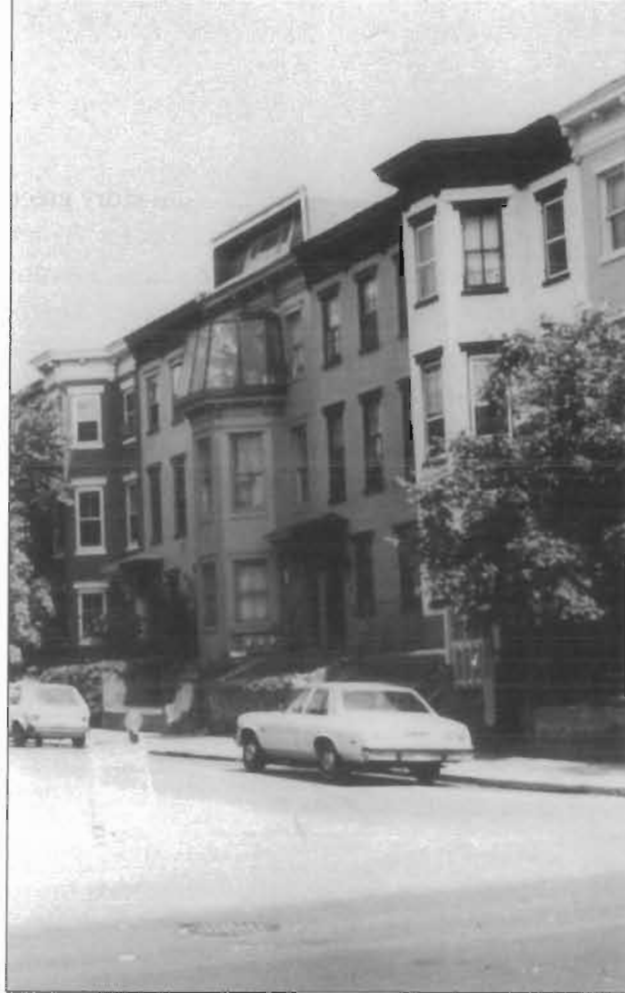
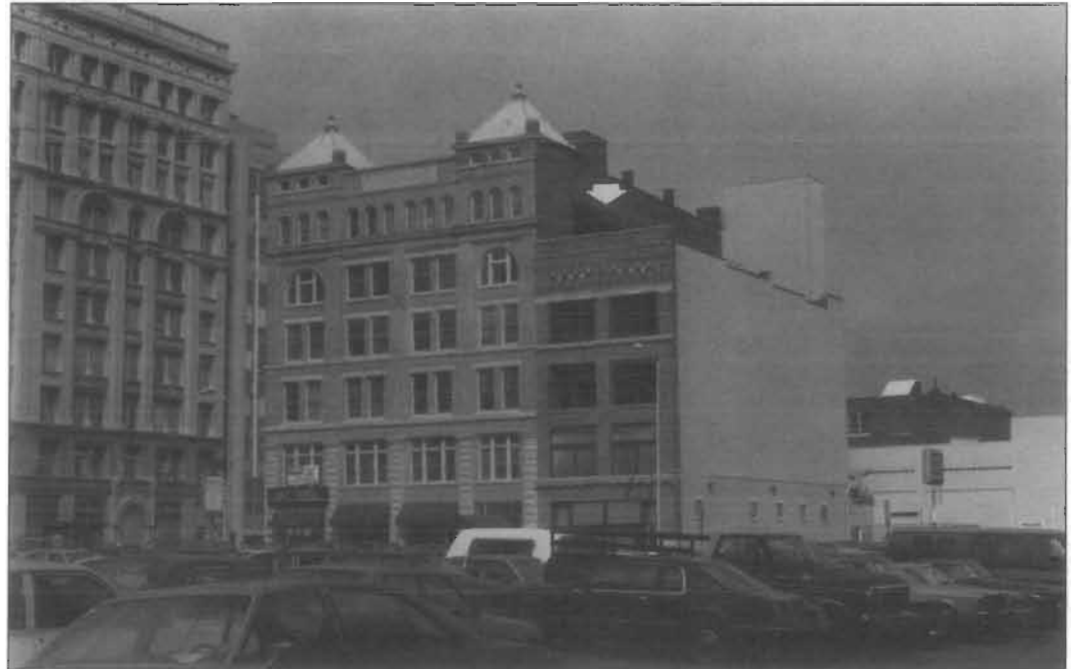
*Left: This rooftop addition has substantially altered the historic profile and proportions of a three-story row house; more important, it has interrupted the uniform roof height of the block. The greenhouse is also a jarring element in an otherwise intact 19th century streetscape. Below: A sizeable employee lounge was added atop this four-story historic commercial building. Because the rooftop addition has been set back from both the front and side roof edges against a party wall, the historic character of the building and the district have been preserved.*
