The Secretary  
of the Interior's  
Standards for  
Rehabilitation &

**I**llustrated  
Guidelines  
for  
Rehabilitating  
Historic  
Buildings

U.S. Department of the Interior  
National Park Service  
Cultural Resources  
Heritage Preservation Services

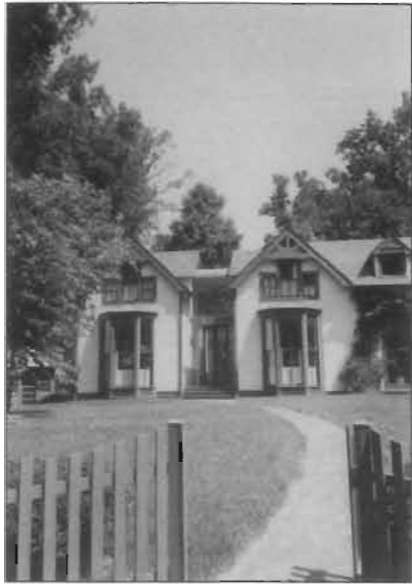
*The historic residence is on the right. By copying the decorative gable and three-part window in the new addition, the old and new portions are virtually indistinguishable. This approach violates the Standards for Rehabilitation.*

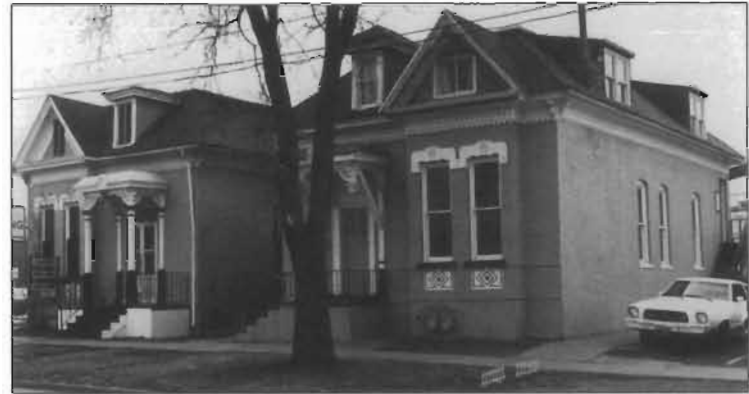
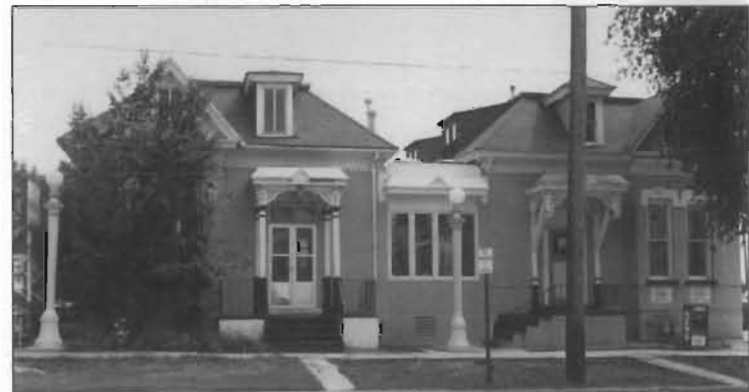
*Two small Victorian cottages, above, were connected to provide additional floor space in a commercial rehabilitation. The inappropriate infill connector, below, is on the same plane as the historic facades, essentially making the two cottages appear as one building. If the new infill had been substantially set back from the facade, the distinct form of each cottage would have been retained.*

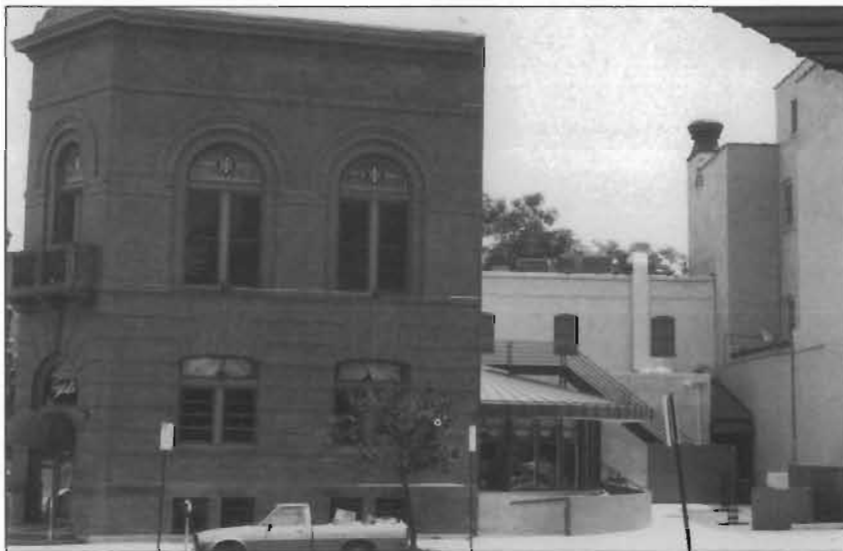
*In rehabilitating a historic bank for a new use, a small restaurant addition was built on the rear. The new addition is compatible with the historic building primarily because of its scale and location.*

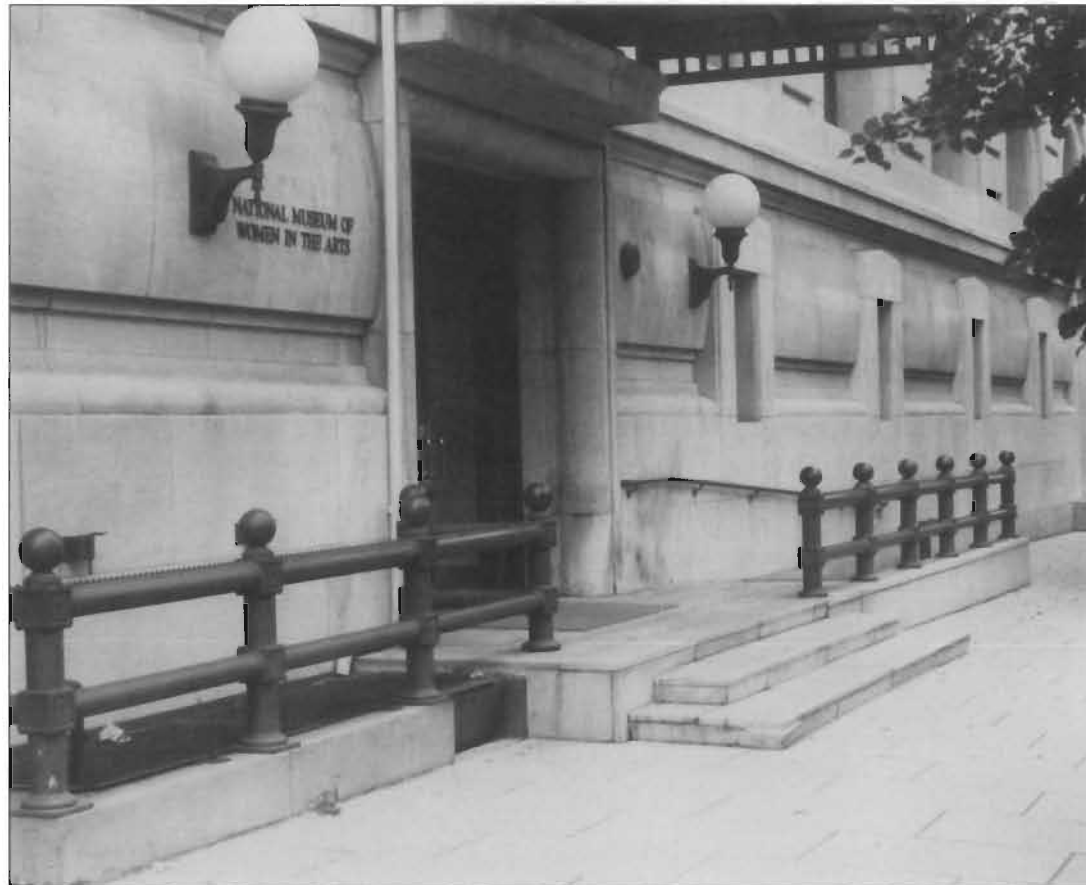
*The historic cast iron railing was preserved when a permanent ramp was designed for this museum's main entrance.*

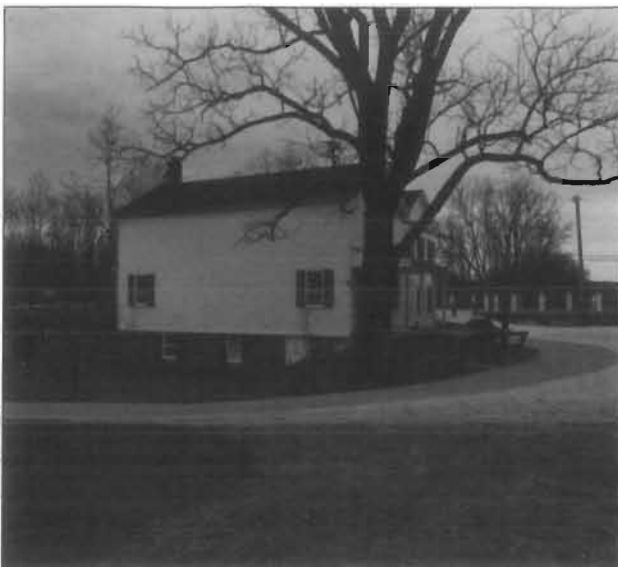
Access to this rural historic site has been improved to include designated parking areas, properly graded ramps and walkways around the site, and access within the building to all services.

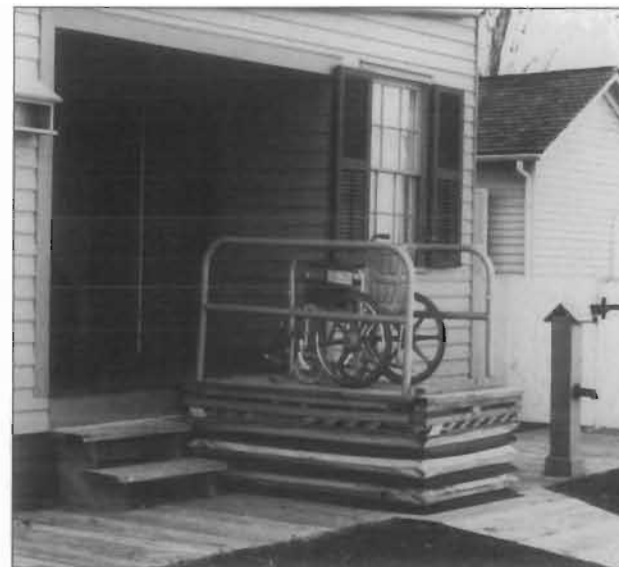
An accordion-type platform lift that retracts to ground level when not in use has been installed to make this historic house accessible.

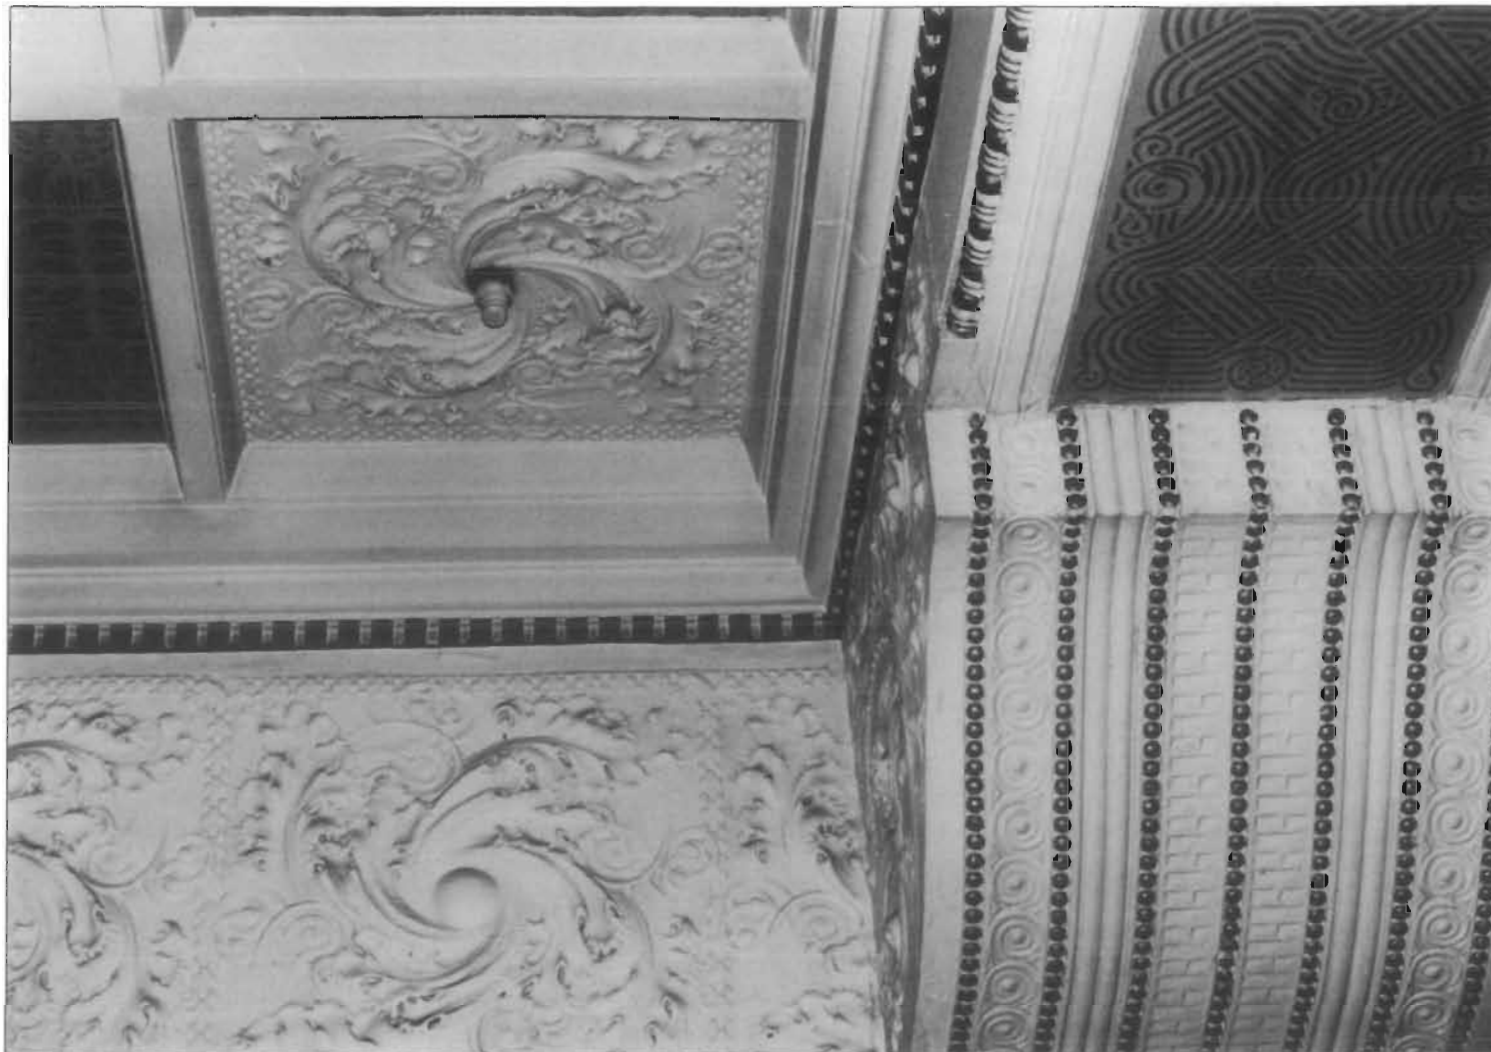
*A sprinkler system has been sensitively installed in this highly ornamental plaster ceiling during the building's rehabilitation. Sprinkler heads have been unobtrusively located in the center of the decorative plaster relief.*

Installing sensitively designed fire suppression systems, such as sprinkler systems that result in retention of historic features and finishes.

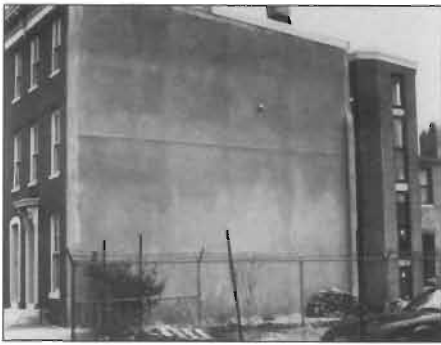
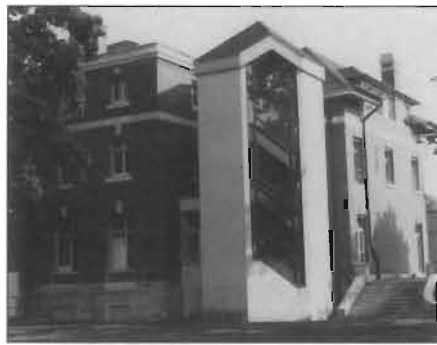
*In order to comply with safety codes, it may be necessary to add an exterior fire stair to a historic building as part of a rehabilitation project. The brick stairtower shown on the top is compatible in materials and scale, and inconspicuously attached to the rear elevation of the historic rowhouse. The example on the bottom shows a large-scale concrete and glass stairtower that is incompatible in materials and scale, located as it is on a highly visible elevation of the historic brick building.*

Placing a code-required stairway or elevator that cannot be accommodated within the historic building in a new exterior addition. Such an addition should be on an inconspicuous elevation.
