Northfield Wastewater Treatment Plant Project

Facility Plan Update

May 2021

City of Northfield

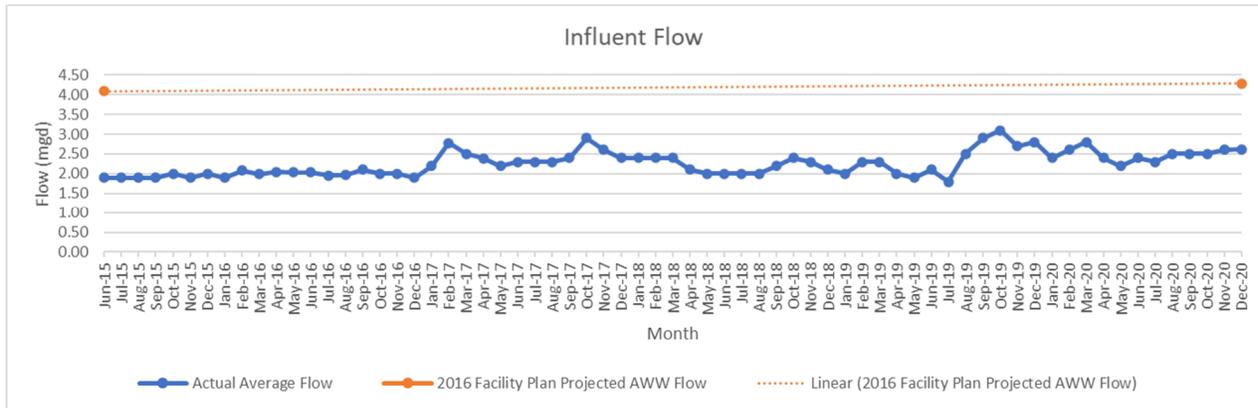
Figure 2-1. Influent Flow

Actual monthly average flow data for the period from 2015 to present were compared against the 2016 Facility Plan projections. Figure 2-1 shows a plot of average monthly influent flow rates and the projected trend plot for average wet weather (AWW) flow (defined as the daily average flow for the wettest 30 consecutive days) from 2015 to 2020 using 2016 Facility Plan data.

Figure 2-1 shows that maximum month average day influent flow rates for the past 5.5 years are well below the projected AWW flow rates from the 2016 Facility Plan, with the highest monthly average flow of 3.1 million gallons per day (mgd) occurring in May 2019. The maximum month average day flow is not an exact representation of AWW flow. Maximum month average day flow measures the highest average influent flow rate over a calendar month, whereas the AWW flow is the daily average flow for the wettest 30 consecutive days. For this study the maximum month average day flow provides reasonable data for comparison purposes.

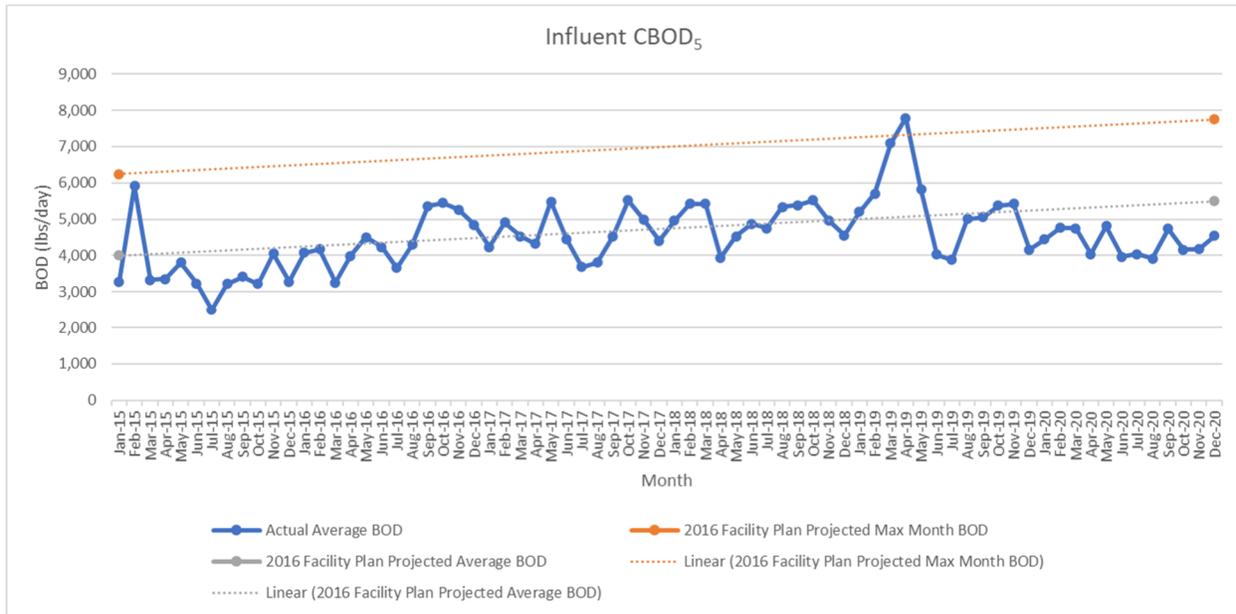
Figure 2-2. Influent CBOD₅

Actual monthly average influent CBOD₅ data for the period from 2015 to present were compared against the 2016 Facility Plan average day and maximum month projections. Figure 2-2 shows a plot of average monthly influent CBOD₅ and the average day and maximum month projected trend plot for 2015 to 2020 using 2016 Facility Plan data.

The average influent CBOD₅ for the past 5.5 years was 4,561 pounds per day (lb/d). The average influent CBOD₅ for the past 5.5 years was 4,561 lb/d. Figure 2-2 shows the maximum month influent CBOD₅ for the past 5.5 years, which slightly exceeded the projected maximum month influent CBOD₅ from the 2016 Facility Plan on a single occasion (7,788 lb/d in April 2019). This occasion is further discussed in Section 2.3. Overall, the plot indicates that the actual influent CBOD₅ is consistent with the 2016 Facility Plan projection through 2020.

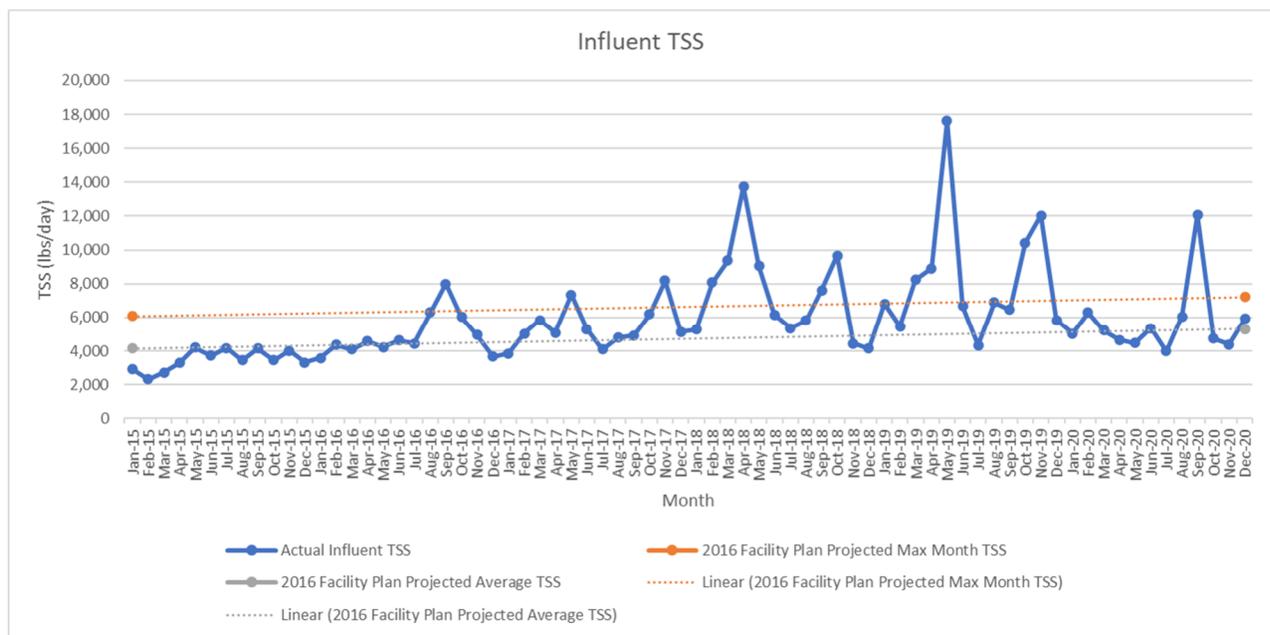
Figure 2-3. Monthly Average Influent TSS

Actual monthly average influent TSS data for the period from 2015 to present were compared against the 2016 Facility Plan projections. Figure 2-3 shows a plot of average monthly influent TSS and the projected trend plot for 2015 to 2020 using 2016 Facility Plan data. The average influent TSS for the past 5.5 years was 5,820 lb/d.

Figure 2-3 shows that the maximum month influent TSS for the past 5.5 years has exceeded the projected maximum month influent TSS from the 2016 Facility Plan on multiple occasions. They are reviewed individually as follows:

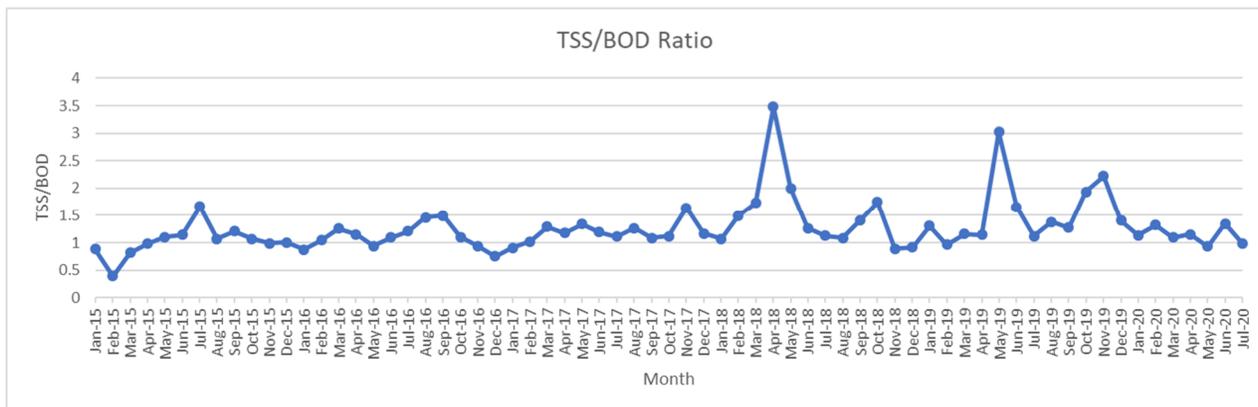
Figure 2-4. TSS/CBOD₅ Ratio

- **February to May 2018:** The spike in influent TSS does not align with peaks in influent flow and influent CBOD₅. Figure 2-4 shows the plant influent TSS/CBOD₅ ratio for the past 5.5 years, and the major spike in April 2018 cannot be explained. The influent sampler cleaning procedure issue discussed above may have contributed to this outlier.

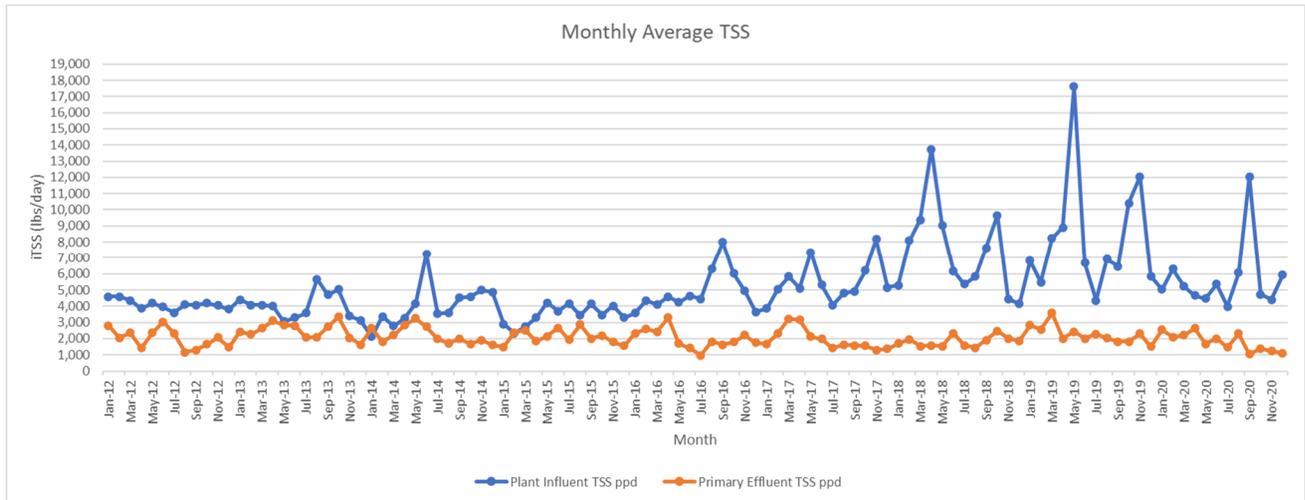
Figure 2-5. Monthly Average Plant Influent and Primary Effluent TSS

The Northfield WWTP’s historical performance and compliance with effluent permit limits suggest that the plant has a higher influent TSS load capacity than is currently documented. The primary clarifier data was reviewed to confirm primary clarifier performance and corresponding TSS loading to the secondary treatment (BAF) process. Figure 2-5 shows the monthly average plant influent and primary effluent TSS performance from 2012 to present.

The data indicates that the primary clarifiers have historically produced consistent primary effluent TSS regardless of the plant influent TSS load. Monthly average primary effluent TSS load is relatively constant and never exceeds 3,600 lb/d into the BAF.

The Veolia process simulations assumed a fixed primary effluent/BAF influent TSS loading based on the plant’s actual historical operating data. The maximum month primary effluent TSS assumptions were 3,117 lb/d in 2025 up to 3,500 lb/d in 2040. The assumptions are consistent with the stable primary effluent TSS data shown in Figure 2-5, even under very high plant influent TSS loading conditions.

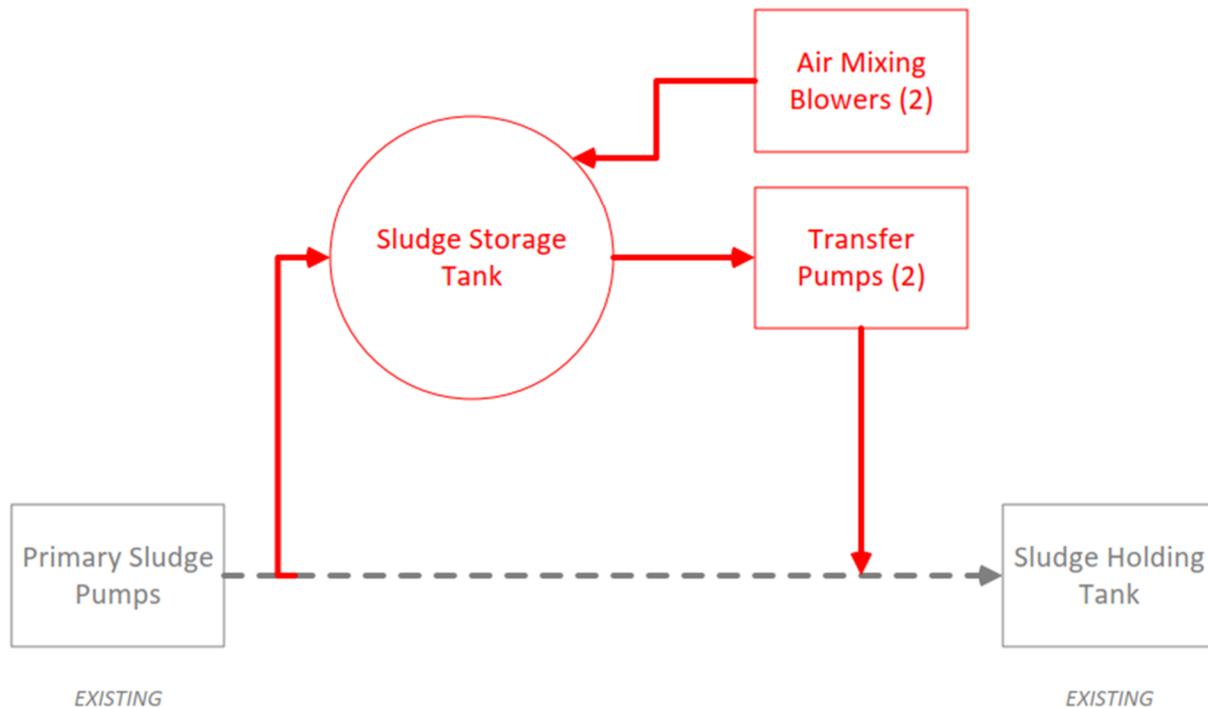
Figure 3-1. Sludge Storage Tank Process Flow Diagram

The proposed location of the new sludge storage tank is east of the Pretreatment/Clarifier Building in the location of the decommissioned buried sludge storage facility. A circular concrete storage tank is proposed with approximate dimensions of 60 feet in diameter and 19 feet of side water depth. Figure 3-1 shows a simplified process flow diagram of the liquid sludge storage tank.

A tee connection and valves would be added to the primary sludge transfer piping between the primary sludge pumps and dewatering facility. The tee connection would divert primary sludge to the new sludge storage tank. Stored sludge would require pumping from the sludge storage tank back into the existing primary sludge transfer piping for conveyance to dewatering. Additional equipment assumptions include the following:

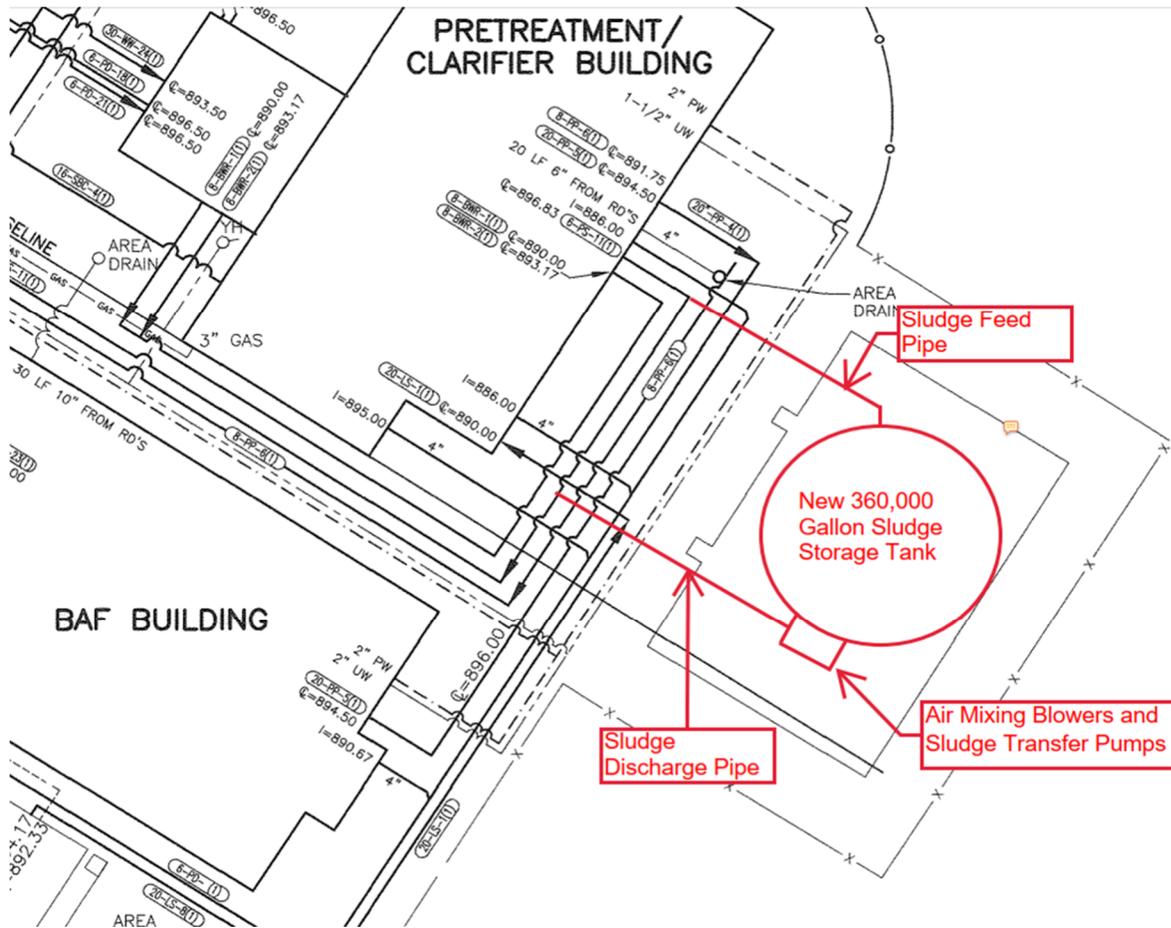
Figure 3-2. Sludge Storage Tank Site Plan

Figure 3-2 shows a simple site plan for the proposed facilities. The cost estimate for the liquid sludge storage facilities is summarized in Table 3-1.

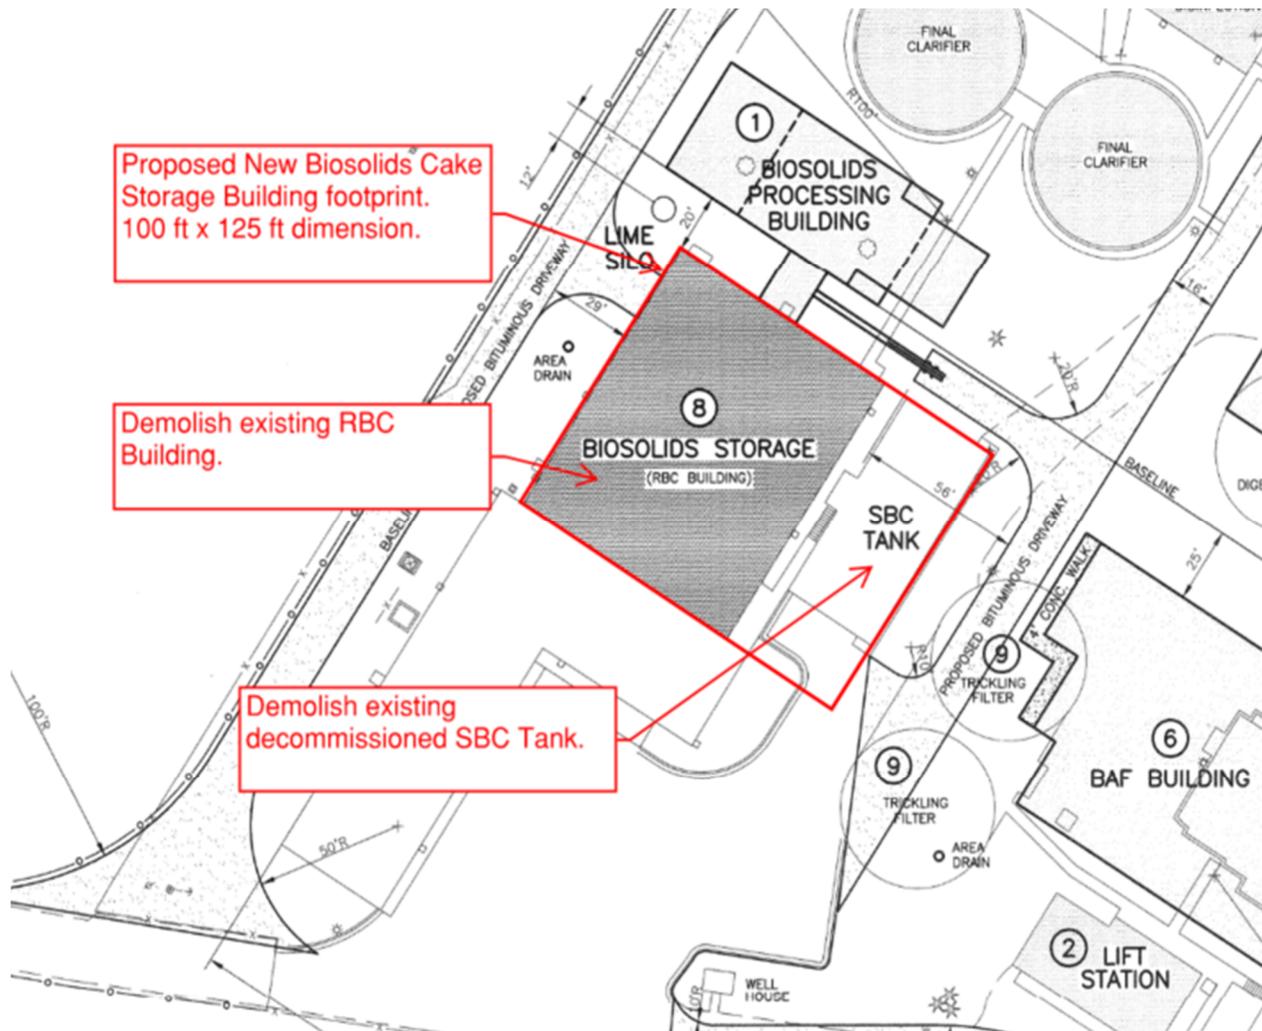
Figure 3-3. Layout for Proposed Biosolids Cake Storage Building

Figure 3-3 shows the site layout for the proposed new biosolids cake storage building.

- Demolish the existing SBC tank.
- Demolish the existing biosolids cake storage building (RBC Building).
- Install concrete footings, concrete flooring, and 10-foot-high perimeter concrete push walls.
- Install pre-engineered metal building to achieve a 20-foot minimum vertical clearance inside the storage area.
- Install overhead doors for vehicle entrance and exit.
- Install plumbing; heating, ventilation, and air conditioning (HVAC); and electrical.
- Complete site work and site restoration.

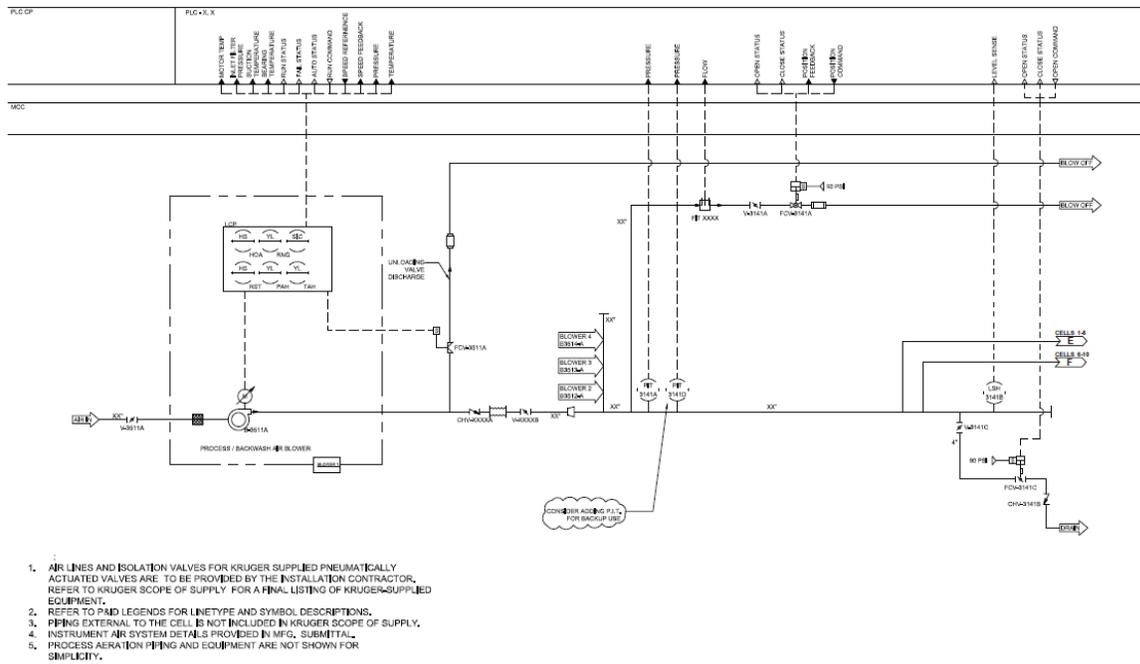
Figure 3-4. HST Blowers

high speed turbo (HST) blowers. The required changes to the existing aeration system are depicted on Figures 3-4 through 3-6. The aeration control strategy is to control blower speed to maintain a setpoint pressure in the common header and use flow meters and flow control valves to control airflow to each BAF cell.

BIOSTYR Piping and Instrumentation Diagram
Blowers
Northfield, Minnesota

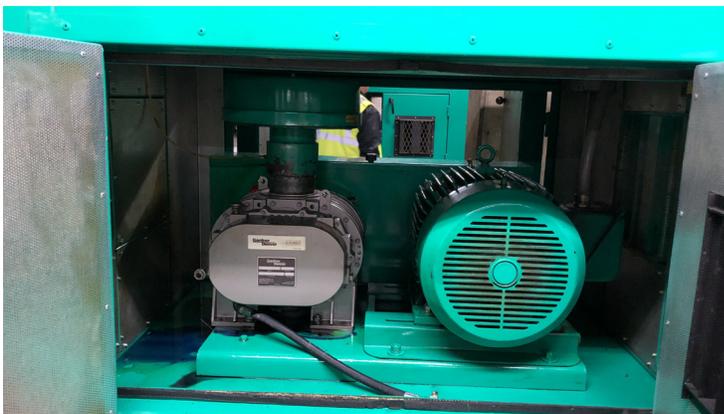
Figure 2. BAF Blower (Gardner Denver)

- Attend to air blowers (Gardner Denver, shown on Figure 2) soon. Several units have vibration readings with more than 2 mils of displacement, and some of the heat signatures are greater than 220 degrees Fahrenheit on the blowers with soundproof cabinets open. Some vibration could be caused by a bad drive belt; therefore, the staff should verify that matched sets of belts are installed on the air blowers. The pulley alignment and condition should also be checked. Additionally, there were several blowers with noticeable pools of oil in the bottom of the cabinets. These blowers should be checked for leaks, and the oil should be cleaned up. It is also recommended that the City use Gardner Denver's maintenance program for overhauling the blowers on a scheduled basis. Gardner Denver will provide exchange units that can be installed while the current blowers are sent out for service.

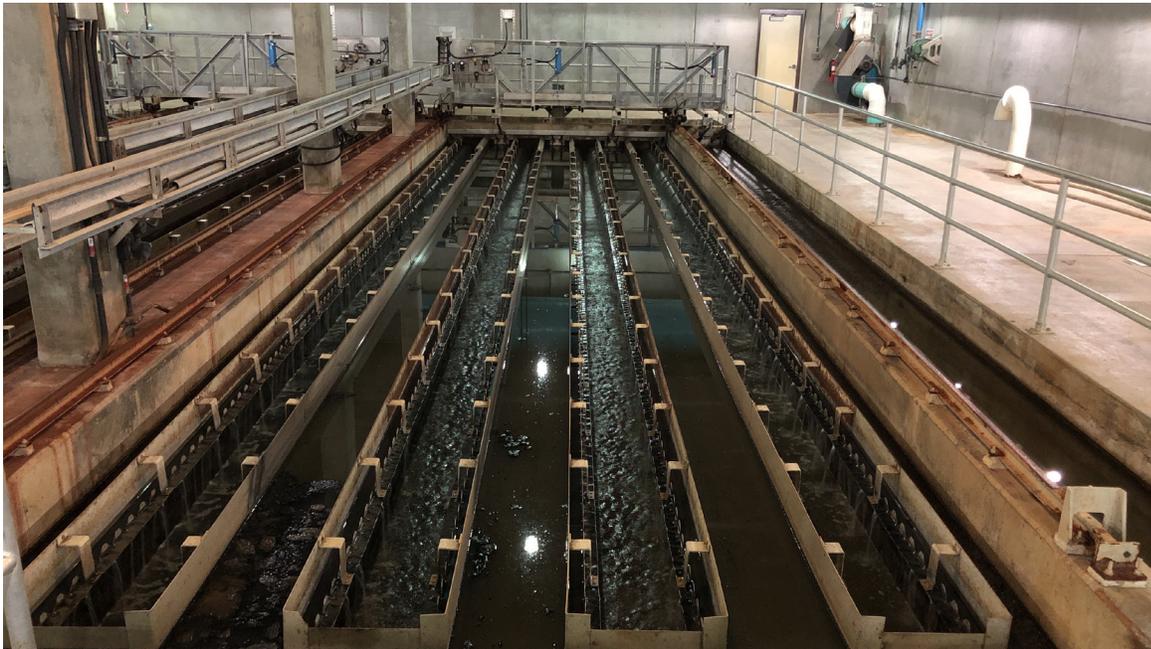
Figure 3. Primary Clarifier (In Service)

- Perform a thorough inspection of the offline primary clarifier, including inspection of the chains, sprockets, wear strips, and flights for wear and to confirm age. While the loadings on the primary clarifiers may be lighter than design load, the chains and especially the pins holding the chains together will wear and ultimately fail over time.
- Test the chain drive assembly to ensure that the quick release/break away system is functional to prevent any type of catastrophic failure to the primary chains and flights.
- Make sure water remains in the primary tanks when they are taken out of service. The absence of water causes the hardware components to dry out, which increases the chance of failure over time.

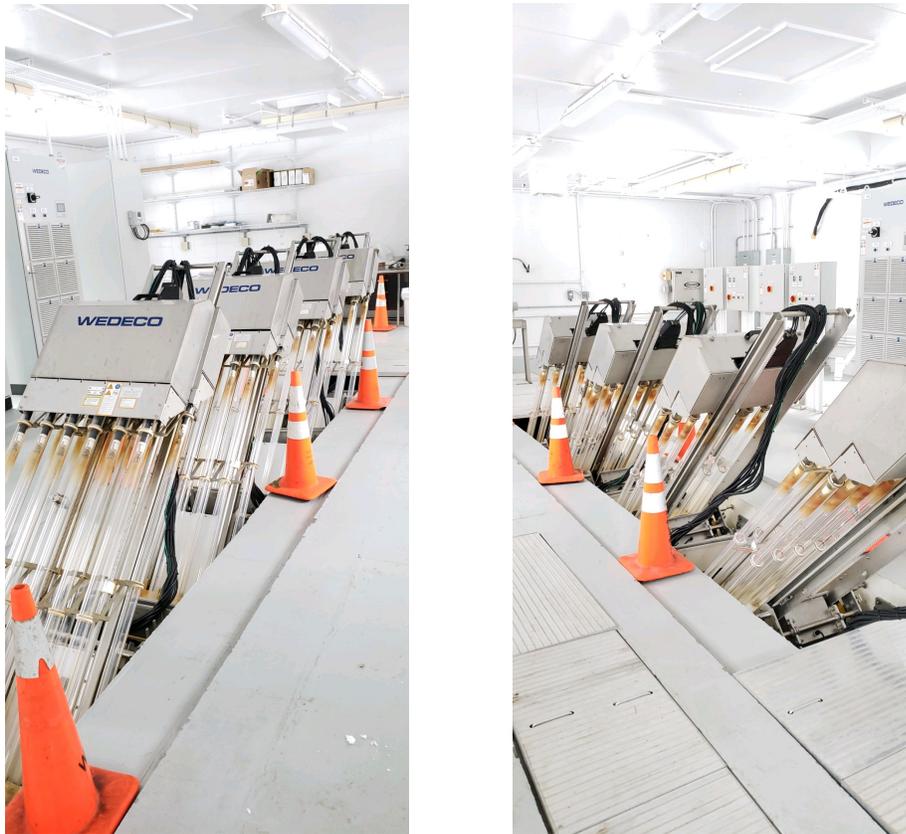
Figure 4. UV System Showing Cords

- Check each UV lamp electrical connection by unscrewing the connection cords and checking the internal O-rings. Replace O-rings if there is any doubt about their ability to seal. The greatest problem with UV lamps is the buildup of moisture inside the glass tube, thus ruining the lamp because connections are not tight or sealed.
- Check all actuator/limit switches for operation while in the up position.
- Inspect all cords for any abrasions or unsmooth surfaces. Abrasions or rough surfaces are a good indicator that a cord may have been overheated or damaged. Cords on the UV system are shown on Figure 4.

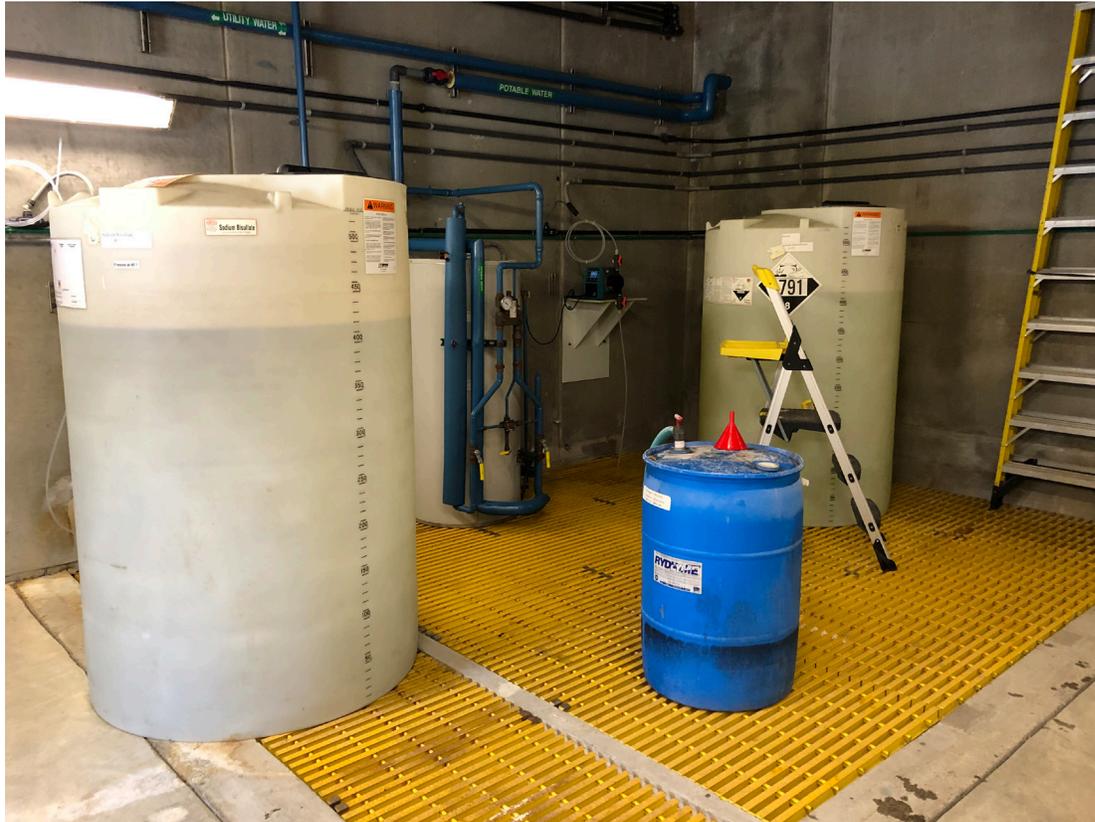
- Procure and install a portable containment unit and place the sodium bisulfate storage tank on the containment unit. The portable containment unit should be sized to contain the entire volume of the storage tank.
- Use drums of sodium bisulfate, increase the size of the existing containment area, or procure and install a double-wall tank to provide secondary containment.

Figure 5. Odor Scrubber Chemical Storage (Containment under Bisulfate Tank Is Inadequate)

The Jacobs team noticed that a similar situation exists in the new biosolids processing area that is under construction and not yet in service. The storage and containment in this area should be reviewed and corrected as well.

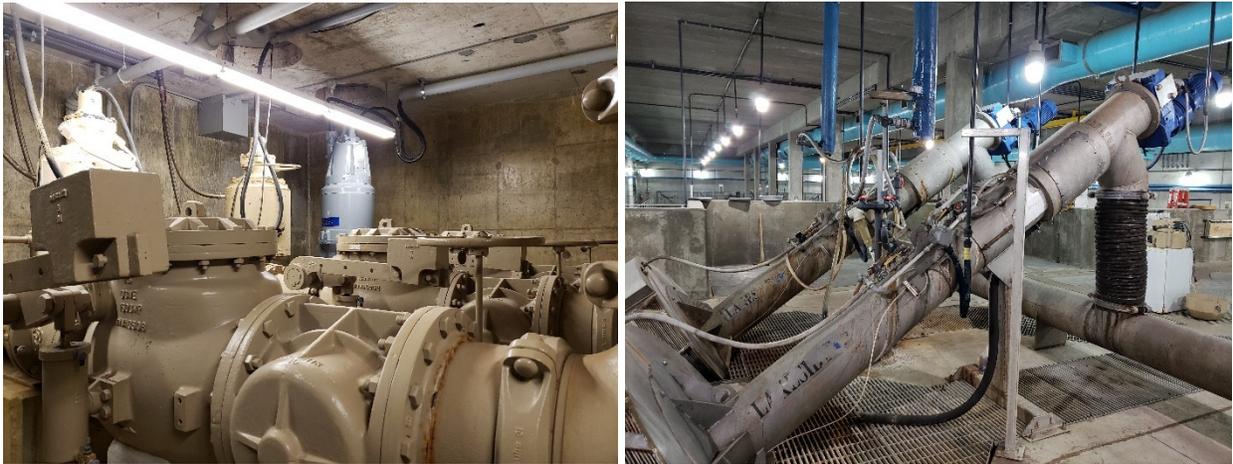
The Northfield WWTP is a 5.2-million-gallon-per-day (mgd) design facility employing an influent pump station consisting of three variable frequency drive (VFD) 86.25-horsepower (hp) dry pit submersible pumps (two older Fairbanks Morse, one new Flygt; see Figure 1) that pump from the wet well to the influent screening process. Influent screening is accomplished by one of two Lakeside rotating drum screen systems and followed by a Pista-Grit grit removal system. Grit and screenings are sent to a dumpster for disposal in a sanitary landfill. Following preliminary treatment, wastewater is dosed with ferric chloride and polymer, and mixed to enhance settling in one of two primary clarifiers (one is normally online). Scum and sludge produced from the primary clarifiers is removed to the solids treatment process.

Figure 1. Left: Two Fairbanks Morse (Tan), New Flygt (Gray) Pumps. Right: Rotary Screens.

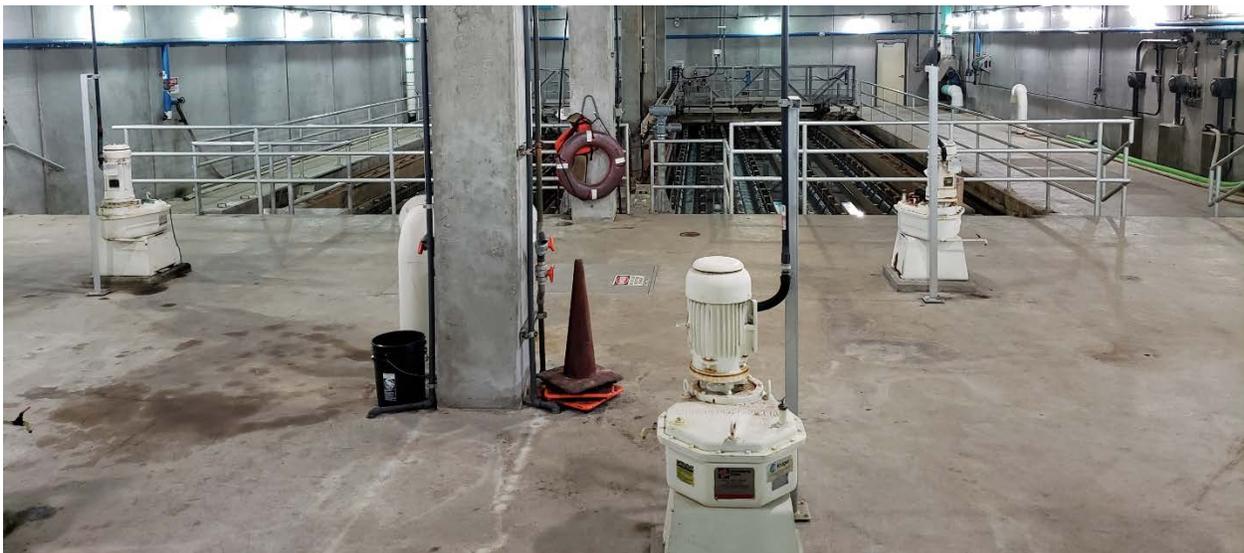
The preliminary/primary treatment building is maintained under negative pressure to capture odors and remove corrosive gases (i.e., hydrogen sulfide). The foul air is sent to a wet odor scrubber system where sodium hypochlorite is used to oxidize odors before the air is vented to the atmosphere. Blowdown wastewater is dechlorinated with sodium bisulfate before being recycled into the treatment plant. Mixers and clarifiers are shown on Figure 2.

Figure 2. Foreground, flash mix and flocculator mixers. Background, primary clarifiers.

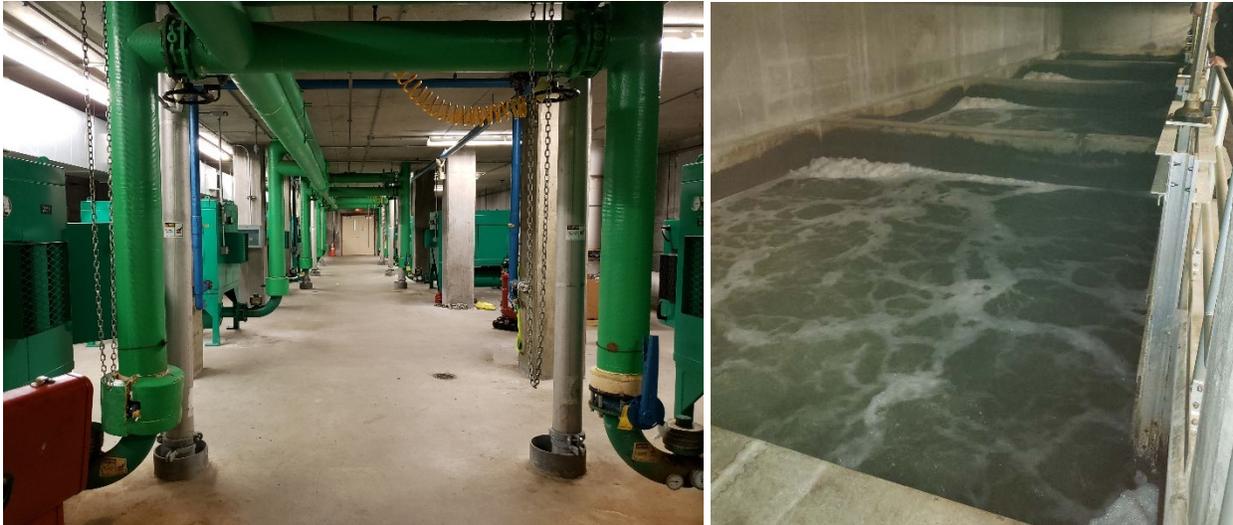
After primary settling, wastewater is pumped to 1 of 10 BIOSTYR treatment system cells arranged in five cells per side grouping. BIOSTYR is a process that uses a proprietary styrene based media, air, and bacteria to treat organic constituents (i.e., biochemical oxygen demand or BOD) in the wastewater. The styrene media provide a place for bacteria to grow and affix itself, allowing for the BOD removal. The styrene serves as a filtration media to capture any solids in the waste stream. Cells are rotated online and offline to facilitate reaction time with wastewater and allow the backwash cycle to remove excess solids captured during treatment. Backwash solids are returned to the primary clarifier influent. The process also removes ammonia as Northfield's NPDES permit includes ammonia discharge limits from April through November and monitoring requirements from December through March. The blower room and a BIOSTYR cell is shown on Figure 3.

Figure 3. Left: Blower Room. Right: Top of BIOSTYR Cells with Treated Wastewater on Surface.

Air supplied to the BIOSTYR process comes from eleven 50-hp positive displacement blowers. Blowers are either on or off; no VFD control is provided for these units. Each blower is valved to a BIOSTYR cell with one backup blower unit for all blowers. Blowers were recently replaced as part of the ongoing capital improvements program discussed in Section 2.4.

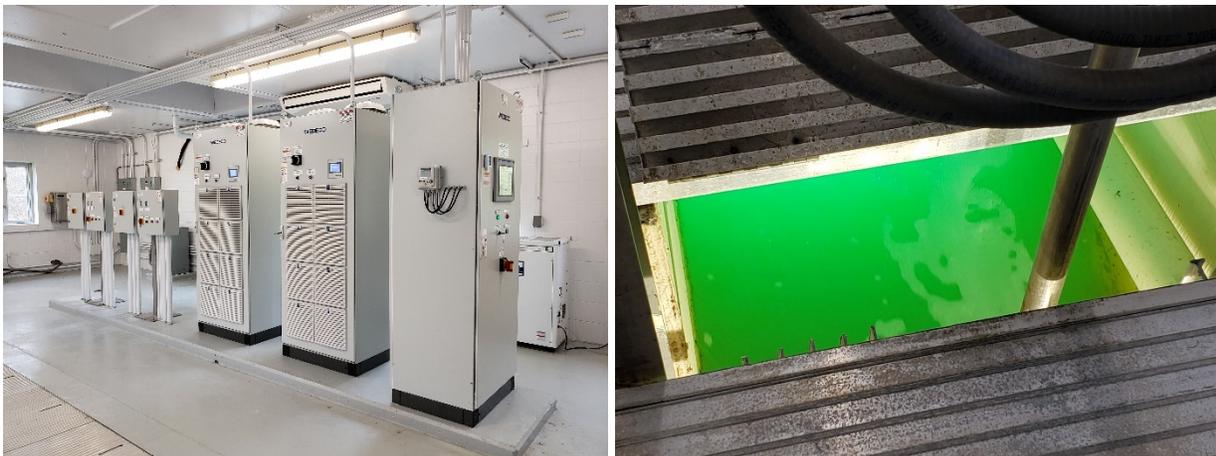
Treated water then flows to the ultraviolet (UV) disinfection process prior to discharge to the Cannon River. This process allows the facility to meet its fecal coliform limit to comply with the NPDES permit. The UV system, shown on Figure 4, was recently updated as part of the capital improvements program.

Figure 4. Left: UV Controls. Right: UV Light in Water.

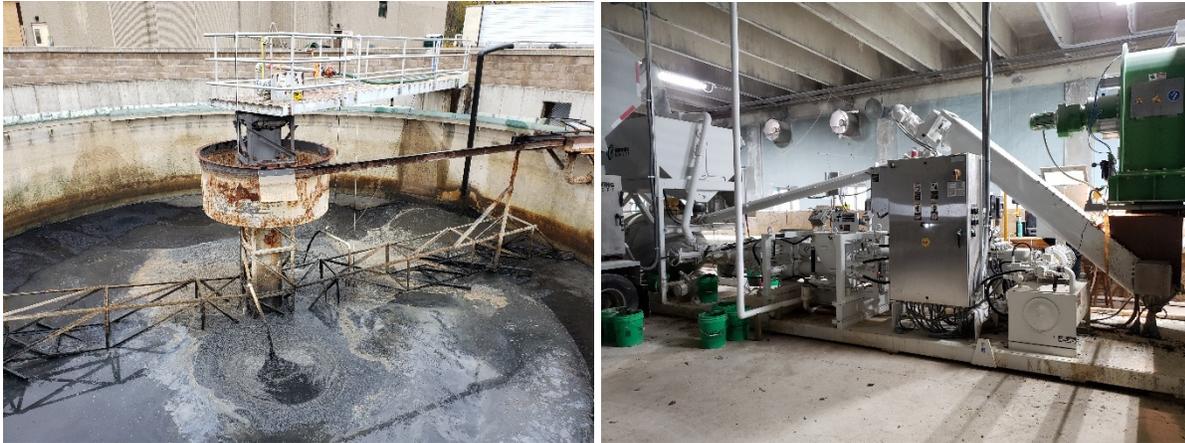
Solids removed from the primary clarifier are sent to the solids treatment process (see Figure 5). Currently, a temporary Schwing Bioset unit is in place for solids handling. Solids are pumped to an existing decommissioned clarifier. The clarifier is used for solids flow equalization before solids undergo the Bioset process.

Figure 5. Left: Solids Storage in Decommissioned Clarifier. Right: Temporary Dewatering, Lime Addition, and Reactor.

Solids from the clarifier flow are pumped to the Bioset dewatering process where excess water is removed. Solids then move to the lime addition and mixing portion of the process. Solids are stabilized within a reactor vessel and then conveyed to a truck for transport to a location for land application or to an onsite storage facility prior to future land application (weather dependent). The dewatering process and lime addition/reactor process are not operated in a fully automatic mode and are not connected to the plant supervisory control and data acquisition (SCADA) system; therefore, these processes require constant operator attention.

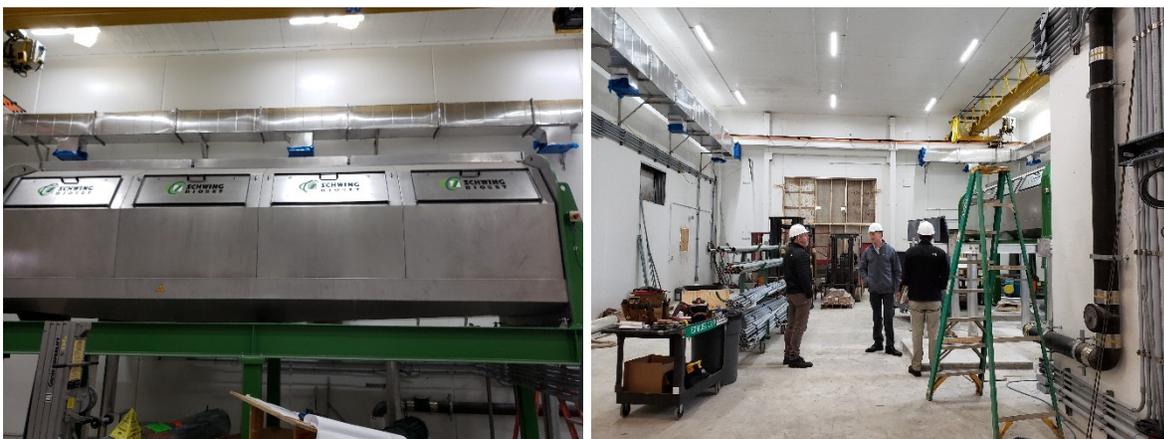
Once the new permanent unit is brought online, solids will go to an aerated holding tank and will then be pumped to a larger capacity Bioset unit. At current loadings, the temporary unit needs to be operated 60 hours per week to keep up with solids production, while the permanent unit, expected in spring 2020, will only need to be operated 18 hours per week. Figure 6 shows a newly installed screw press and the solids dewatering room.

Figure 6. Left: Newly Installed Screw Press for Solids Dewatering. Right: Newly Renovated (Still in Process) Solids Dewatering Room.

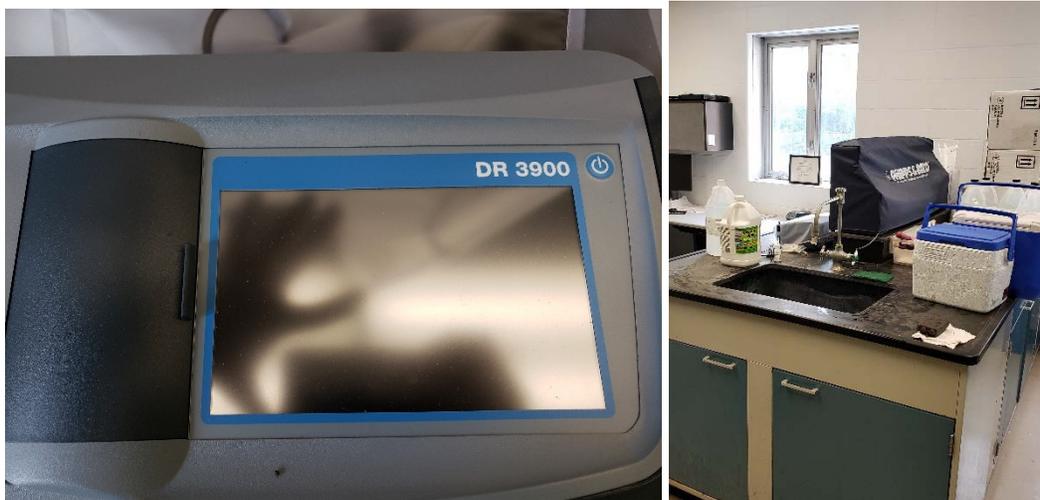
The plant has an onsite laboratory, which is used only for two NPDES reportable parameters: pH and dissolved oxygen. The remainder of the required compliance sampling is contracted out to a certified laboratory. The plant laboratory has the capability to test all process control parameters necessary to optimize the facility, including a Hach 3900 Spectrophotometer that can test many parameters. In addition, a jar testing unit is onsite and can be used to optimize polymer and coagulant dosing. Unfortunately, due to staffing limitations Northfield staff admit that there is insufficient time to utilize the on-site equipment for optimization testing and only absolutely required NPDES testing is completed on-site. Test equipment is shown on Figure 7.

Figure 7. Left: Hach DR3900 Spectrophotometer. Right: Lab Bench with Jar Testing Apparatus under Cover.
