# THE SECRETARY OF THE INTERIOR'S STANDARDS FOR REHABILITATION &

# ILLUSTRATED GUIDELINES ON **SUSTAINABILITY** FOR REHABILITATING HISTORIC BUILDINGS

U.S. Department of the Interior  
National Park Service  
Technical Preservation Services

2011

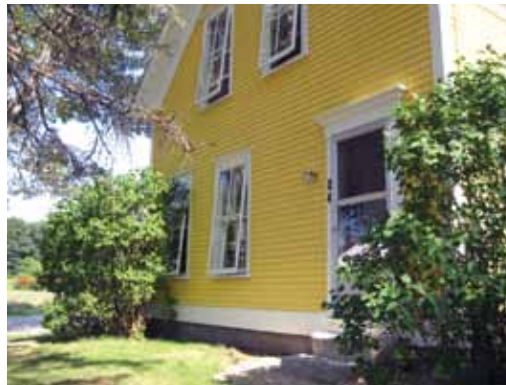
25

**Not Recommended:** [27] A broken sash cord can be repaired easily and does not justify replacement of the window.

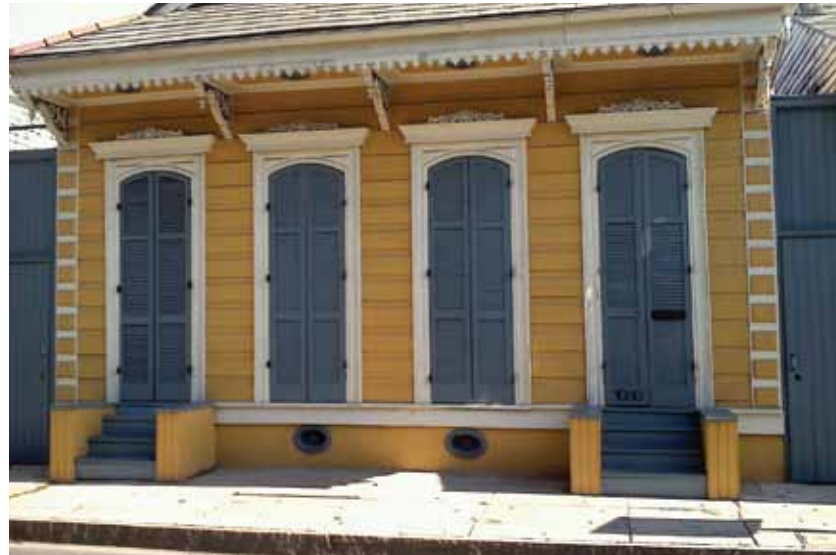
**Recommended:** [55-57]  
Wood vents in the gable ends of a historic house and a barn and cast-iron oval vents in a masonry foundation traditionally helped air circulate.

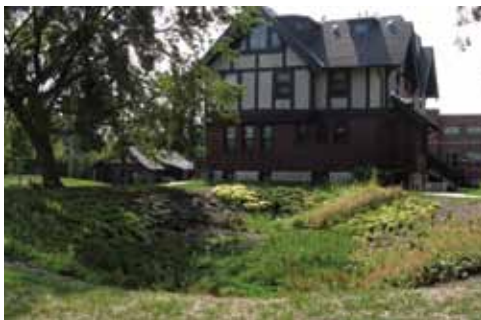
**Recommended:** [98-100] Rain gardens and rain-water collection tanks are features that may be added to a historic property to improve storm-water management and increase on-site water use.

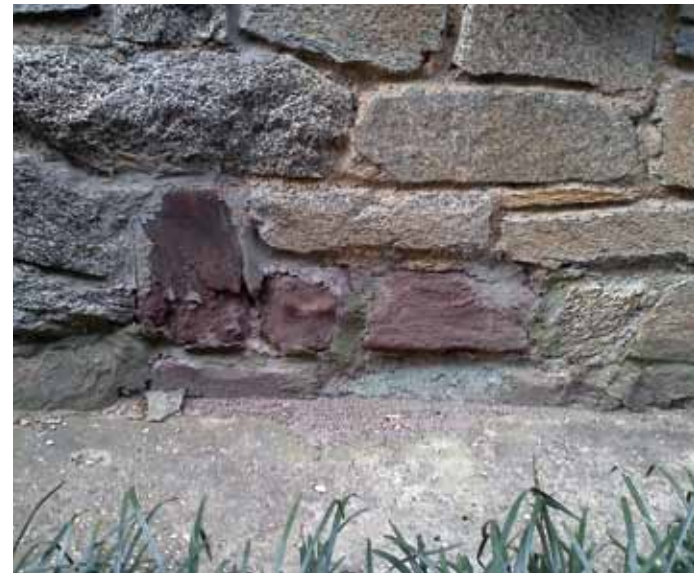
**Not Recommended:** [101] Splash back from the impermeable concrete paving next to the foundation is damaging these stones.
