APPENDIX C

Historic/Original and Current Materials - Exterior

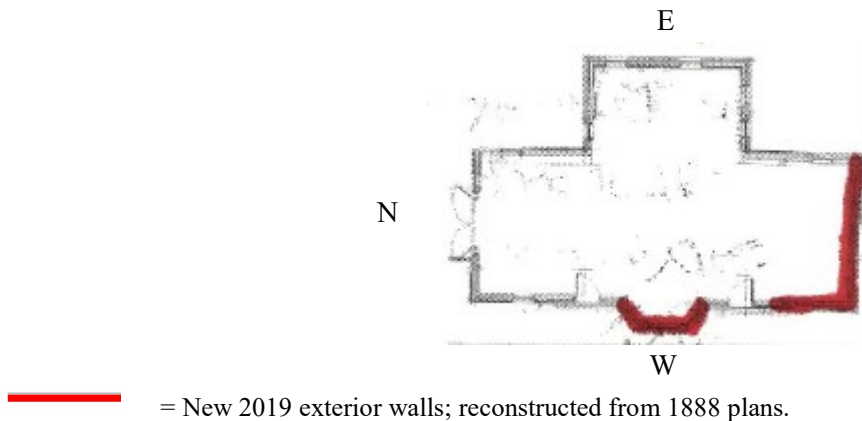
For clarity in the subsequent text, see the image below that identifies the three exterior wall areas that were removed in 1944, but were rebuilt 2019, i.e., station bay on west wall, southwest corner of west wall, and south wall.

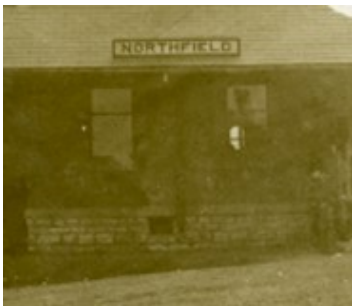
1910

Foundation: The original blueprints and archival photos indicate the original foundation was limestone.

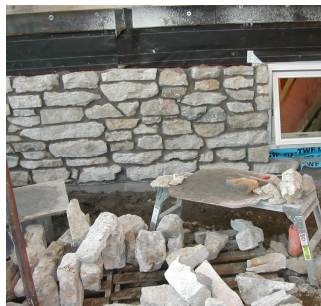
By 2015 when the property was acquired, it had been coated with concrete. Original limestone was salvaged and reused in 2016 as veneer on a new concrete foundation.

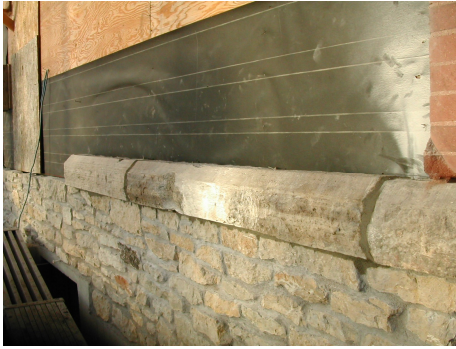
Original water table from baggage room bump-out added to new south wall.

To provide matching stone for the depot main room, those pieces were then used for the missing water table on the main building that had been removed in 1944, chiefly the south wall, and original bay area. Recycled, similar stone water table was then purchased for the baggage room bump-out. Thus, all sides of the main part of the building currently have the original stone water table, and the baggage room bump-out has the similar newly purchased recycled water table stone.

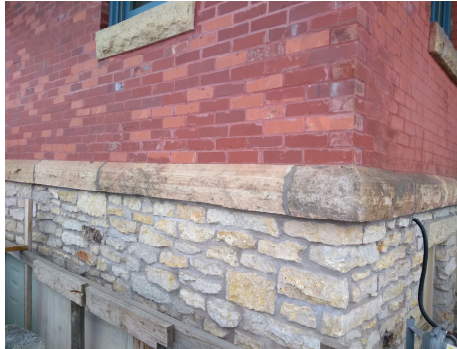
Original stone added to south wall (left) Original stone in place (right)

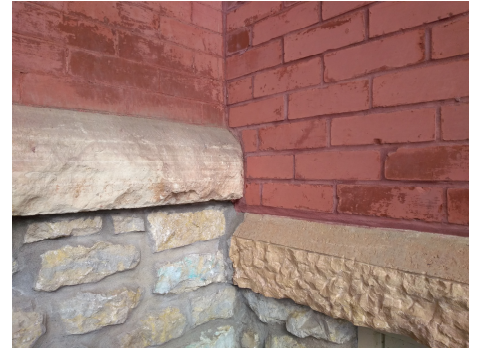
Original stone in place on main room (left) Recycled stone on baggage room bump-out (right)

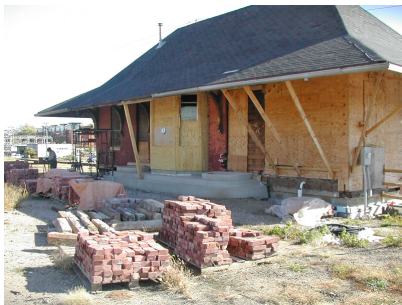
2017 New walls needing brick

Brick: All but three sections (the south wall, the southwest corner of the west wall and station master bay) contain original brick or brick added in modifications before 1944. The City donated bricks from a former local school house (Washington Elementary) that was built in the same late 1800s era. Those recycled bricks were used for the new south wall, southeast corner of west wall, and station master bay.

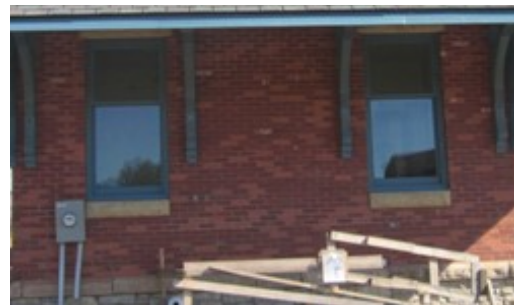
2019 South wall with added recycled brick

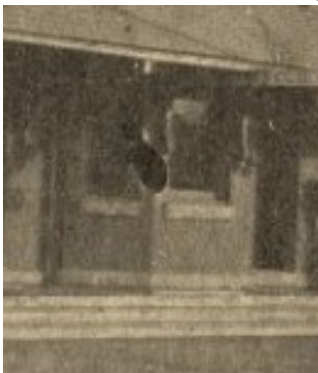
1896

Station Master Bay: The original station master bay was in the center of the track (west) side until 1944 when it was removed; a small bay was constructed on the southwest corner of the west wall; and a double door installed in the original bay opening. The original blueprints were used to reconstruct the station master bay.

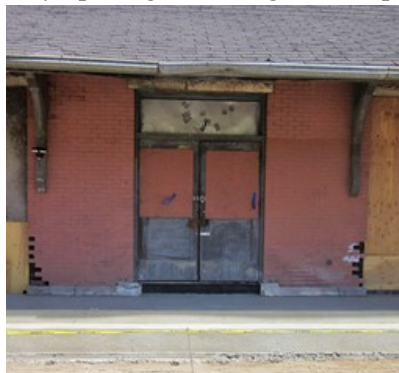
2015 Double door replaced bay

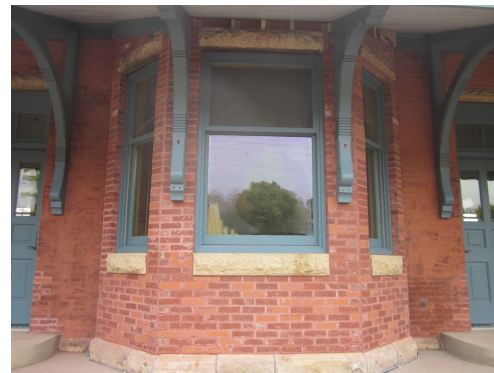
2019 Reconstructed station master bay

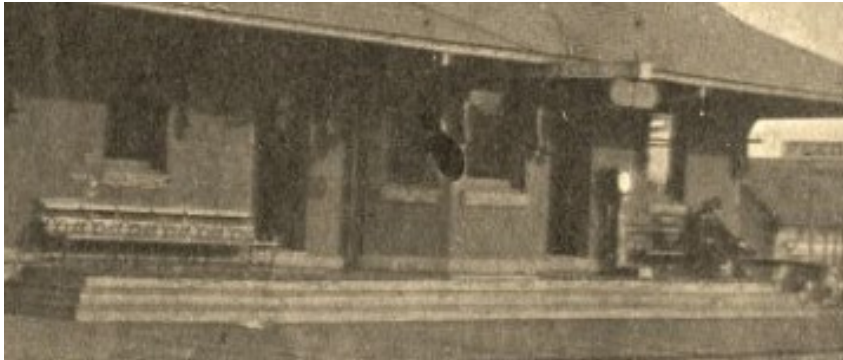
1896

Steps: Archival photos are consistent with the 1888 blueprints regarding the track side steps. The original top step was lower than the floor of the depot (see photo). To comply with current building code, the 2019 top step is level with the interior floor. In order to maintain the reveal of the original water table, this top step does not extend the length of the depot. The remaining steps extend most of the length of the depot providing a similar profile as the original.

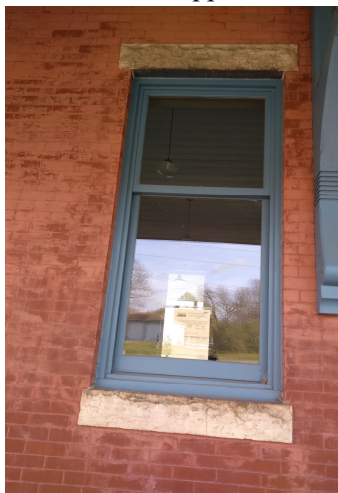
Original lintel and sill

Door & Window Lintels, and Window Sills: All of the window lintels and sills are the original rock-faced limestone or were added before 1944 (two windows with smooth concrete lintels were added in 1910 when two restrooms were created in some of the baggage room). The windows that were removed in 1944 (on the south end, the southwest corner of the depot, station master bay) have been rebuilt using the rock-faced limestone originally on the baggage room water table.

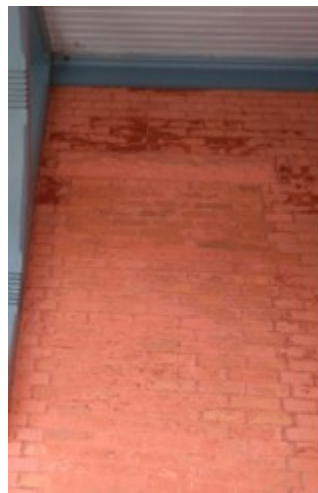
One of two lintels painted over when doors removed and openings bricked over in the 1910 addition of restrooms.

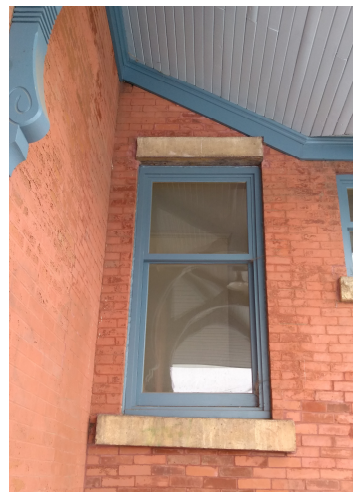
One of two 1910 windows with smooth concrete lintels and sills in the added restrooms in the former baggage room.

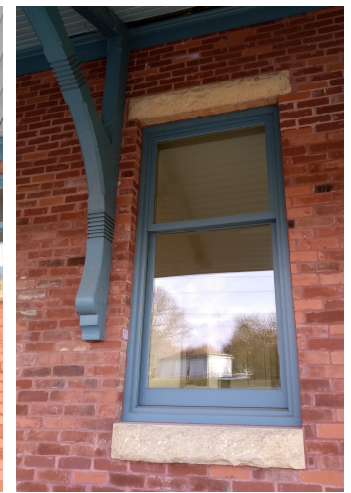
2019 replacement, one of windows on south side, southwest corner and station master bay.

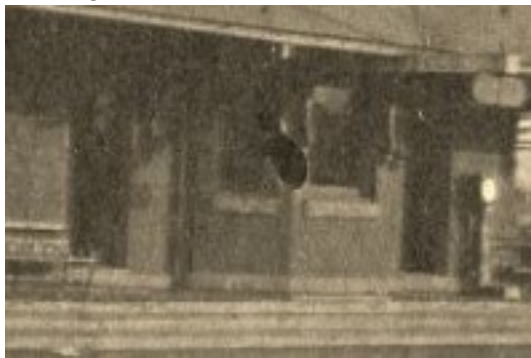
1896

Exterior Doors: None of the original exterior doors with transoms existed when the property was acquired in 2016. In 1944 the two original track-side (west) exit doors with transoms were converted to windows and the station master bay was replaced by a double door. That was reversed in 2019 when new, custom made doors with transoms were ordered using the 1888 blueprints (glass replaced the top panels). Double doors of the same design were added on the north wall for a handicapped access entrance replacing the 1944 picture window.

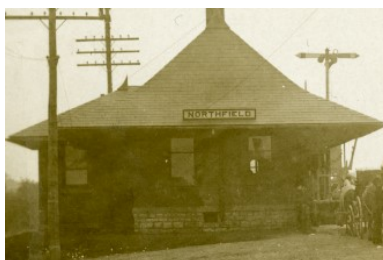
ca 1910
Two north windows

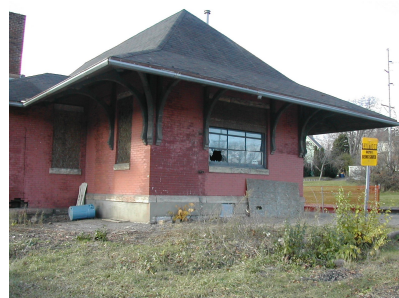
1944 Conversion: Two windows were replaced with one picture window

All door lintils are the original rock-faced limestone lintils; the lintil above the 1944 picture window (now the double doorway) on the north side was likely created from the lintils of the two windows that were replaced by the picture window in 1944. That picture window lintil remains in place for the new handicapped accessible double door.

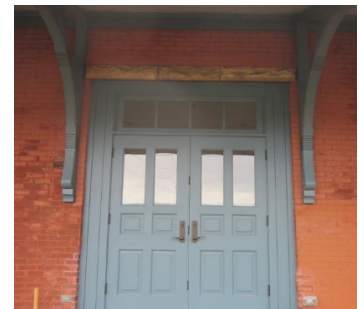
2019 New handicapped access doors; floor is level with pavilion floor; see details on p. 8.
