APPENDIX B
Archival and Current Exterior Photos

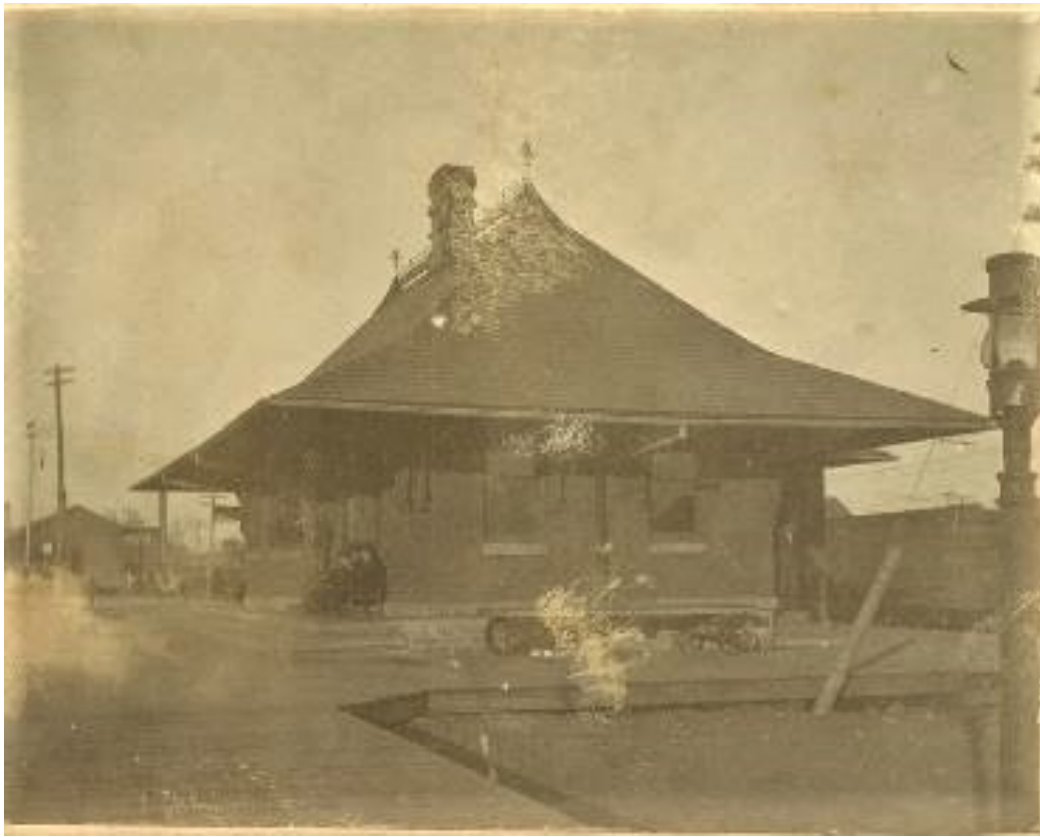
Before 1910

South Wall

Visible Features: Limestone foundation, water table, and window sill; two windows in men's waiting room; swooping roof; roof cap and cresting; detailed chimney.

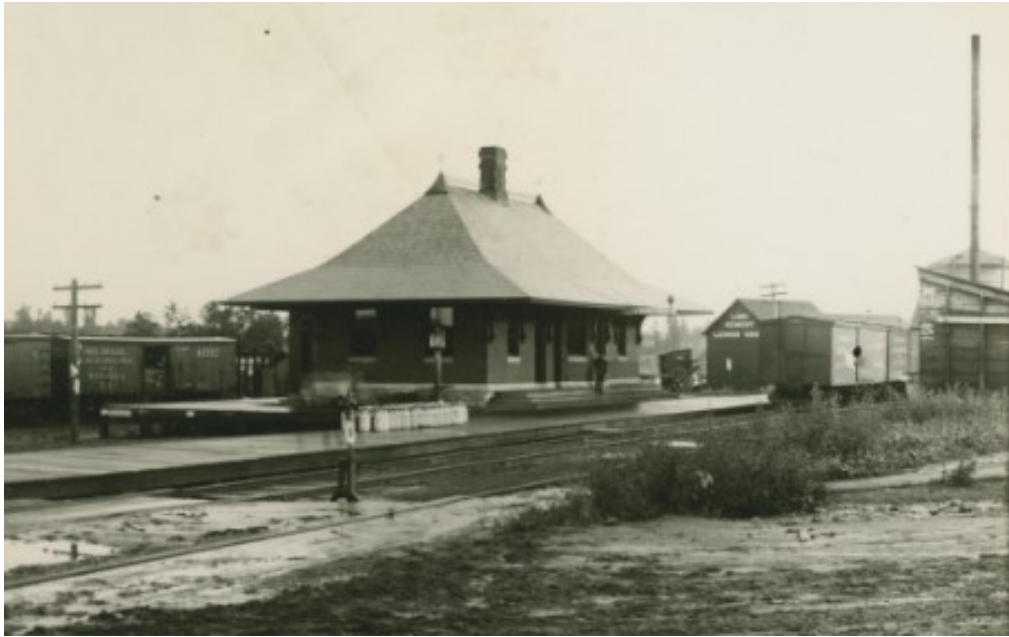
Before 1910

The above photo shows the depot west and north walls. It also shows the platform leading around to the east side baggage room door and the east side entrance to the main waiting room for women (see floor plan in Appendix A). The east wall would have included the platform on both the north end for women and on the south end for men. Photo also shows the outhouse for the depot (between depot and “*Lime, Cement, Lehigh Coal*” shed) used until the baggage room was converted in 1910 to two restrooms and a coal bin and boiler room.

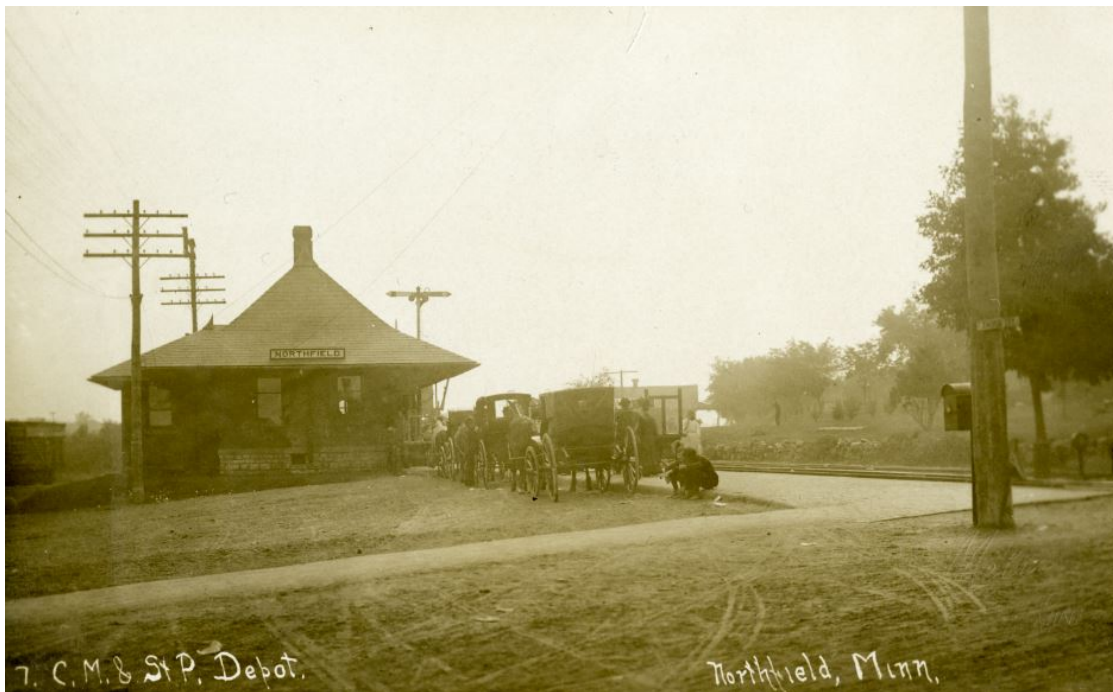
Before 1910

North wall

Visible Features: Limestone foundation, two windows in women's waiting room, swooping roof, roof cap on baggage room, Northfield sign, order blade signal, chimney (in center for heating stove in center serving both waiting rooms), baggage room door for women (far left).
