Scriver Block Condition Assessment Northfield, MN

Prepared for the
Northfield Historical Society

Submitted January 17, 2022

PREPARED BY
MACDONALD & MACK
ARCHITECTS

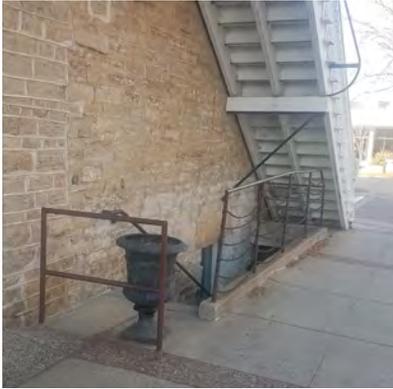
37. Exterior basement stairwell and wood stair to second floor

The first area of water infiltration is from the Division Street sidewalk into the Basement stairwell. While there is a functioning area drain at the bottom of the concrete steps, it is unknown where this drain empties. Storm water cascades down the concrete steps from the sidewalk, and snow/ice accumulate in the stairwell during the winter. This has significantly deteriorated the stone foundation walls and the window openings. Mortar is missing, stones are eroded, and there are gaps that extend almost 18" into the wall. One hole near the door to the basement was large enough to stick an arm through and the back of the interior construction could be seen.

- Remove the existing concrete stair from the Basement stairwell.
- Repair all stone/mortar deterioration on the foundation walls, especially in the stairwell.
- Inspect, televise, and ensure the basement stairwell areaway drain functions and drains to code compliant piping.
- Remove infill from the basement stairwell and install metal stairs.
- Install a curb/landing at the top of the basement stairwell to divert water away from the stair.
- Repair minor wood deterioration and peeling paint on the exterior staircase to the second floor.
- Seal around the base of the building at the Historical Society main entrance to prevent water from infiltrating the basement window wells along Bridge Square.

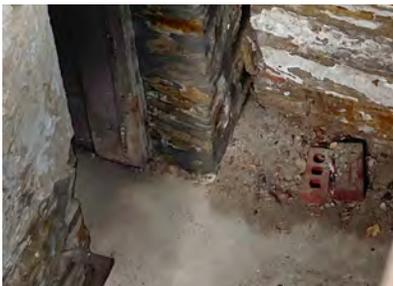
40. Bottom of basement stairwell

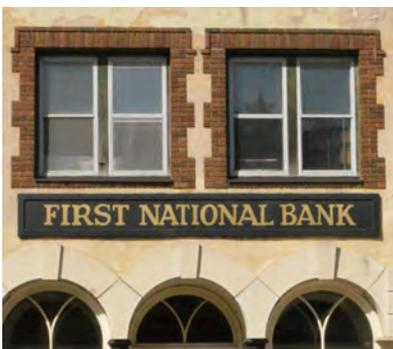
47. Bank non-historic upper windows

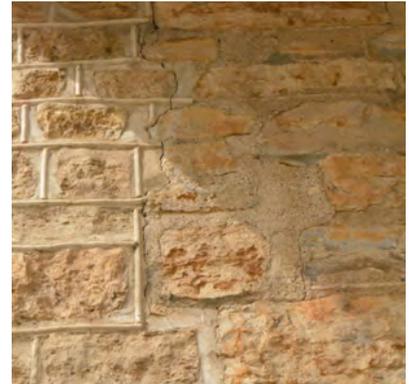
- Coursed ashlar stone on the east elevation is a new wall built of a backup of concrete masonry units with a stone veneer
- Stucco and brick on the second floor
- Elimination of four arched window openings on the second floor, and replaced with the current flat topped, wider, window openings on the east elevation
- A new first floor entrance on the east elevation
- Concrete stairs and infill to the basement on the east elevation
- Removal of a deeper cornice overhang over the current decorative metal cornice

48. Scriver Block East ashlar stone

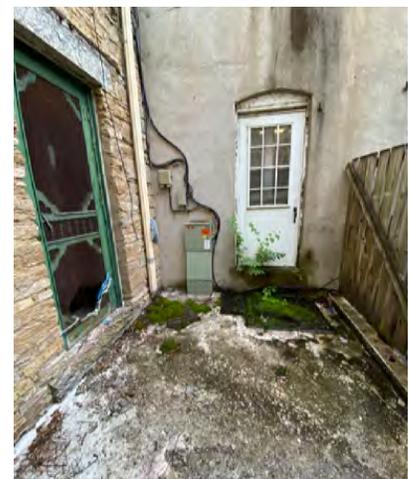
55. Rear of Scriver Block at Bank porch

- Repair Bank porch masonry in conjunction with other exterior masonry repairs.
- Perform an inspection on the upper portions of the building using a lift:

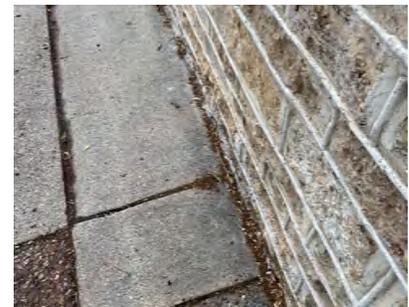
- The sealant joints between concrete sidewalks and the building have deteriorated.
- There are areas where water has entered the building, particularly along the north side of Scriver Block East, because of a failed joint.

61. Sealant at sidewalk and building joint

- Replace and/or provide sealants around the door and window frames in conjunction with the refinishing or replacement of doors and windows or work on adjacent exterior masonry and interior wall construction.

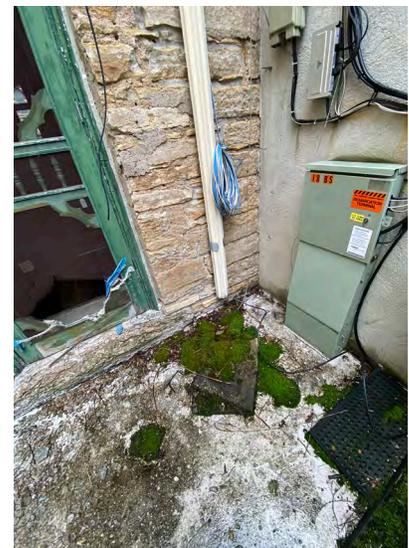
- Stone door and windowsills on the Scriver building are delaminating and chipping.
- Cardboard or carpet used as a splash block at base of downspout from roof above with lots of moss.
- Stone and mortar debris on floor, primarily appears to be from deteriorating door sill. Some organic debris in northeast corner below window.
- Debris and moss partially blocking curb scupper. Appears to have some back-up during heavy rain events based on location of some debris.
- Some staining and increased moisture levels observed on the elevator equipment room walls below indicating water infiltration through or around the CIP porch floor assembly.

62. Debris at Bank porch

- Install cap flashing at the column capital at the northeast corner pilaster.
- Maintain Bank porch floor and curb scupper free of debris.
- Remove carpet/cardboard splash block from Bank porch floor and replace with a downspout extension and proper splash block.

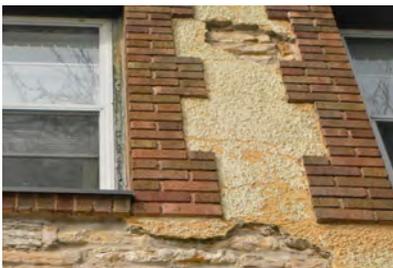
- The stucco on the building is a non-historic veneer over historic stone.
- The stucco has hairline cracks and in some areas on Scriver Block East and West shows some slight signs of displacement/loss of key. On the east elevation of Scriver Block East, sections of deteriorated stucco on the second floor have already been removed in preparation for future limestone wall restoration.

65. Stucco on second floor

- Hammer sound areas of stucco on the second floor and remove any loose areas.
 - Inspect the underside of the metal cornice to determine why the lower joint gap is increasing. If the cornice appears stable, install a trim piece of metal to cover the gap to prevent the squirrels from accessing the underside of the cornice.

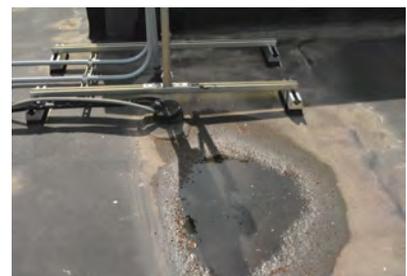
The roof is in fair to good condition. All perimeter elements appear to be watertight. The two issues that are visible are some areas of wrinkled roofing and areas of ponding/standing water near the roof hatch. The areas of ponding have created compacted insulation underneath, which create larger areas of ponding each season.

69. Ponding on roof

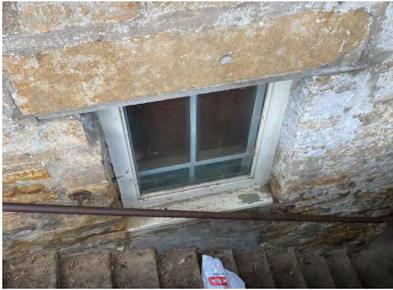
Basement windows are in fair condition with some areas of wood rot near the bottom of sashes and frames due to water infiltration, see **Site** for additional condition information.

70. Basement stairwell window

- Consider restoring basement stairwell windows if concrete stair is removed and replaced with a more historically appropriate metal stair. Otherwise, repairs openings to prevent on-going moisture infiltration into basement and to preserve any remaining historic window components within the existing openings.

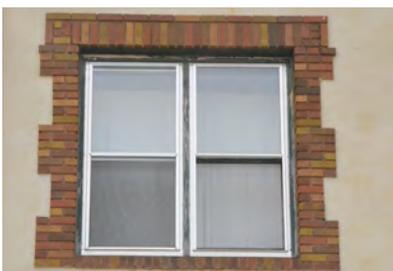
The second-floor windows show varying signs of deterioration, and their condition ranges from fair to poor. The fair condition windows are on the east elevation and on the second floor of Scriver Block West. The other second floor windows are in poor condition with peeling paint, loose storm windows, deteriorated wood, and open areas of water infiltration.

73. Second floor windows

- In the event NHS chooses to take a maintenance approach in lieu of restoring second-floor exterior facades, perform a complete window rehabilitation on all the second-floor windows. This will include the removal of the windows, removal of all loose paint, dutchman or patching repairs of deteriorated wood members (including the sill and frame of the windows), reconnecting the pulley weights, repainting, and reinstalling the windows.

- During the window rehabilitation, remove the aluminum storm windows and repair and patch the wood deterioration of the exterior sills and jambs. Install new interior storm windows.

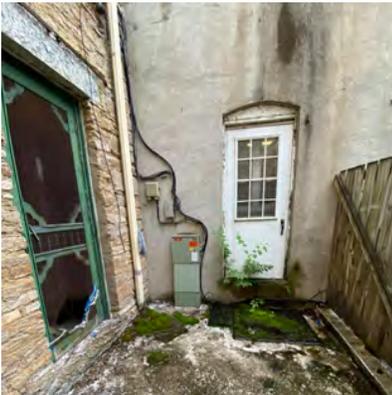
Overall, the Bank porch entrance's condition is fair. Its screen door's metal screen is rusting and torn. Peeling paint is common on both the screen door and exterior wood door and may indicate some minor wood deterioration below. Its door hardware is broken making it hard to open on the rare occasion someone needs to access the porch.

78. Bank porch entrance

- Scrape, patch and epoxy wood repair, and repaint the doors and sidelight panels.
- See **Site** and **Air Infiltration/Exfiltration** for discussions of an added threshold at the 406 Division Street main entrance door that is letting water into the building and for weatherstripping.

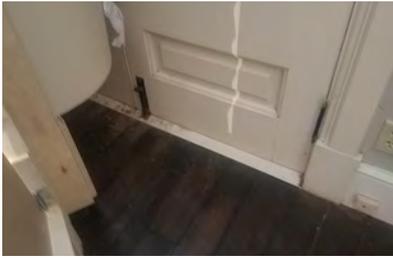
83. Debris blown in under 406 Division Street entry doors

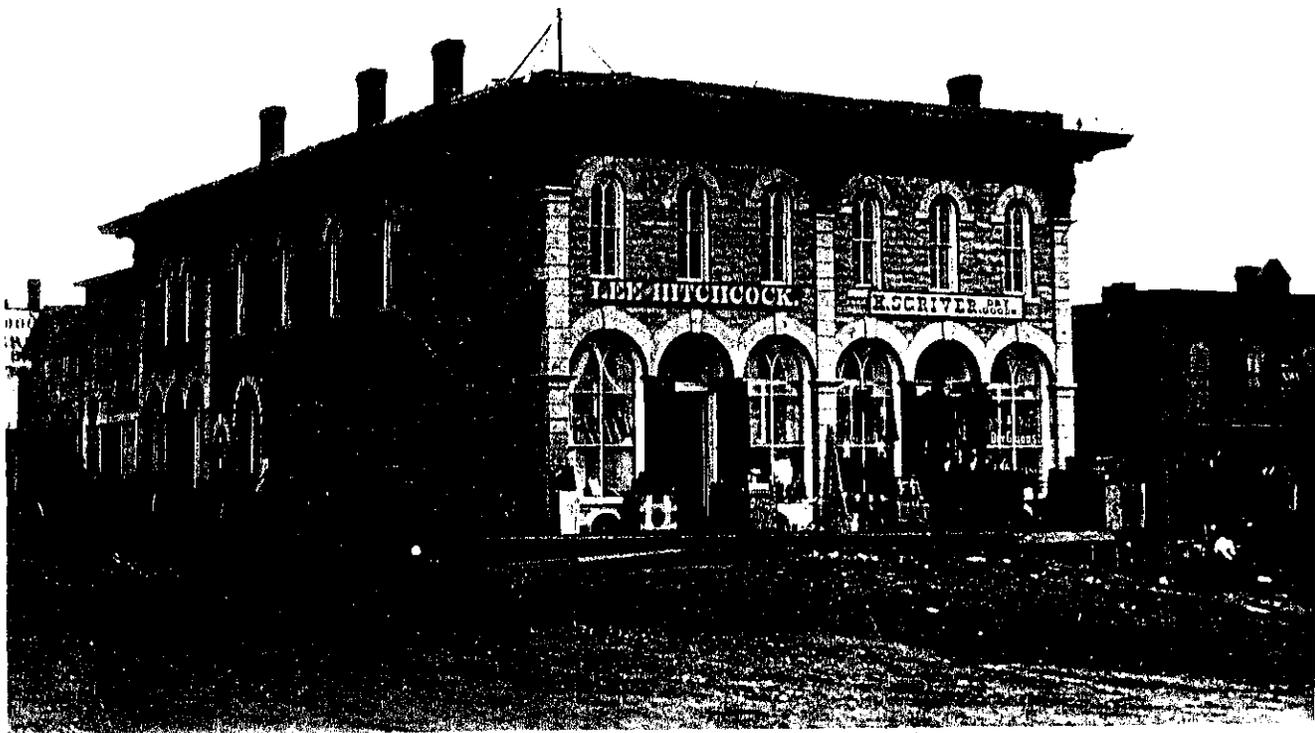
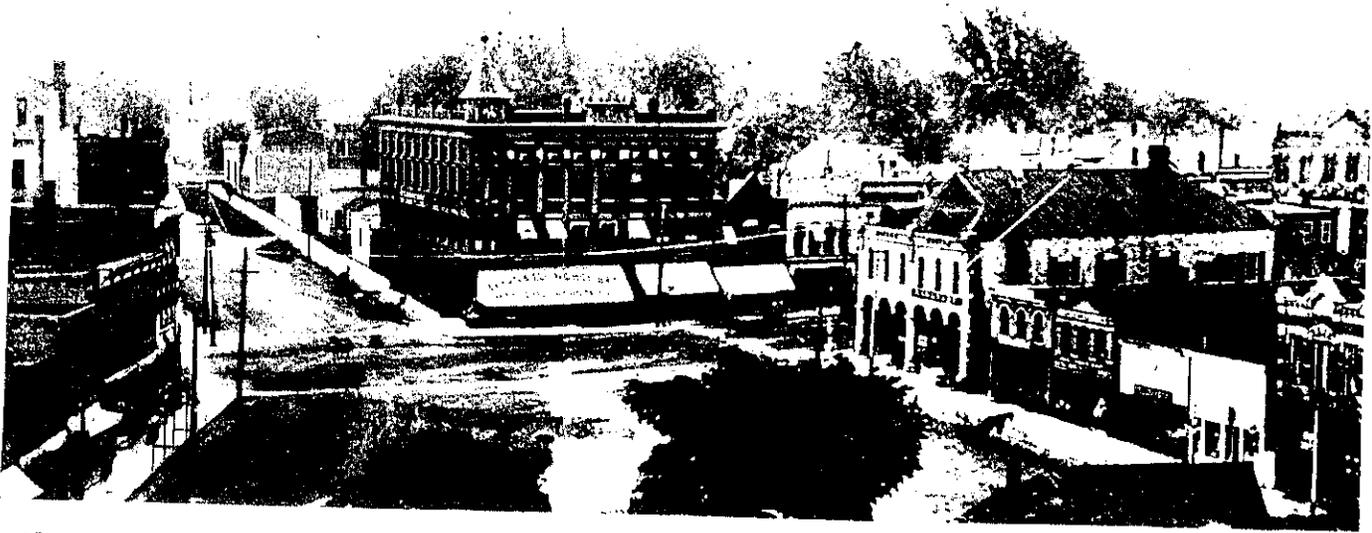
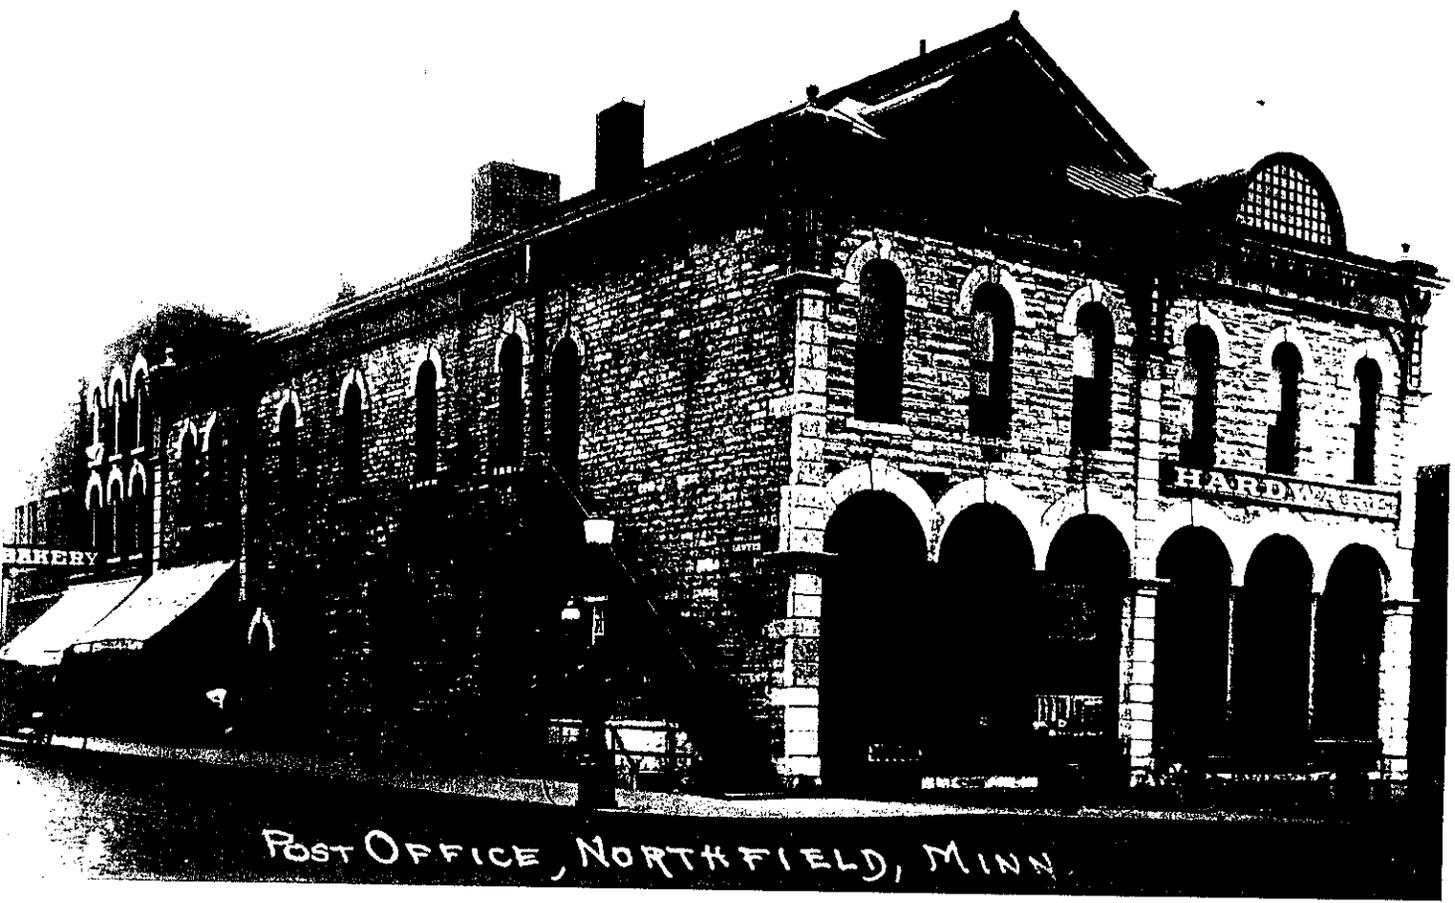
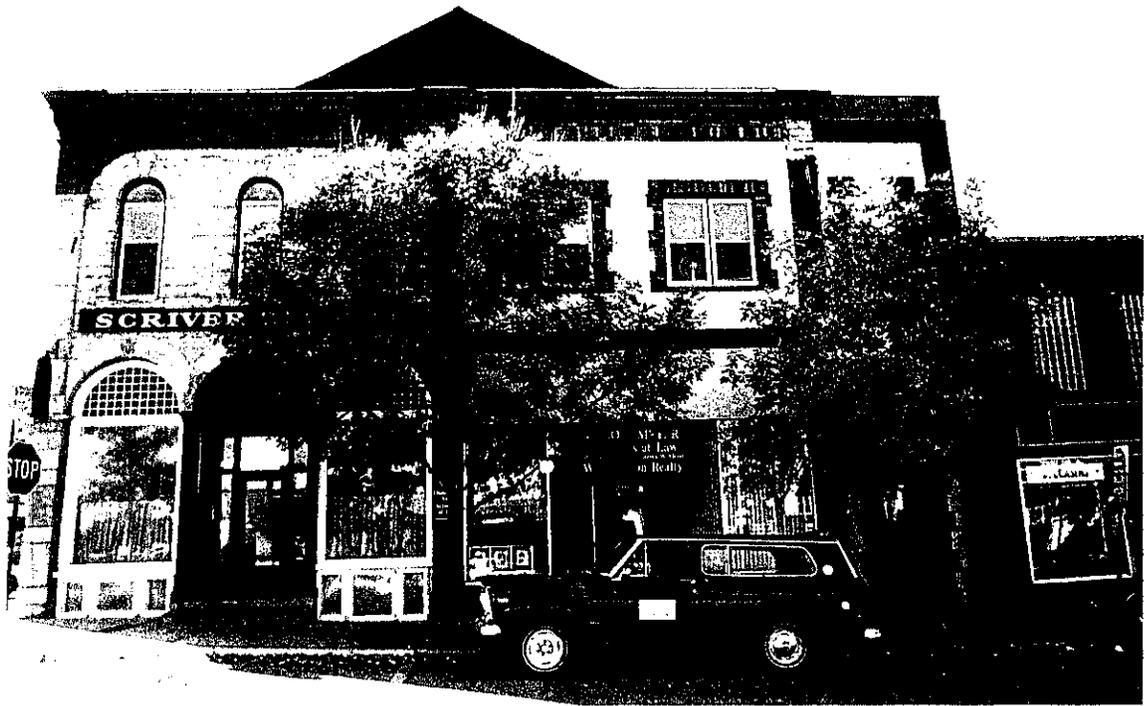
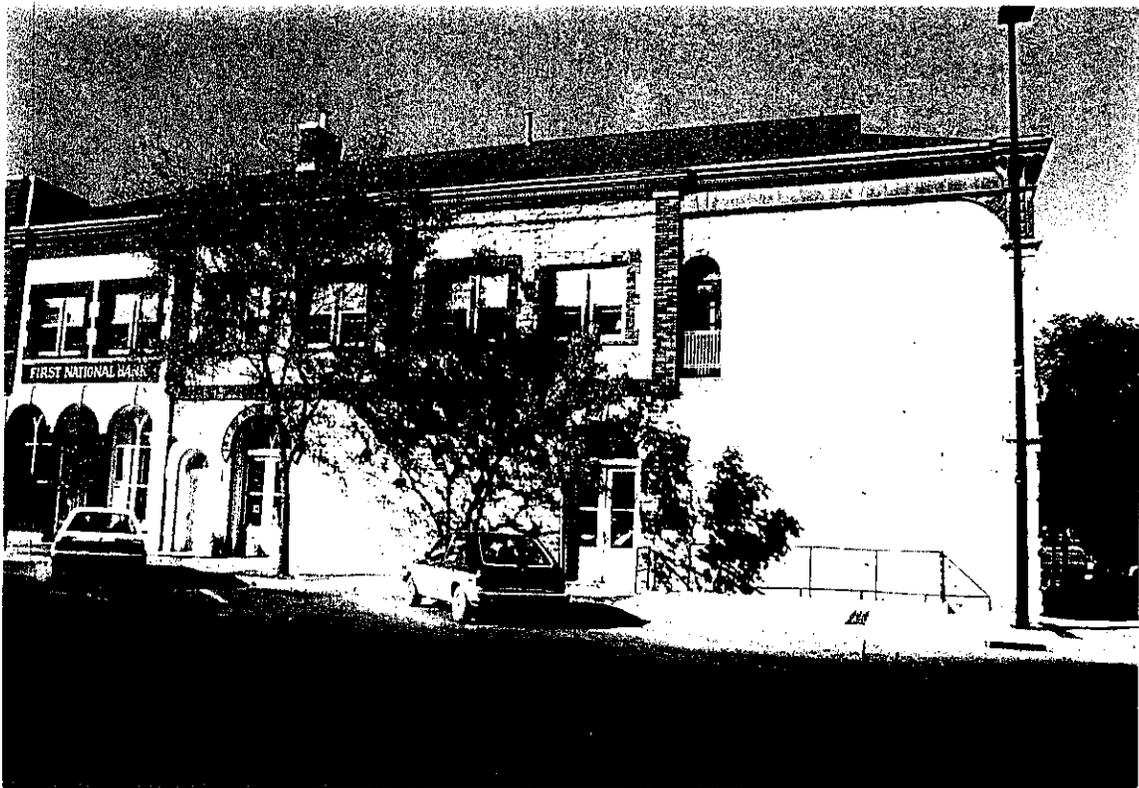
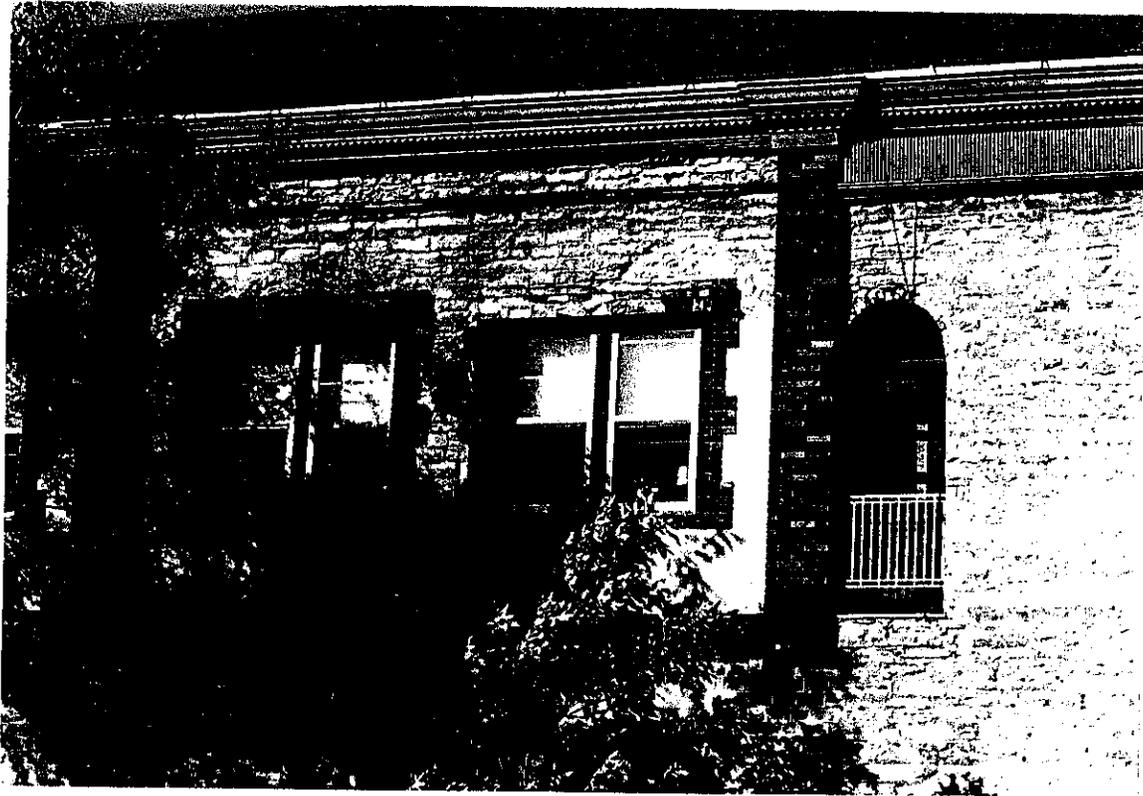
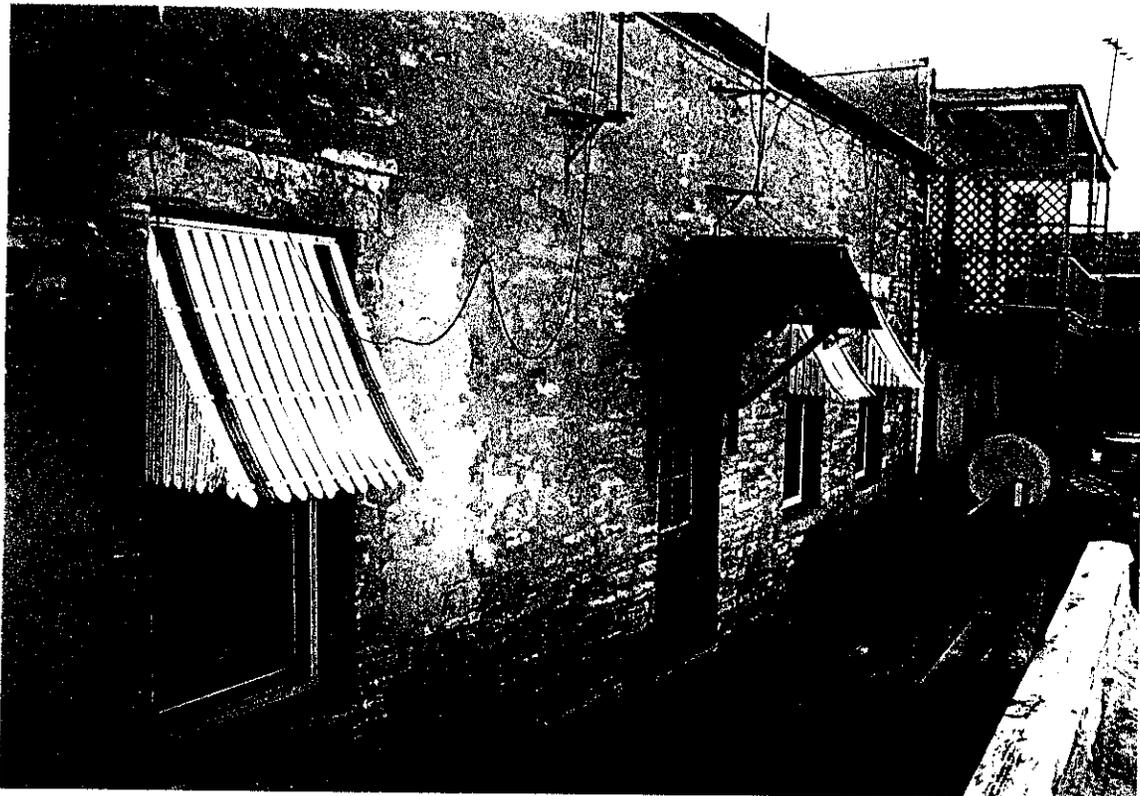
I. BUILDING PHOTOGRAPHS - HISTORIC AND CURRENT

- a. About 1870, showing Division Street side and Bridge Square side before stairway added. Wood sidewalks. No basement stair.
- b. About 1874, showing added wood stair but no basement entrance.
- c. About 1898, taken from the top of Ames Mill showing the west face, Bridge Square side and sloped roof added in 1888.
- d. About 1918, showing Division Street side and Bridge Square side. Second generation storefronts and stair to basement.
- e. 1990 (color). Bridge Square side and Division Street side - partially restored.
- f. 1990 (color). Stucco and brick deterioration on Division Street side. West side exit balcony and wall.

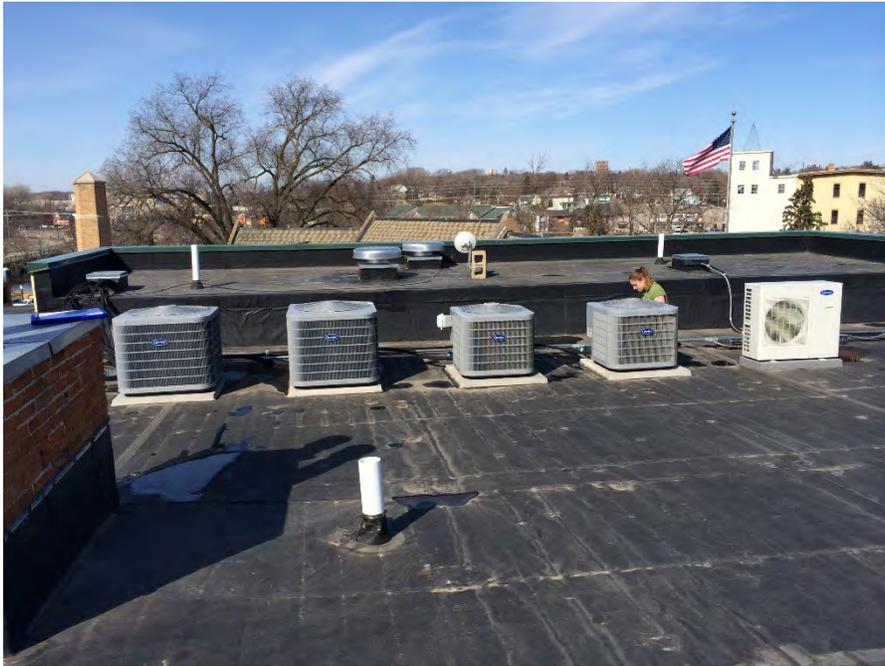
Each DX cooling coil is piped to a dedicated condensing unit on the roof (refer to photo in attached Figure 1), and each heating coil has a hot water circulation pump dedicated to it. A remote (in the space served) wall-mounted thermostat controls the fan, cooling, and heating at each AHU. The location of each AHU and its respective thermostat are shown on the attached floor plans.

Figure 1: Condensing Units

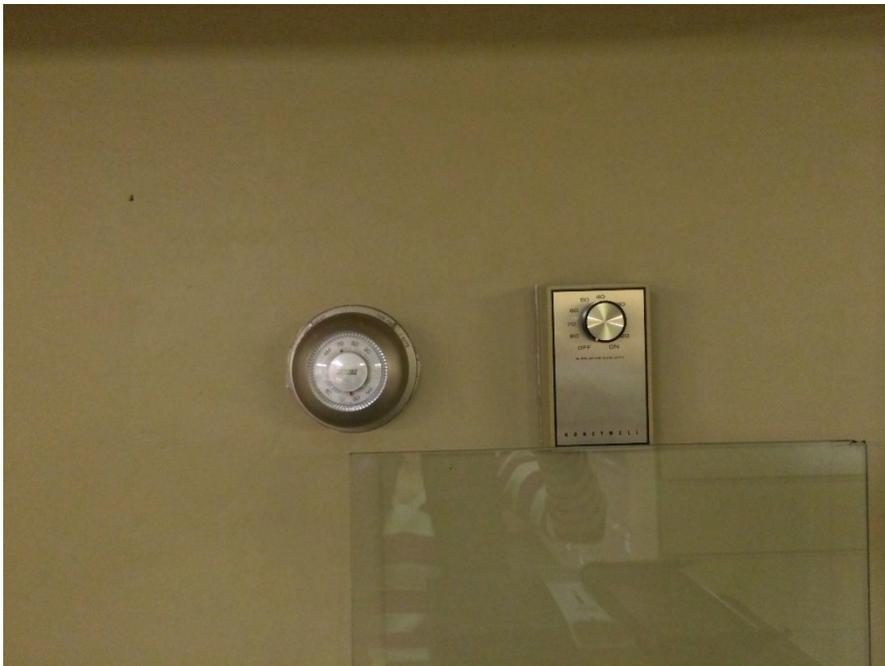
AHU-1, serving the Lower Level Archives, Collections, and Work Room, is unique in that it has a wall-mounted humidistat next to its thermostat. Please refer to Figure 2 for a photo of the thermostat and humidistat currently located in the Work Room. QSE believes that the humidistat was originally intended to allow for space humidity control, but the controls currently do not function as required to realize humidity control.

Figure 2: AHU-1 Thermostat & Humidistat

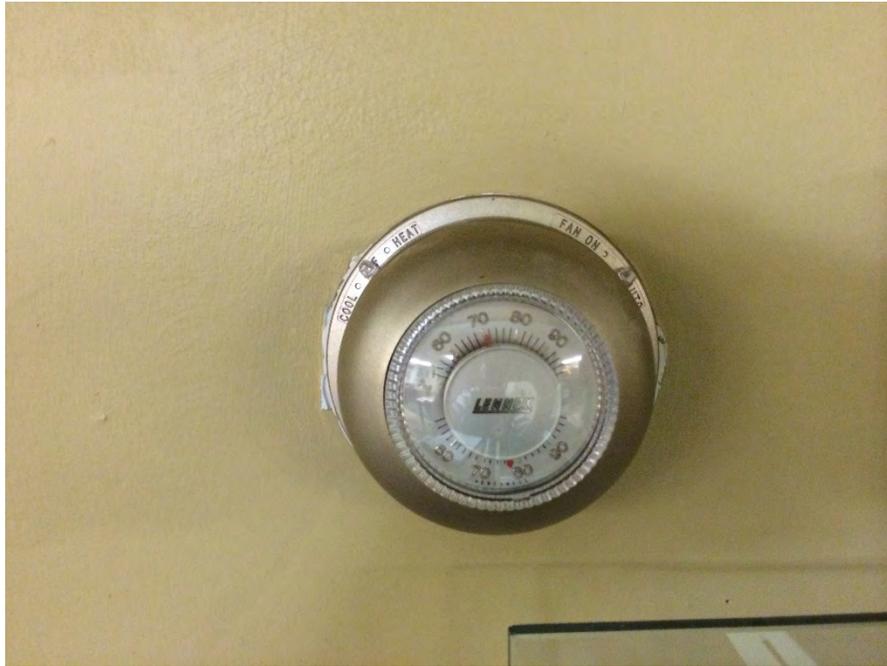
AHU-2, AHU-3, and AHU-4 are all controlled via their wall-mounted thermostats for space temperature control only. Please refer to Figure 3 for a photo of a typical thermostat currently used for these systems. The clear plastic disk on the front of the thermostat is used to manually set the desired space temperature as shown by the red indicator on the top scale of temperatures. The actual space temperature is shown by the red indicator on the bottom scale of temperatures.

Figure 3: Typical AHU-2, AHU-3, AHU-4 Thermostat

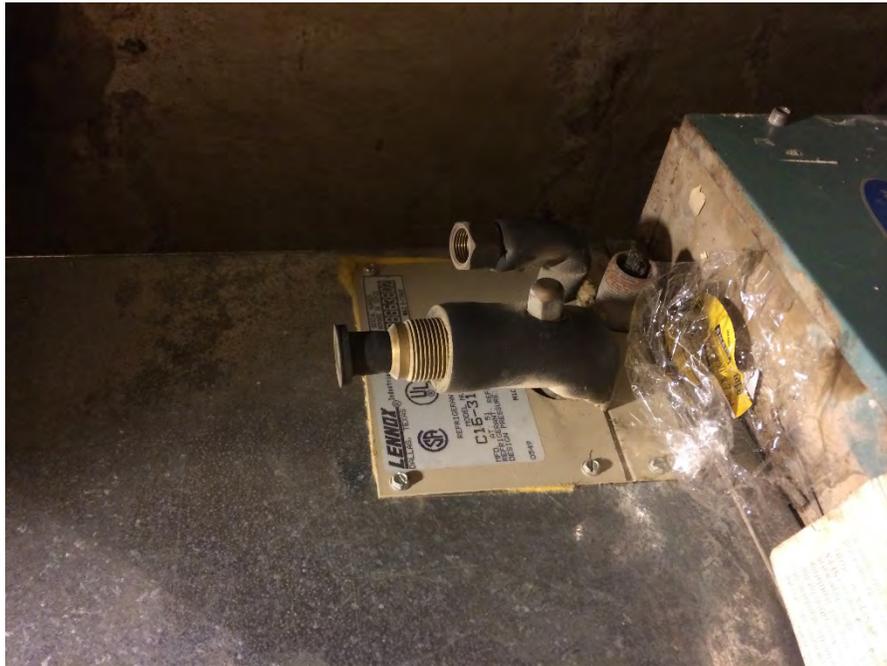
AHU-5 is unique in that it does not have a rooftop condensing unit, although it appears to have a DX refrigerant cooling coil in the air handling unit (Figure 4). This means that AHU-5 does not currently have any cooling capability and the Lower Level Meeting Room is only heated when needed. The AHU-5 thermostat on the Meeting Room wall (Figure 5) has a manual set point adjustment dial only and does not allow the NHS to choose between FAN ON and AUTO for circulation fan control. Whenever the space temperature falls below set point the fan starts and the heating hot water pump energizes. When the space temperature is satisfied, both the fan and pump stop.

Figure 4: AHU-5 DX Cooling Coil Connections

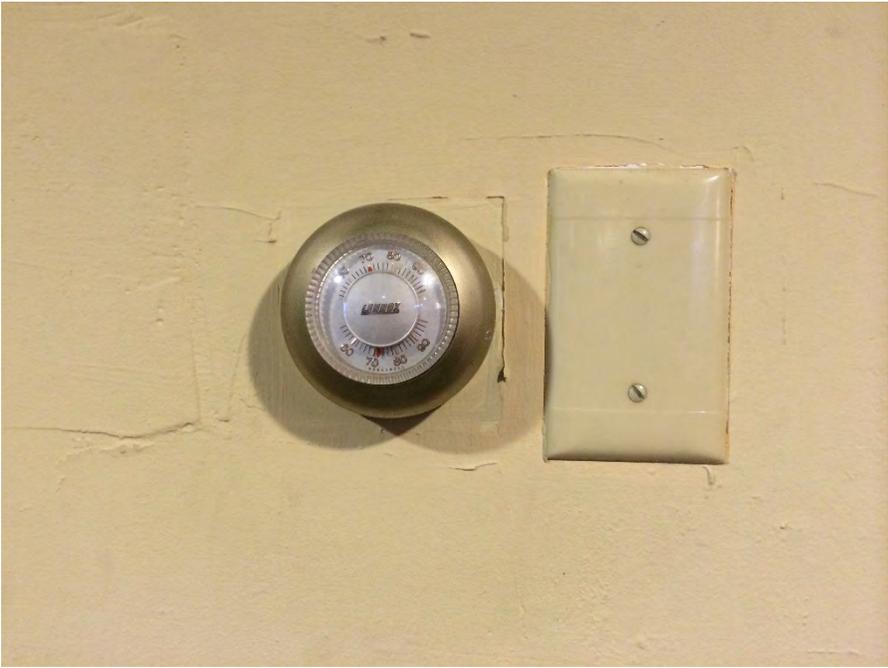
Figure 5: AHU-5 Thermostat

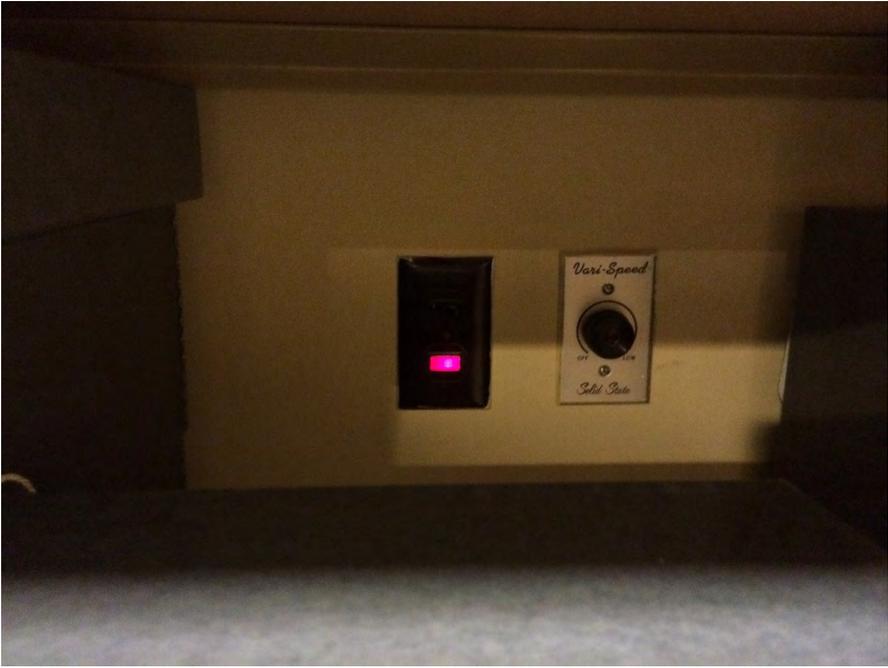
The Lower Level Meeting Room also has a manually-controlled exhaust fan in the southwest corner of the room. Figure 6 is a photo of the on/off switch for the exhaust fan next to a fan speed dial, both of which are wall-mounted and concealed behind boxes on a shelf.

Figure 6: Meeting Room Exhaust Fan Controls

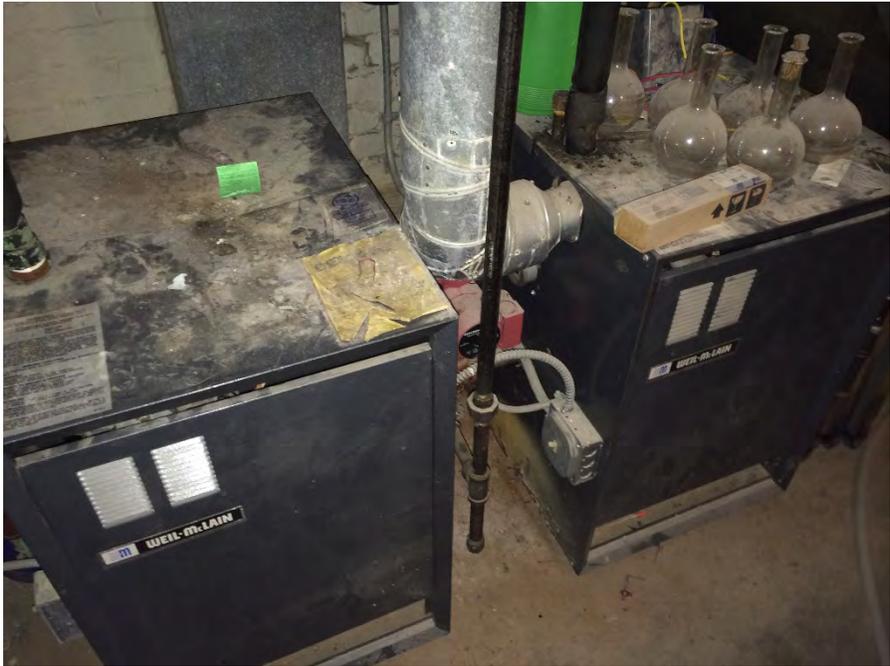
Heating hot water is generated by two boilers located in the Lower Level mechanical room (Figure 7). Hot water is circulated by pumps to the AHUs and to a strip of finned tube radiation in the Main Level stairwell. Each of the dedicated AHU pumps is started/stopped by its respective thermostat, while the pump serving the stairwell is manually controlled on and off by a toggle switch near the boilers (Figure 8).

Figure 7: Boilers

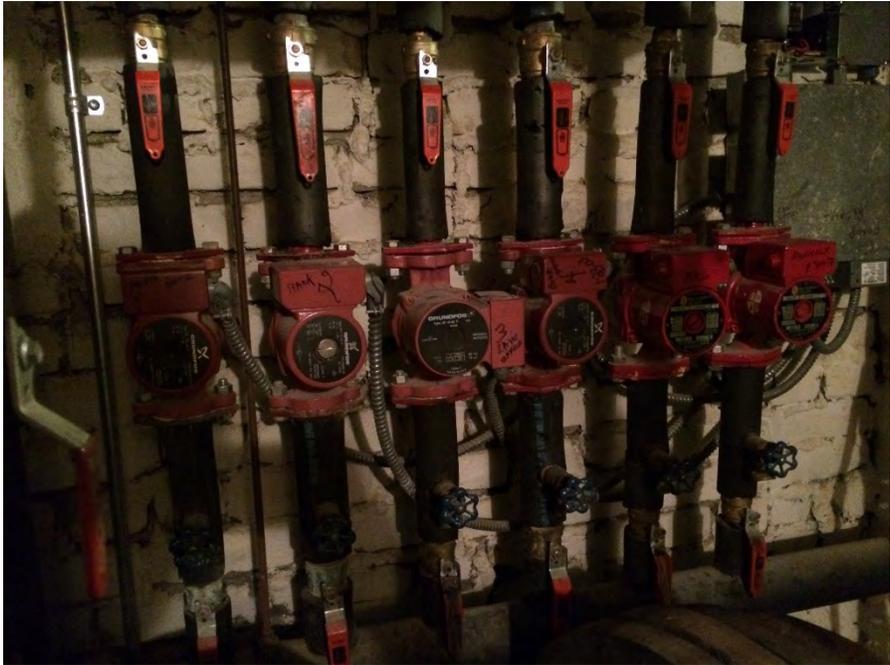
Figure 8: Heating Hot Water Pumps

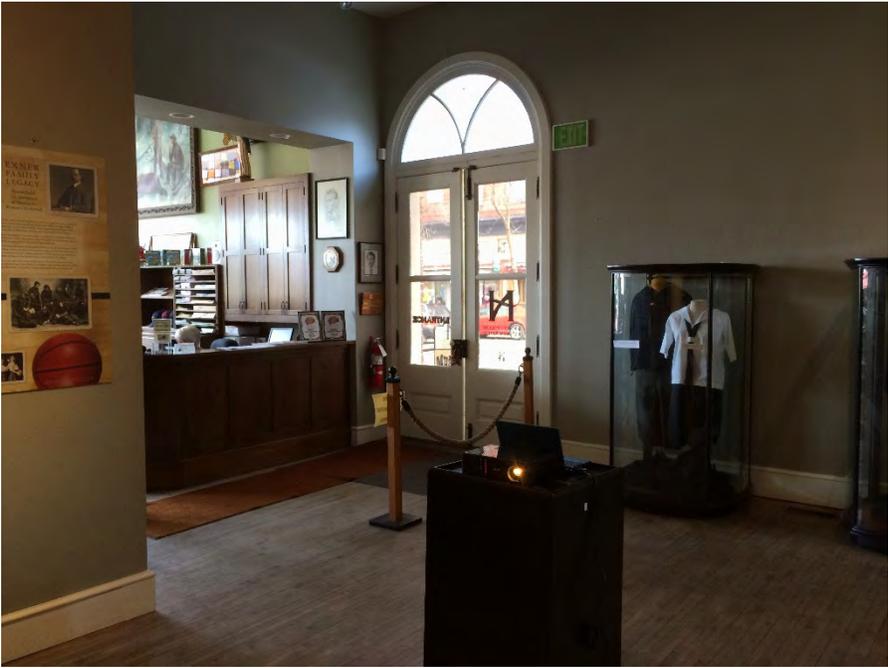
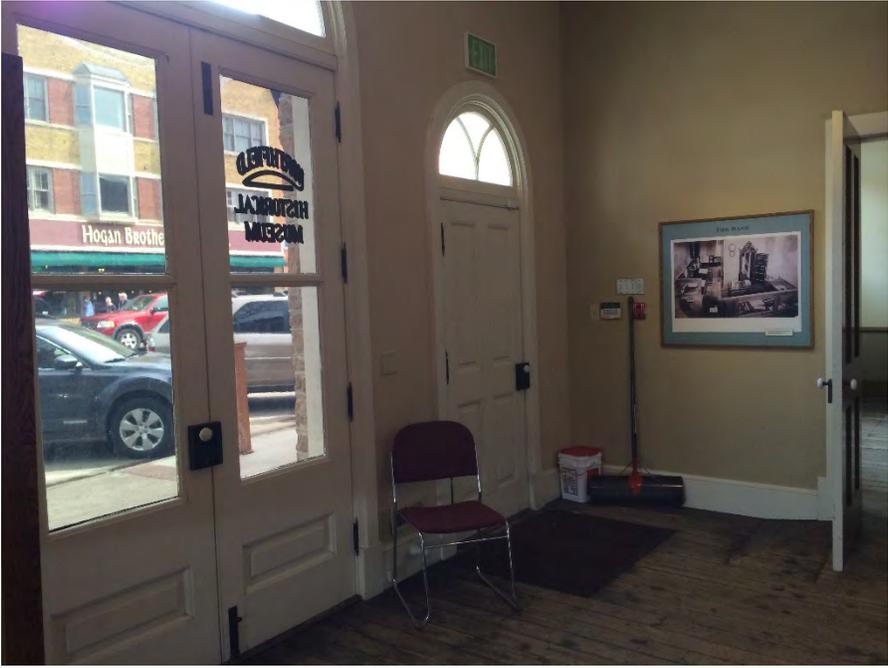
The Main Level exterior doors in the Museum Shop and galleries are in varying conditions of “leakiness.” Figure 9 and Figure 10 are photos of 3 of the 5 doors that lead directly from the Museum to the outdoors. Any air leakage through these doors will degrade the indoor environmental conditions, creating hot/humid microclimates in the summer and cold/dry microclimates in the winter.

Figure 9: East Door to Entry Gallery

Figure 10: East Doors to Exterior Gallery

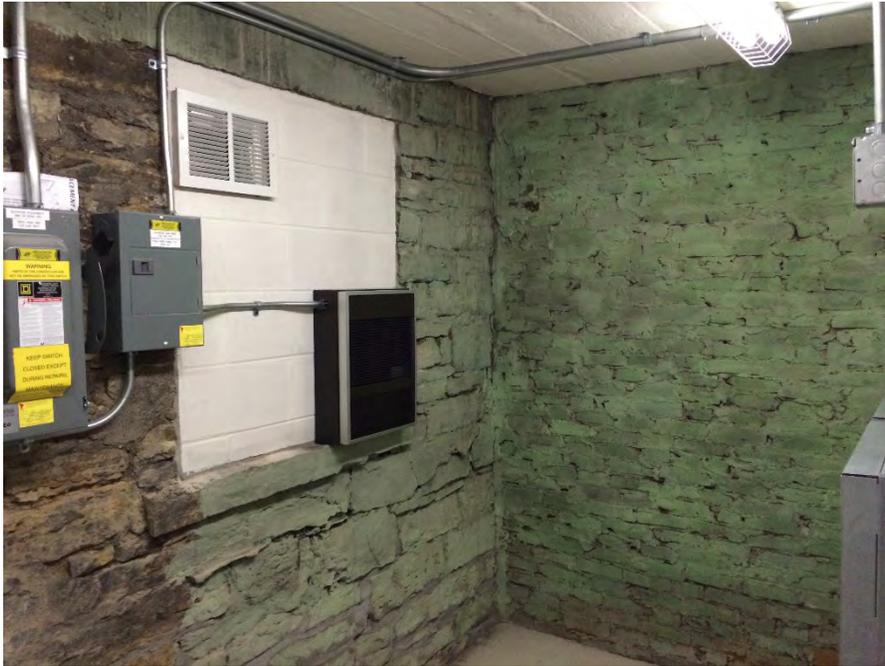
Figure 11: Elevator Machine Room Transfer Grille

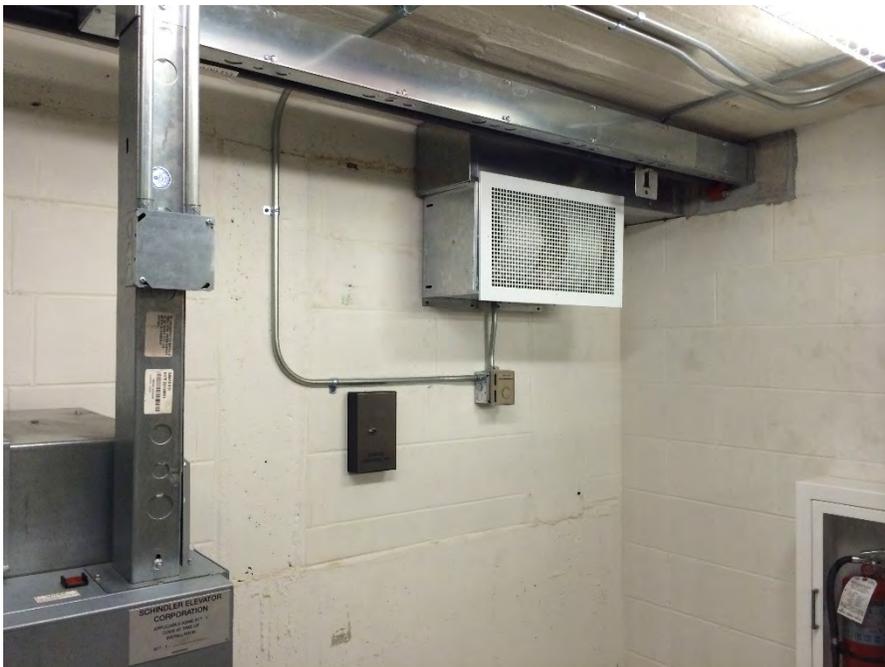
Figure 12: Elevator Machine Room Exhaust Fan & Thermostat
