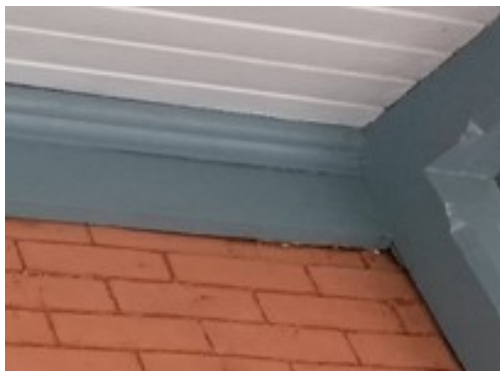
Cornice Board: All existing cornice boards between the brick and the soffit v-board on the north, east and west walls appear to be original; the cornice boards on the restored south end of the west side and the new south wall were added in 2019.

Original cornice board

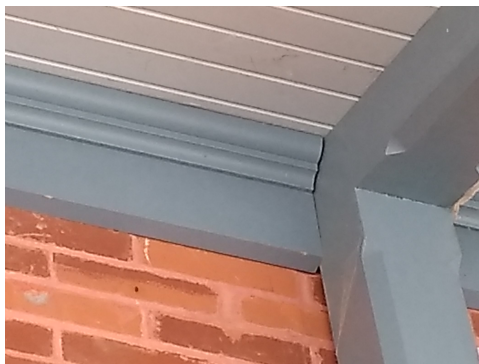
2019 New cornice board on south wall

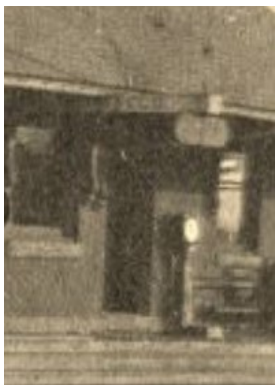
Order Board (yet to be mounted): The Midwest contact for the Milwaukee Road Historical Association donated an order board to the project since an archival photo (1896) indicated the depot did have one. A new mount was built and mechanism cleaned.

1896 In front of bay.

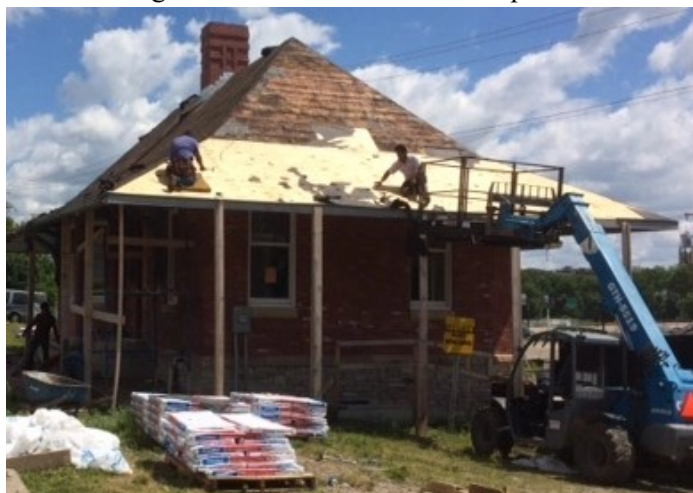
2016

Roof: Although the blueprints indicate a slate roof, there is no conclusive evidence of what was installed. Asphalt shingles were on the roof when acquired in 2015 and have been replaced with new asphalt shingles.

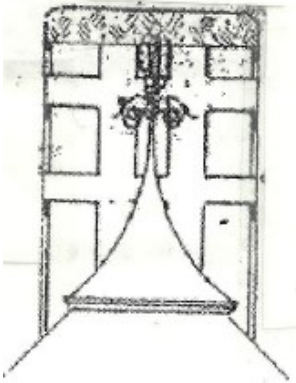
1888 plans

Chimney: The blue prints and archival photos indicate a uniquely patterned brick chimney and roof cresting. The chimney, used for a central heating stove in the center of the depot, was removed in 1910 when a new heating system was installed. The brick chimney was replicated using the blue prints and recycled bricks obtained from the 1944 freight house and contains the white bathroom vent pipe. Adding roof cresting was considered but was deemed a hazard due to lightening and difficulty of installing lightening rods on the wide eaves.

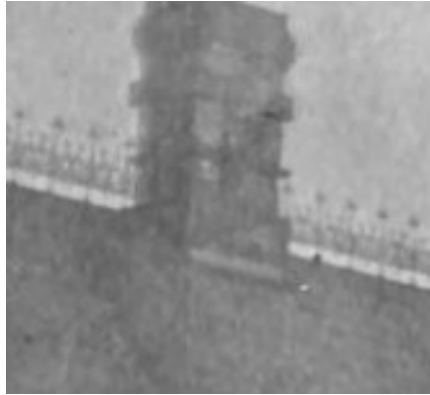
1896 Cap omitted as directed on blue print

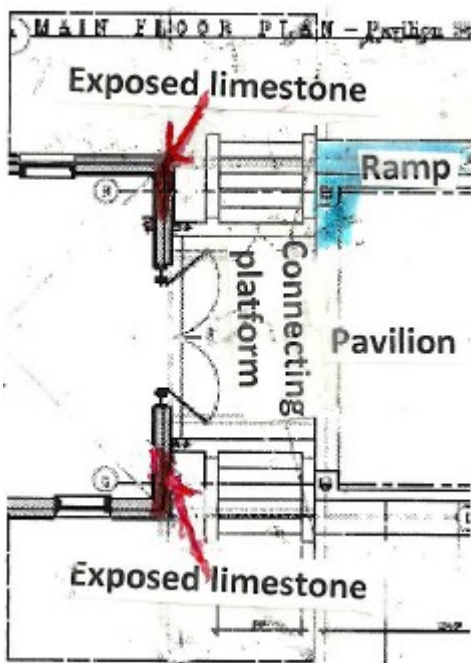
As shown below, the door entrance is level with the depot platform that will be contiguous with the pavilion floor (see site plans below). The depot and the new pavilion, a separate structure and City project, will be connected only by the platform. The ramp will start near the transit hub and run south on the track side of the pavilion providing access to both the pavilion and the depot. That ramp placement allows minimal intrusion on the depot building. As shown below, the stairs on both sides are significantly distanced from the foundation; the only portion of the north foundation that is covered is the area immediately outside the doorway.

Connecting platform between depot double door and pavilion. Future ramp will be on the west edge of the pavilion (track side to the right).
