SCRIVER BLOCK - East Elevation Exterior Restoration

Northfield Historical Society, 408 Division Street South, Northfield, MN 55057

SCRIVER BLOCK
East and North Exterior Restoration
Northfield Historical Society
408 Division Street South, Northfield, MN 55057
DRAWN BY DATE 2025 12 12 REVISION

COVER

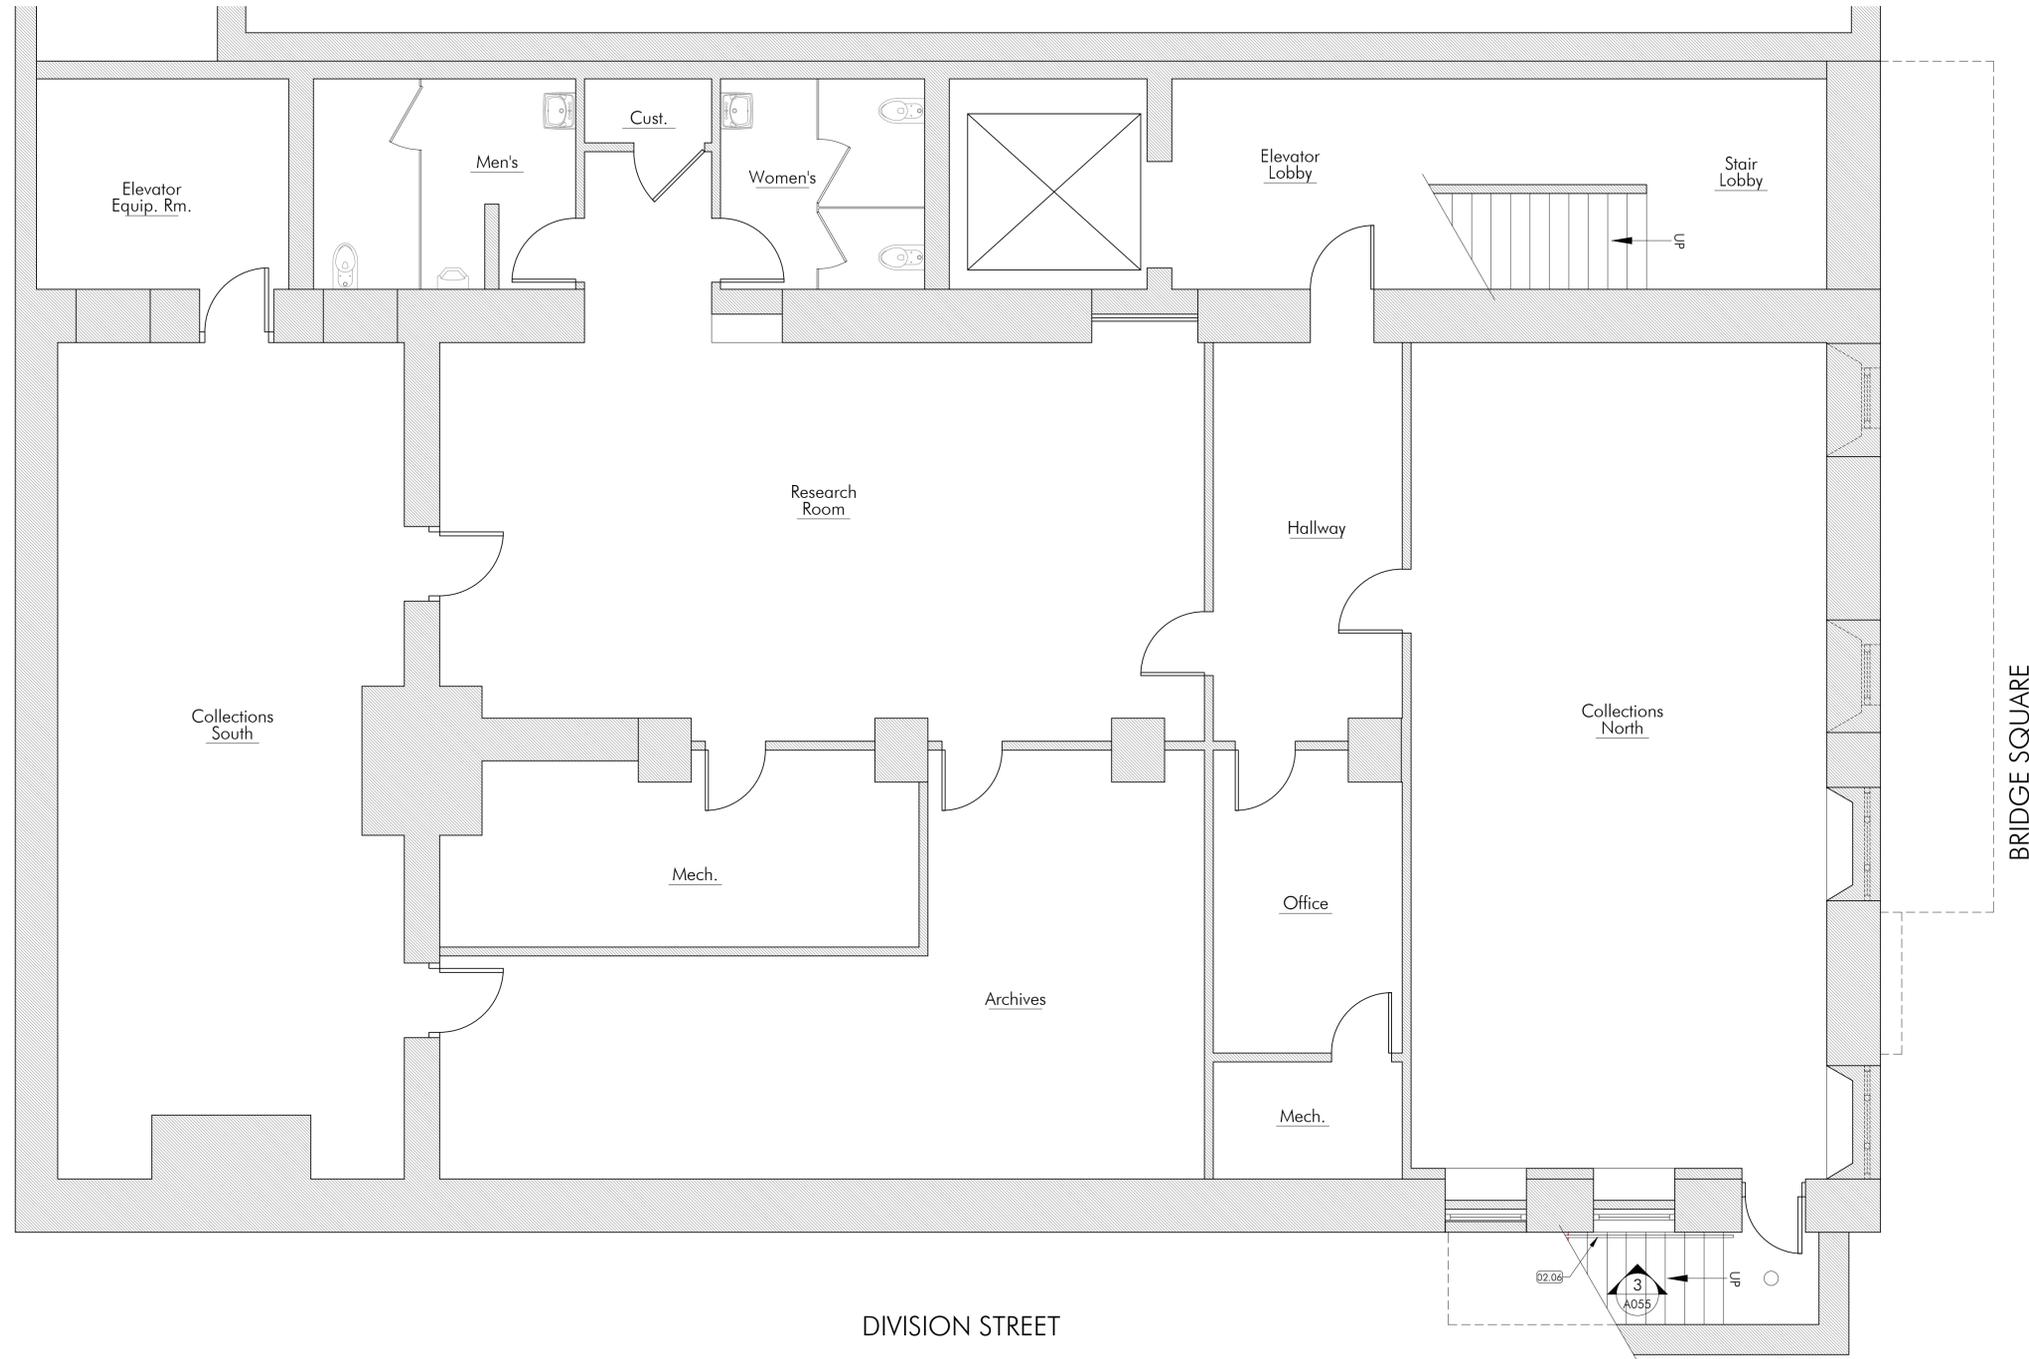
BASEMENT
DEMOLITION
PLAN

- DIVISION 02 - EXISTING CONDITIONS
 02-04 Remove wood stair and second floor landing.
 02-06 Remove handrail. Salvage for reinstallation.

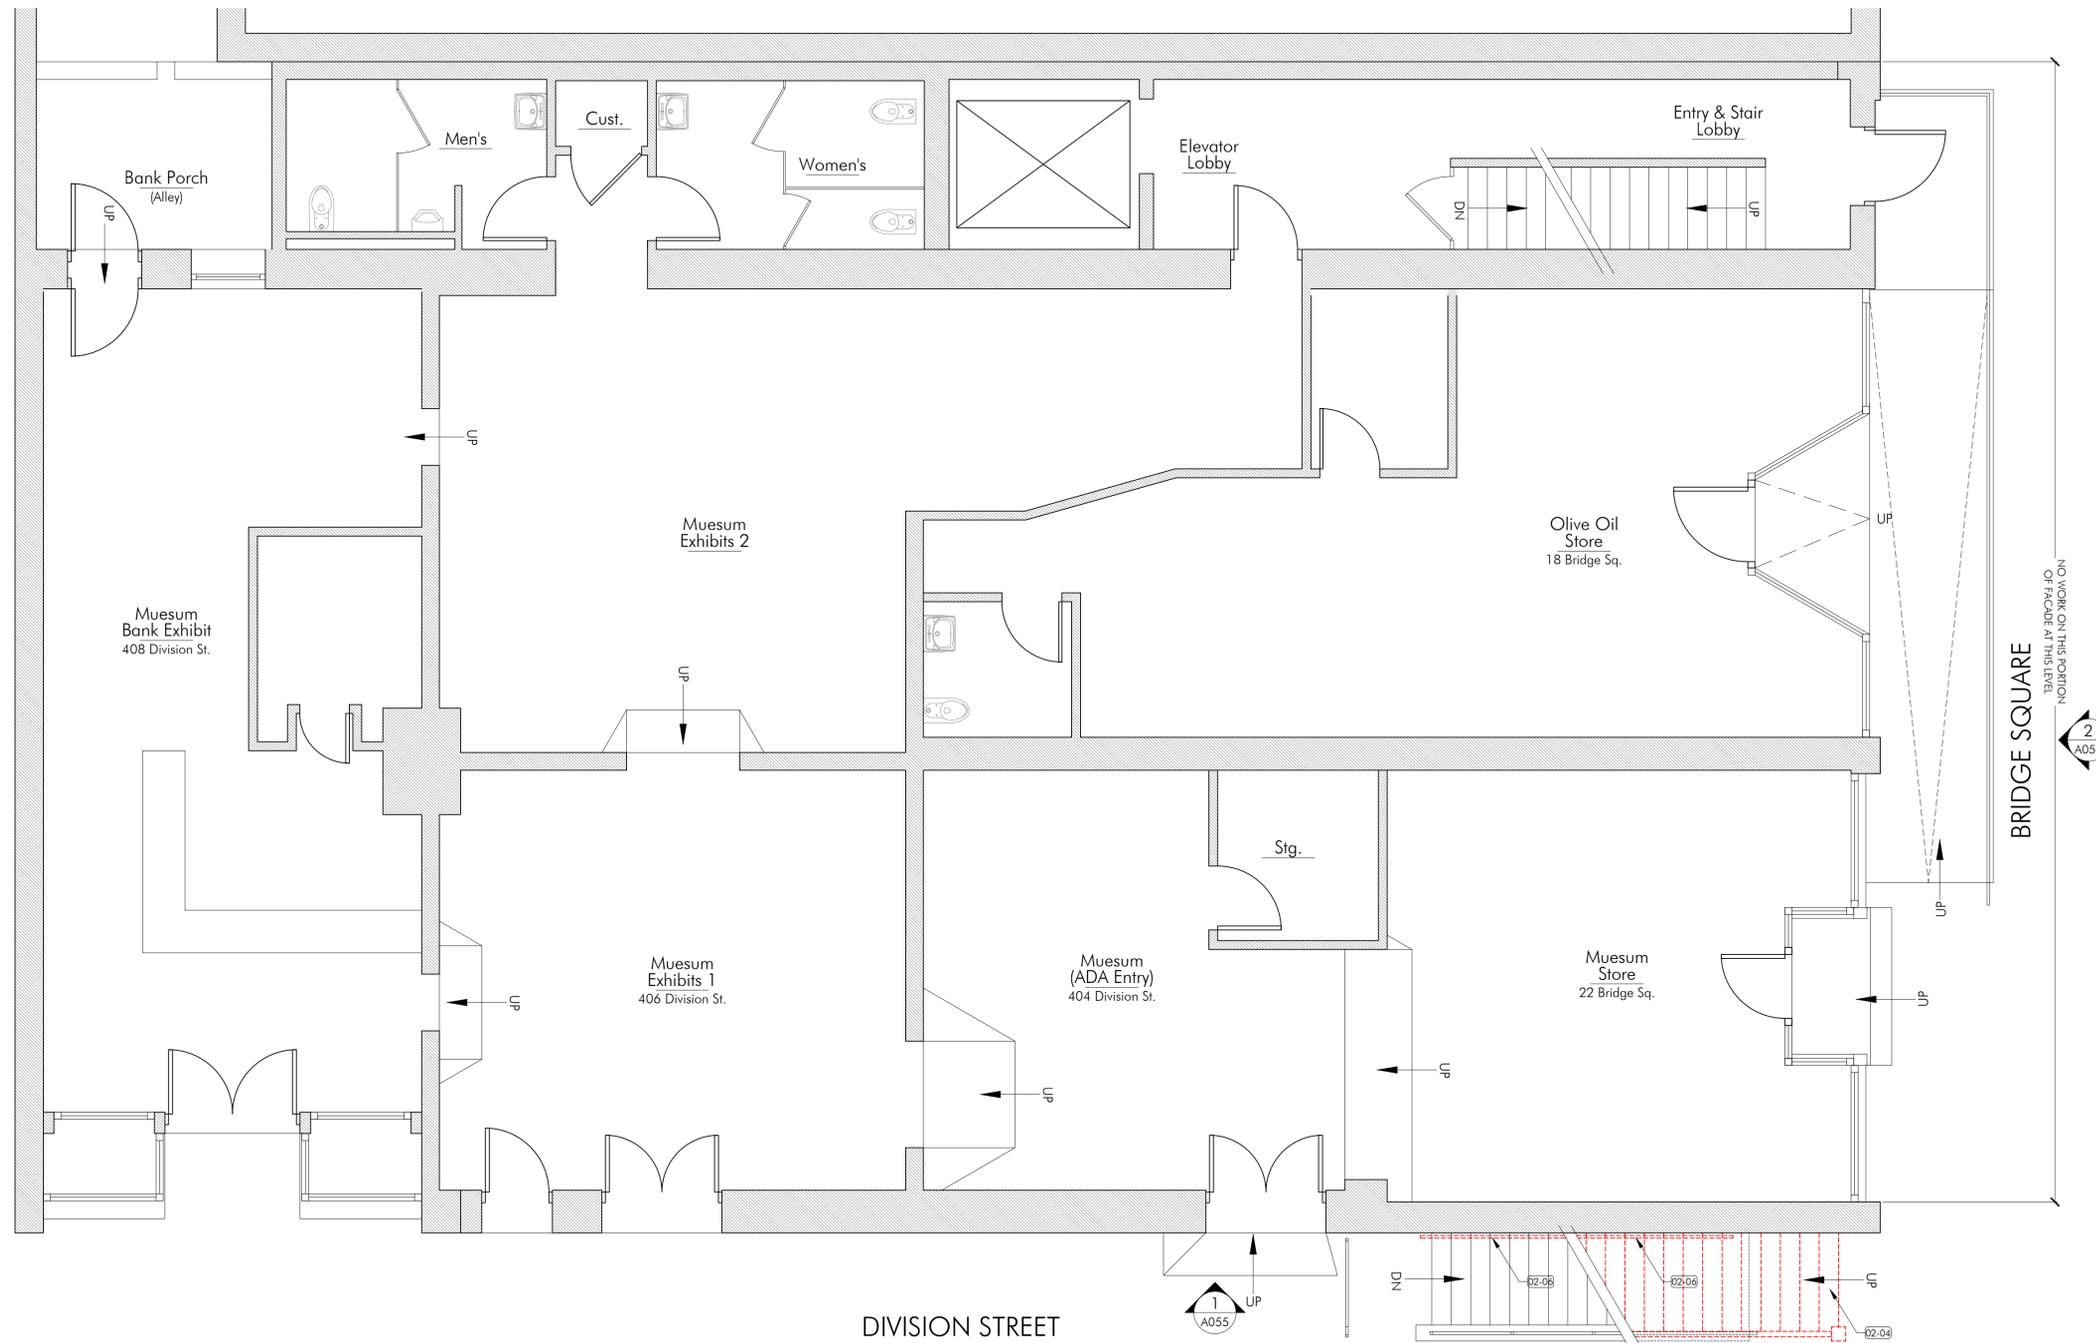
FIRST FLOOR
 DEMOLITION
 PLAN

NO WORK ON THIS PORTION
 OF FACADE AT THIS LEVEL

- DIVISION 02 - EXISTING CONDITIONS**
- 02-04 Remove wood stair and second floor landing.
 - 02-06 Remove handrail. Salvage for reinstallation.
 - 02-08 Remove windows. Demolish walls as needed for new window installations.
 - 02-12 Remove brick veneer banding.
 - 02-13 Remove brick veneer pilasters.
 - 02-15 Remove primary window sashes and frames, retain brick molding in place. Remove storm windows.

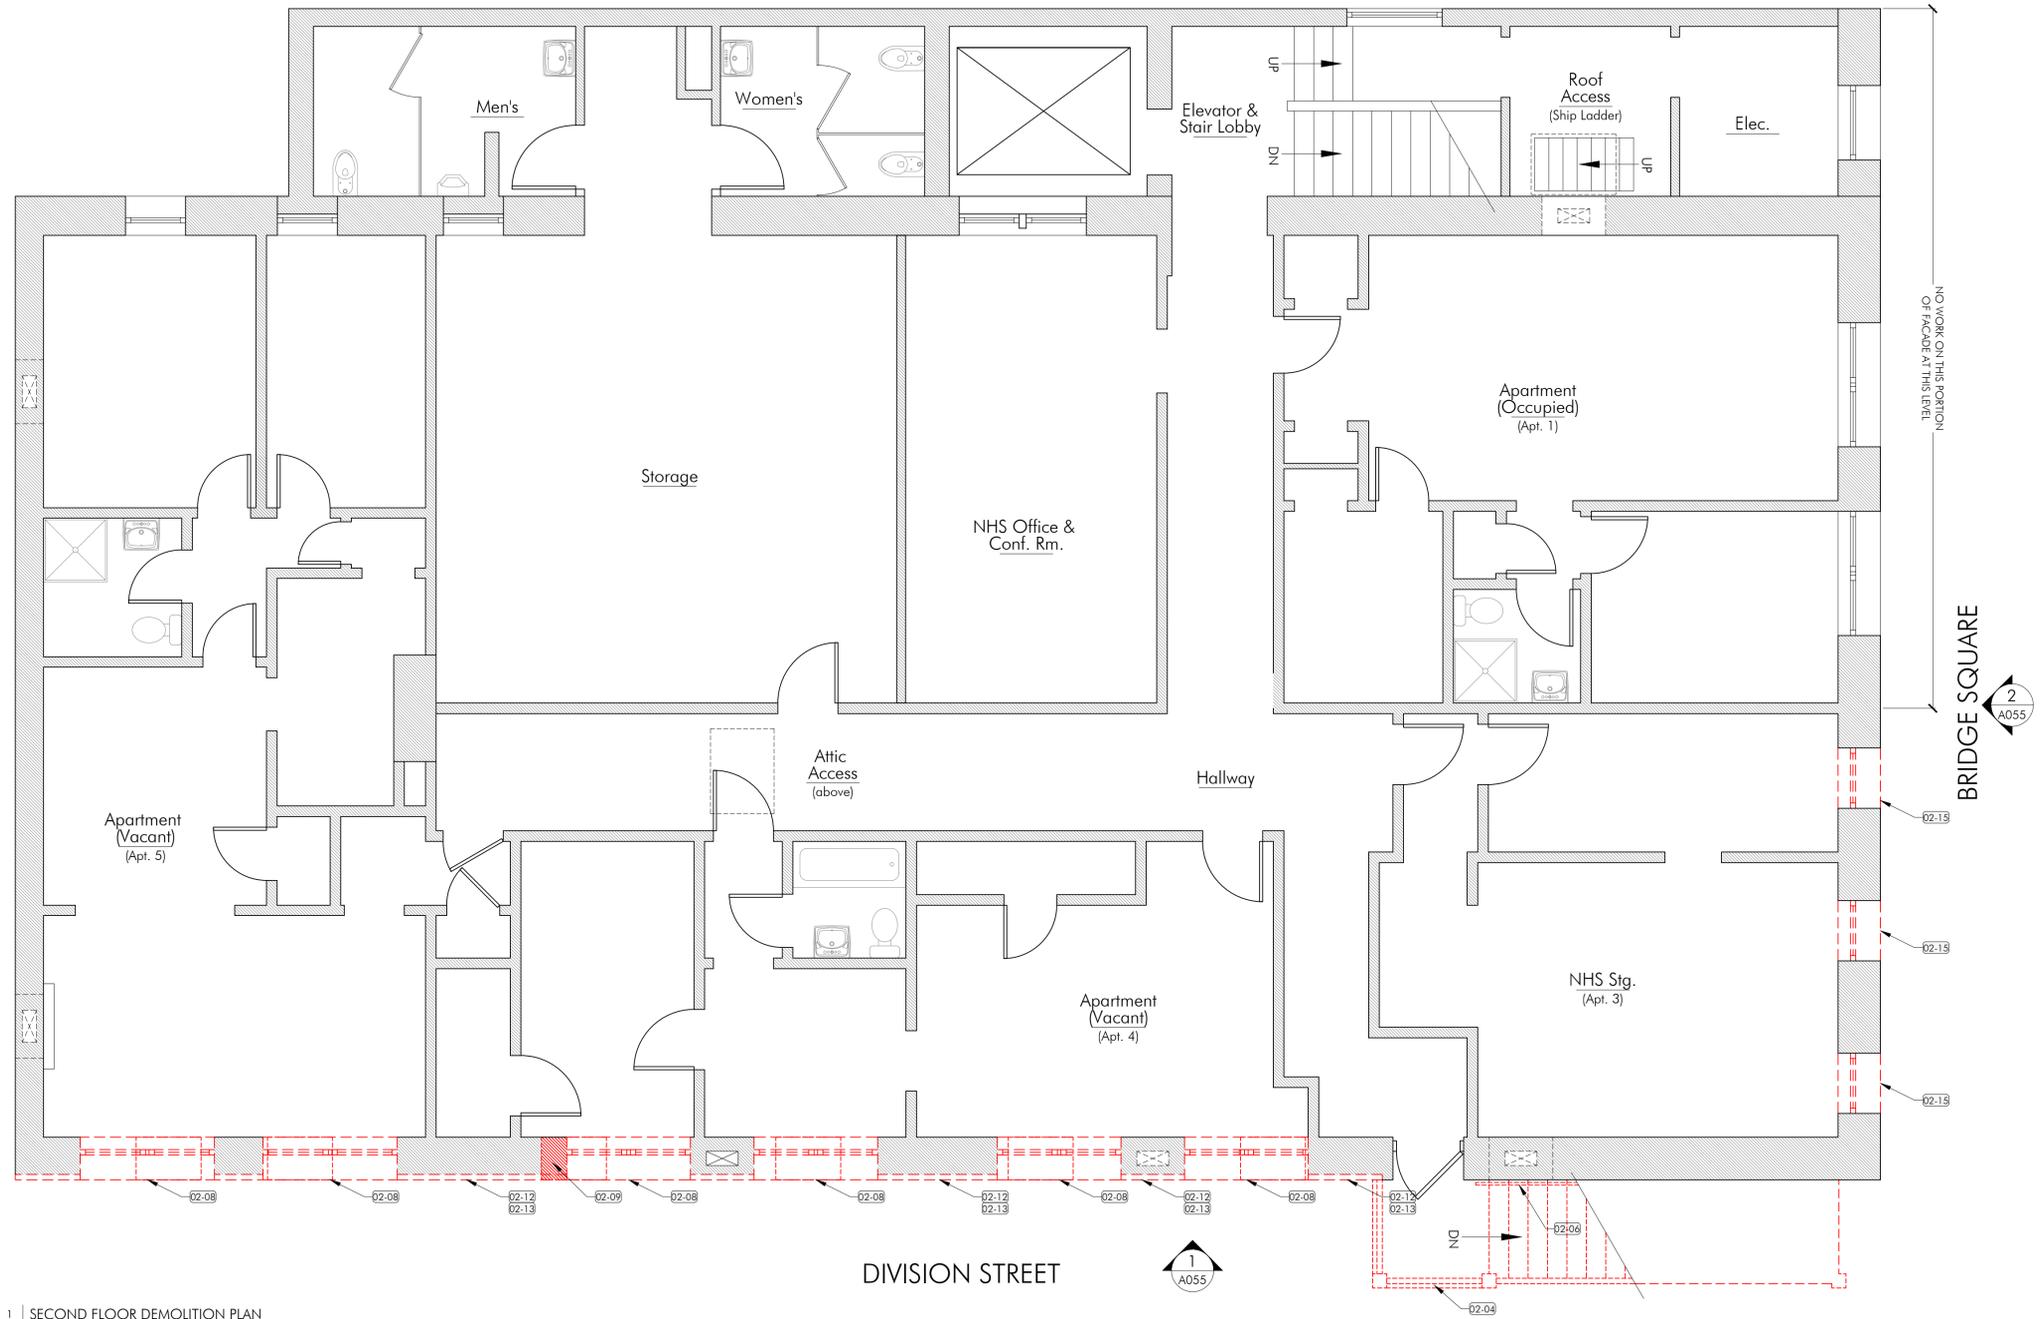
SECOND FLOOR
 DEMOLITION
 PLAN

NO WORK ON THIS PORTION OF FACADE AT THIS LEVEL

- REMOVE SURFACE MATERIAL OR MATERIAL FOR NEW OPENING

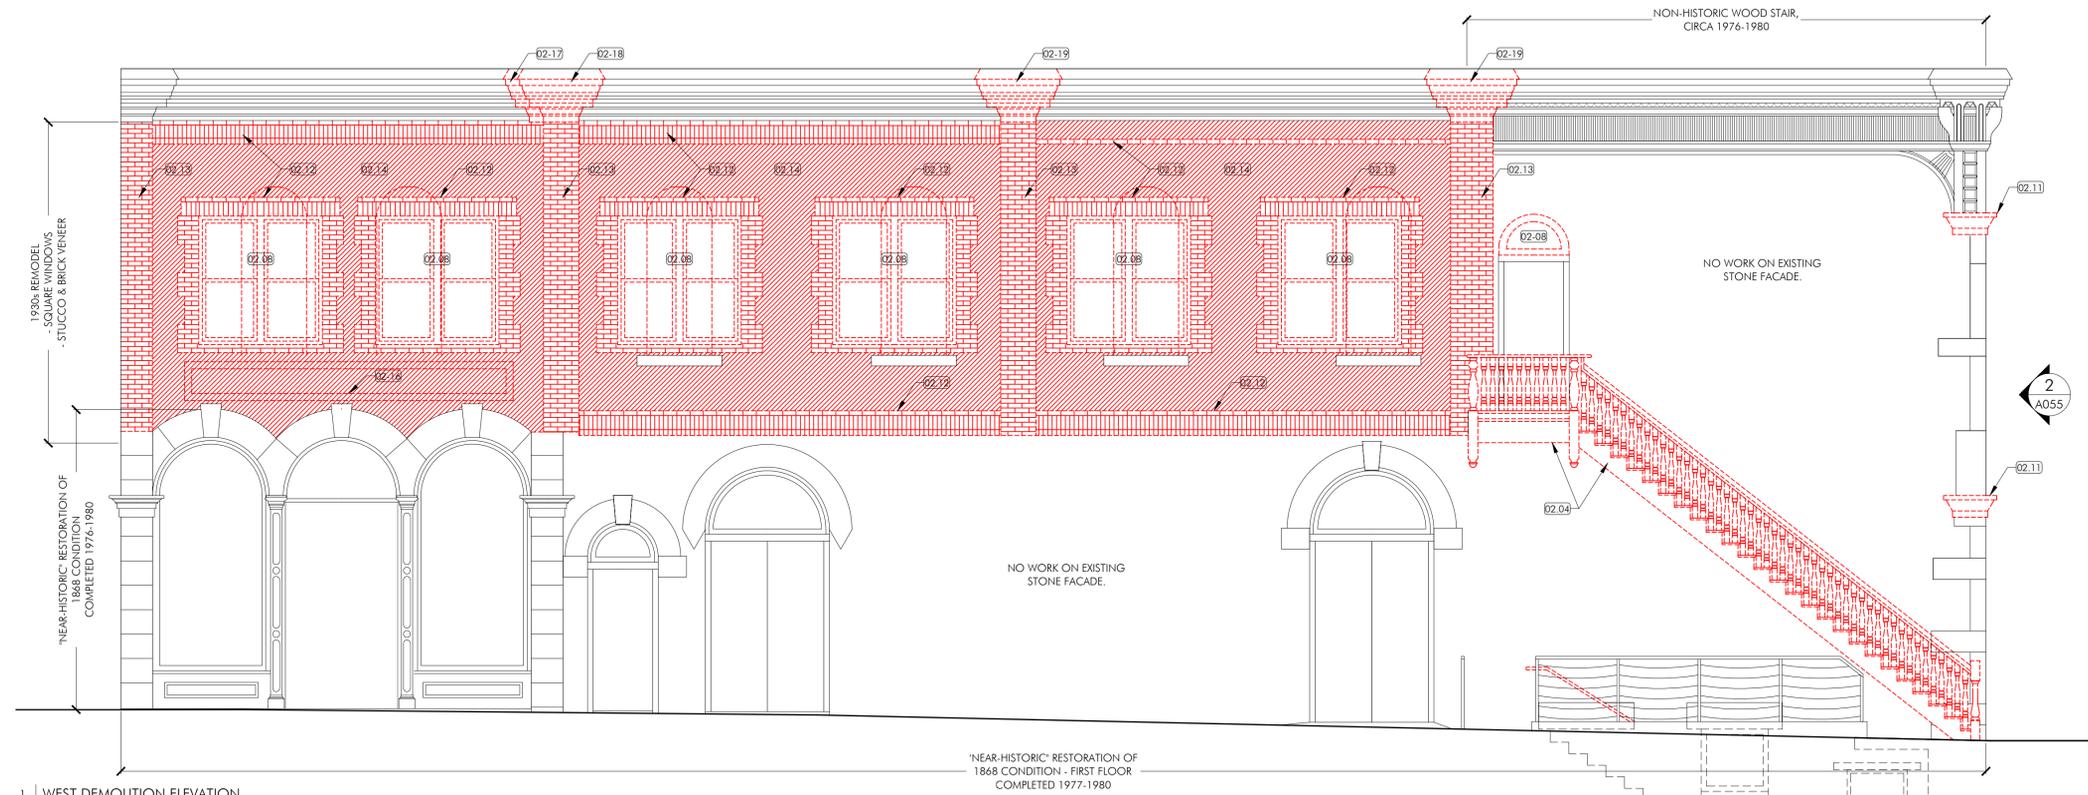
1 WEST DEMOLITION ELEVATION

- 02-04 Remove wood stair and second floor landing.
- 02-05 Remove storefront glass, door, and bulkhead.
- 02-06 Remove handrail. Salvage for reinstallation.
- 02-07 Dismantle ramp, landing, and railings. Salvage for reinstallation.
- 02-08 Remove windows. Demolish walls as needed for new window installations.
- 02-11 Remove deteriorated pilaster cap.
- 02-12 Remove brick veneer banding.
- 02-13 Remove brick veneer pilasters.
- 02-14 Remove plaster layer on stone.
- 02-15 Remove primary window sashes and frames, retain brick molding in place. Remove storm windows.
- 02-16 Remove sign. Salvage for reinstallation.
- 02-17 Remove portion of metal cornice.
- 02-18 Remove metal cornice capital. Salvage for reinstallation.
- 02-19 Remove metal cornice capital. Salvage to owner.
- 02-20 Remove brick veneer to level of sidewalk. Demo as needed for new bulkhead installation.

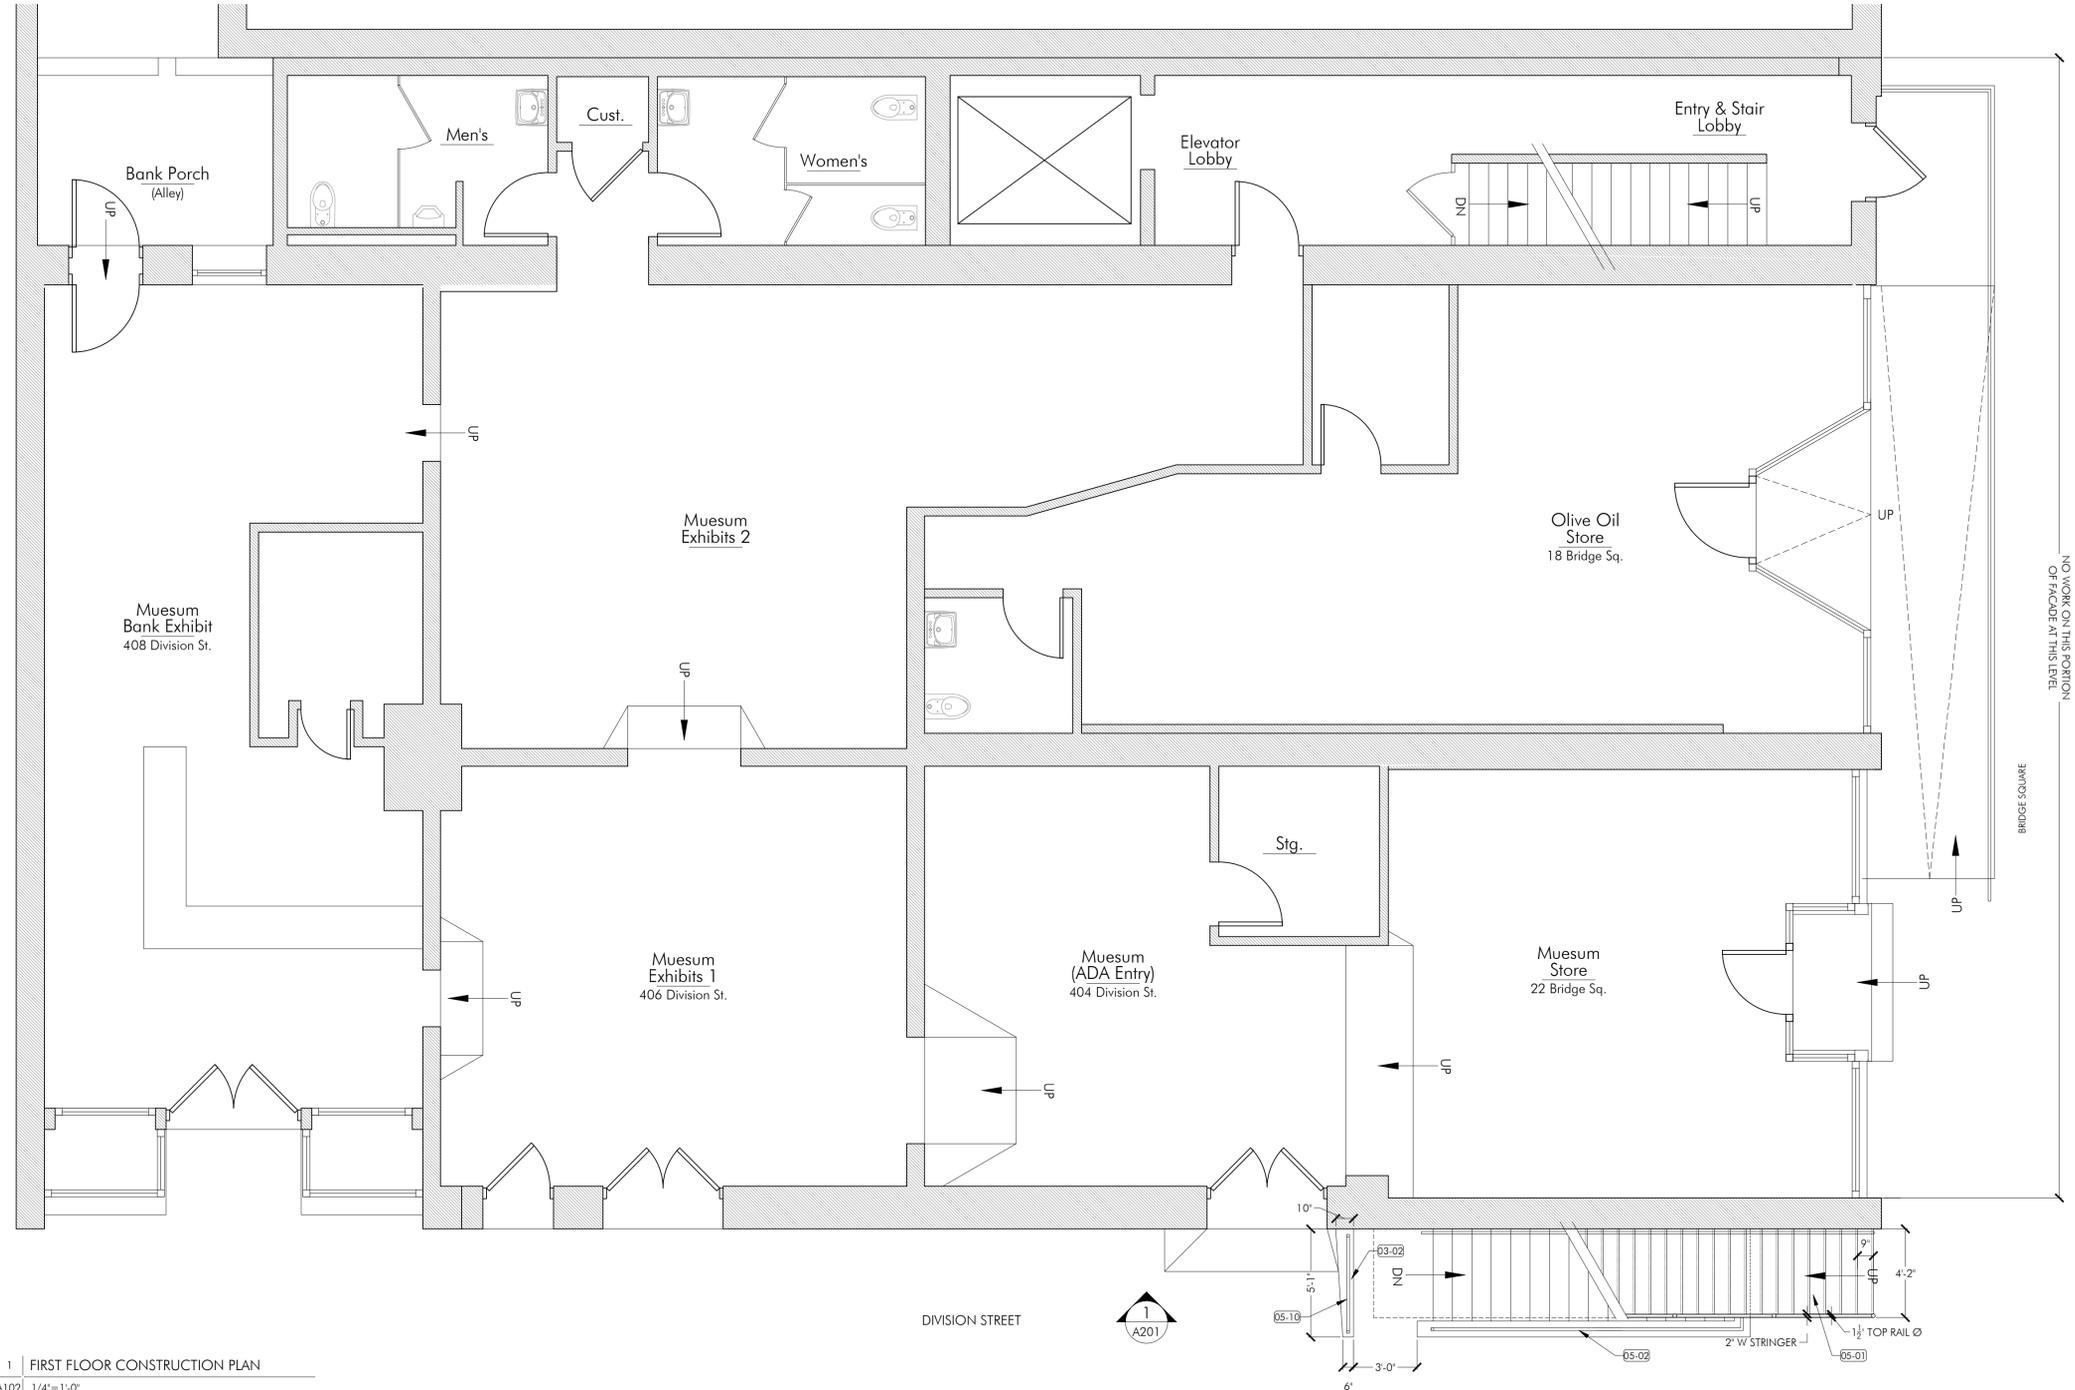
FIRST FLOOR
 CONSTRUCTION
 PLAN

- DIVISION 03 - CONCRETE**
 03-02 Provide new concrete curb.
- DIVISION 05 - METALS**
 05-01 Provide new metal staircase, guardrails, and handrail.
 05-02 Repaint salvaged basement handrail, reinstall.
 05-10 Install new metal guardrail, match existing.

NO WORK ON THIS PORTION OF FACADE AT THIS LEVEL.

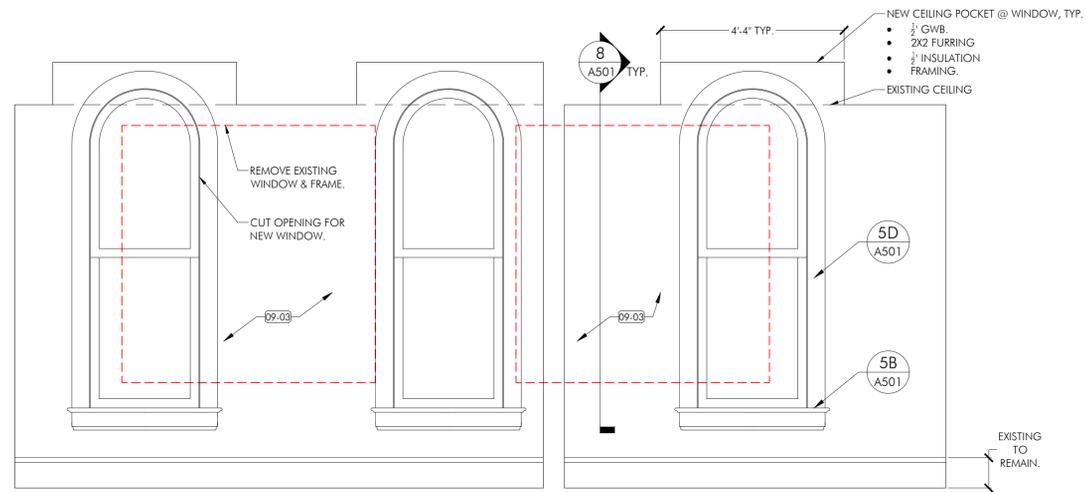
2 | TYPICAL INTERIOR ELEVATION 2ND FL WINDOW

09-03 Patch plaster wall at removed windows. Match existing.

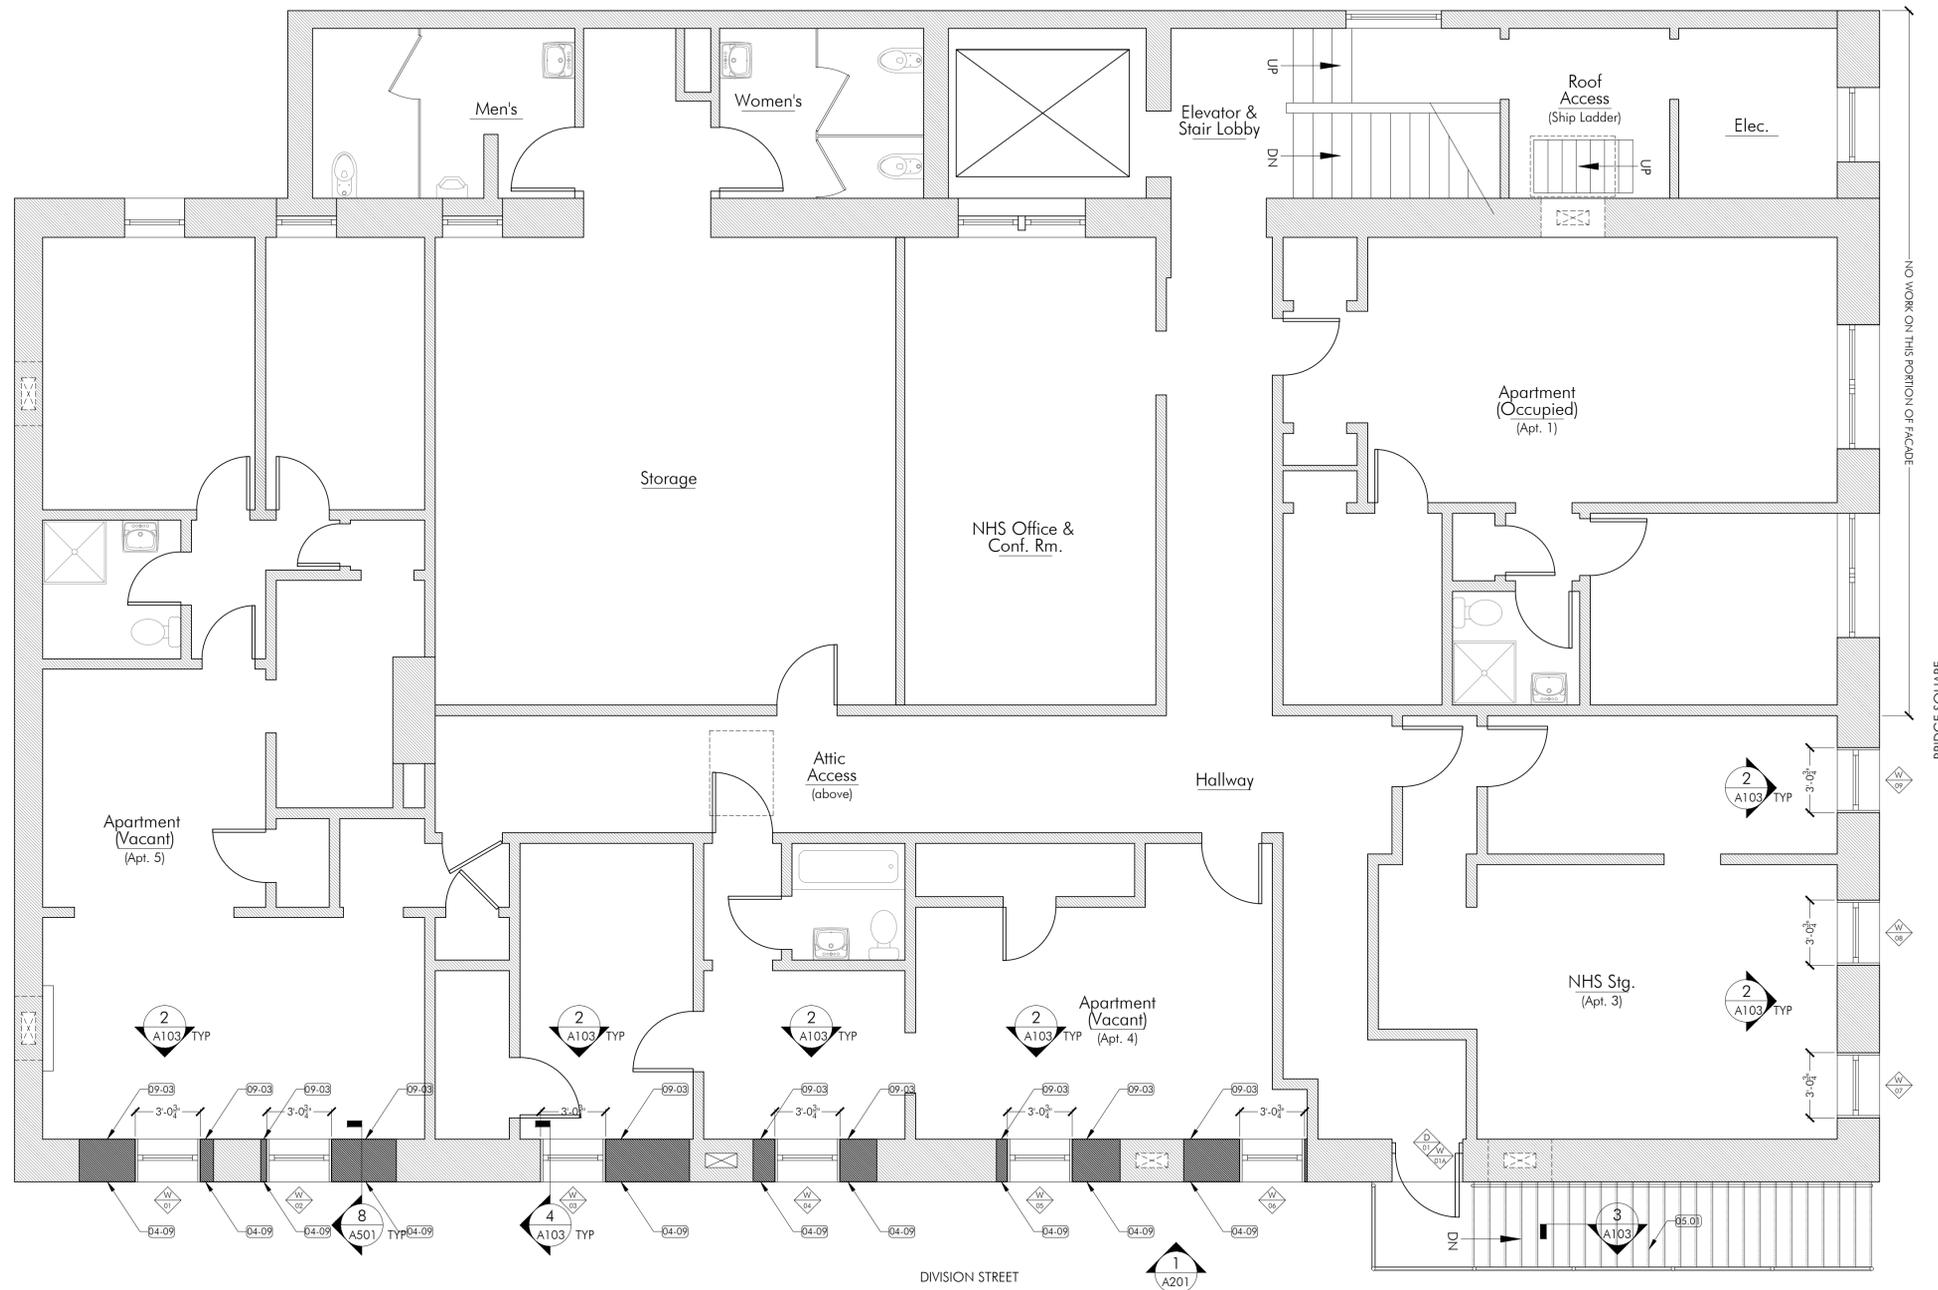
1 | SECOND FLOOR CONSTRUCTION PLAN

04-04 Repair remaining stone after plaster and brick veneer removal. Repoint stone as needed.
04-09 Install stone to match existing to infill at covered window.
