REPORT OF INSPECTION PROCEDURES AND RESULTS FOR
DETERMINING QUALIFICATIONS OF A
TAX INCREMENT FINANCING DISTRICT AS A REDEVELOPMENT DISTRICT

ARCHER HOUSE REDEVELOPMENT TIF DISTRICT
NORTHFIELD, MINNESOTA

March 2, 2021

Prepared by:
LHB, Inc.
701 Washington Avenue North, Suite 200
Minneapolis, Minnesota 55401

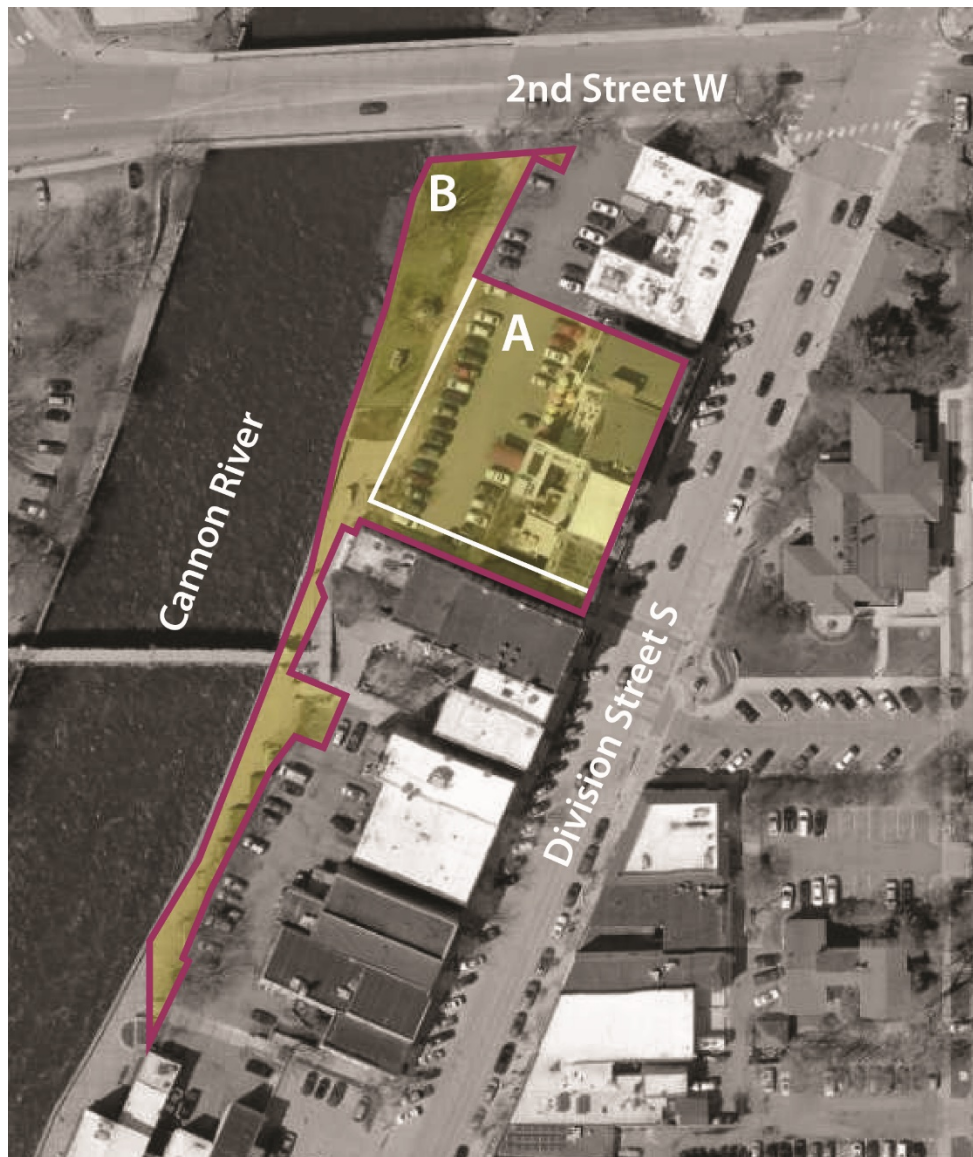
Diagram 1: Proposed TIF District

LHB was hired by the City of Northfield to inspect and evaluate the properties within a Tax Increment Financing Redevelopment District ("TIF District") proposed to be established by the City. The proposed TIF District is bounded by the Cannon River, 2nd Street West, and Division Street South (Diagram 1). The purpose of LHB's work is to determine whether the proposed TIF District meets the statutory requirements for coverage, and whether one (1) building on two (2) parcels, located within the proposed TIF District, meet the qualifications required for a Redevelopment District.

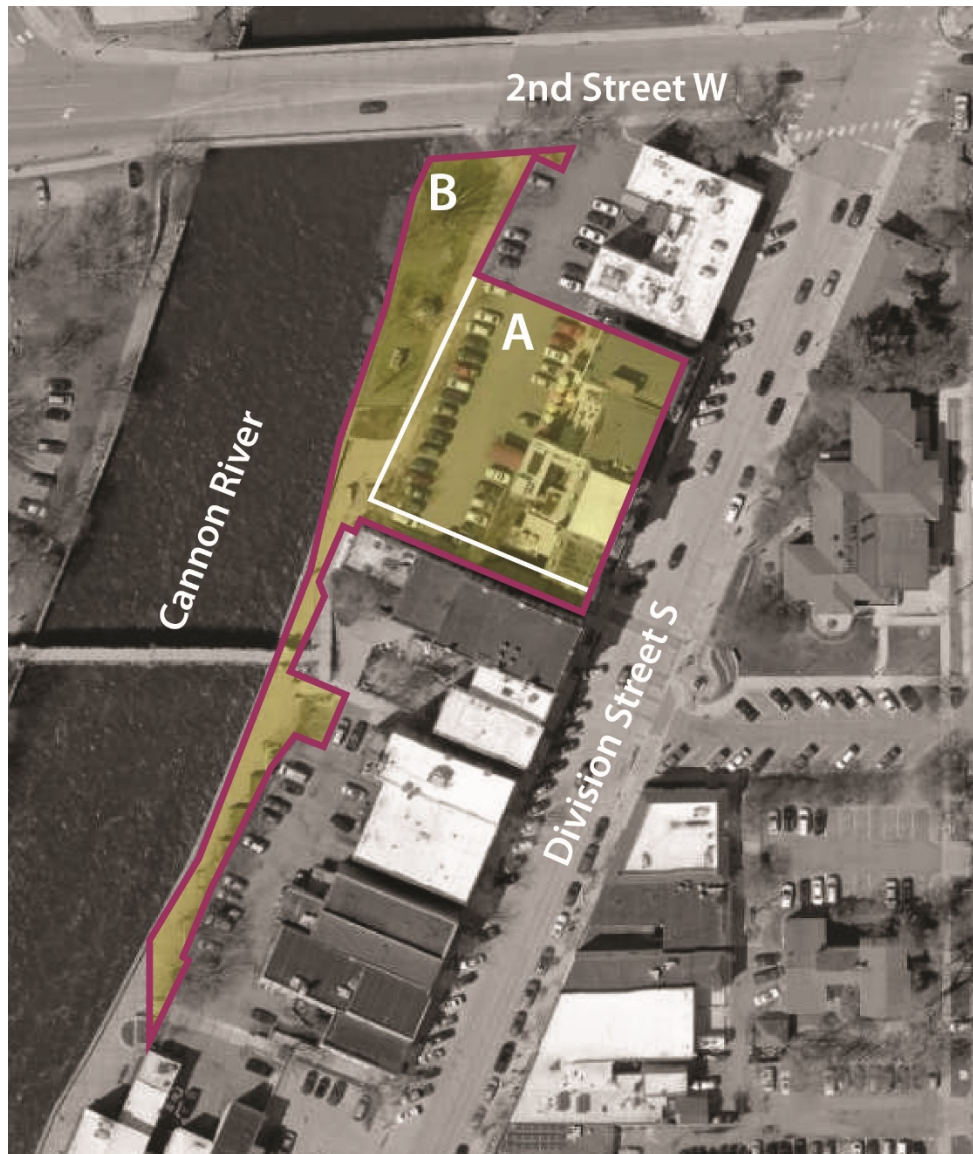
Diagram 2 – Coverage Diagram

The proposed TIF District met the coverage test under *Minnesota Statutes, Section 469.174, Subdivision 10(e)*, which resulted in parcels consisting of 100 percent of the area of the proposed TIF District being occupied by buildings, streets, utilities, paved or gravel parking lots, or other similar structures (Diagram 2). This exceeds the 70 percent area coverage requirement for the proposed TIF District under *Minnesota Statutes, Section 469.174, Subdivision (a) (1)*.

Shaded area depicts a parcel more than 15 percent occupied by buildings, streets, utilities, paved or gravel parking lots or other similar structures

- The proposed TIF District has a coverage calculation of 100 percent which is above the 70 percent requirement.
- 100 percent of the buildings are structurally substandard which is above the 50 percent requirement.
- The substandard buildings are reasonably distributed.

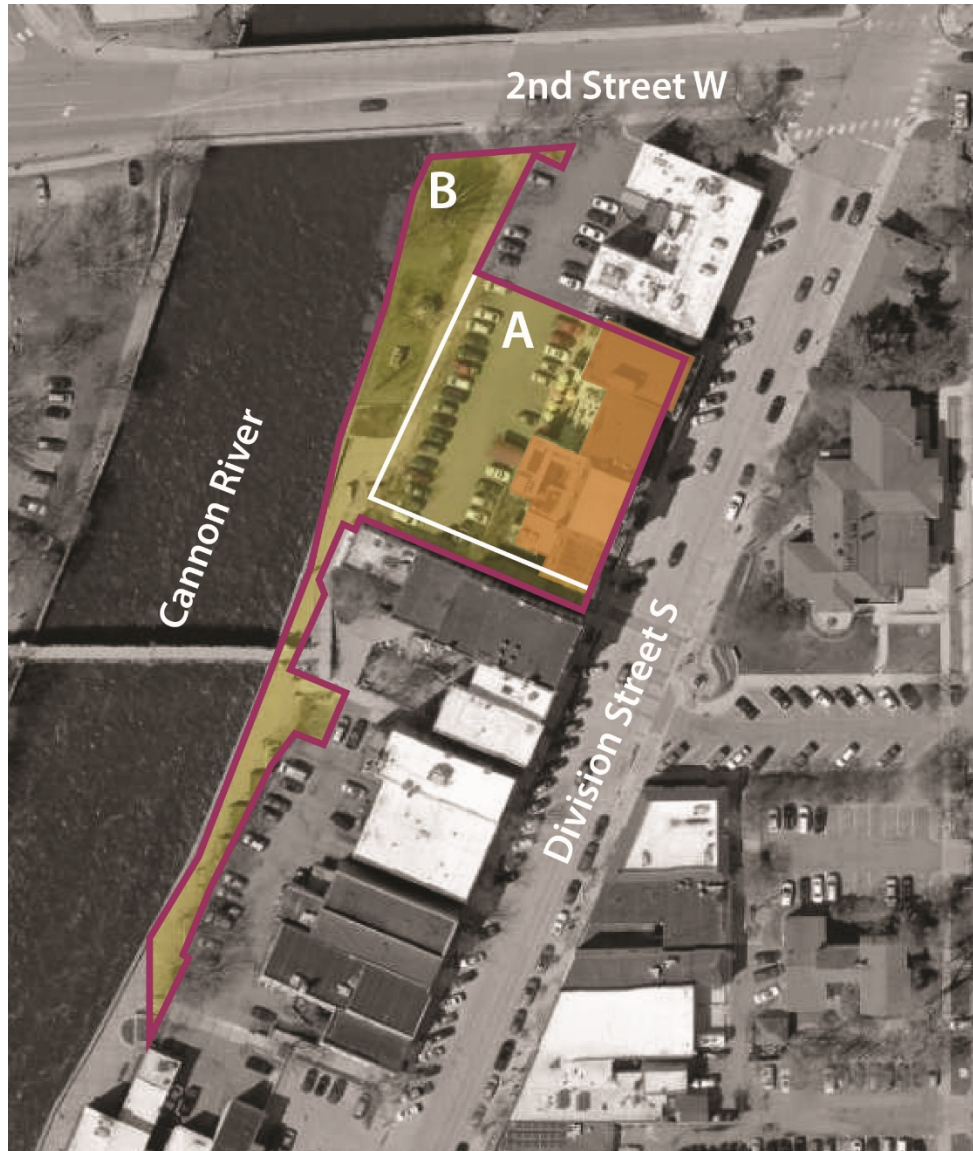
Diagram 3 – Substandard Buildings

The parcels with substandard buildings are reasonably distributed compared to all parcels that contain buildings.

Shaded green area depicts parcels with buildings.
Shaded orange area depicts substandard buildings.
