Summary of response of Save the Northfield Depot (STND) re: 2-14-23 Schematic Design of Pavilion and Transit Hub¹

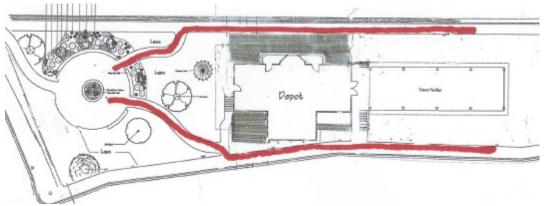
Concern was expressed at the Feb. 14th meeting about a scenario in which a person in a wheel chair in the depot garden would be disadvantaged and would be required to go around to the east (along 3rd St.) and then north along the N-S drive to the ramp. Thomas tried unsuccessfully to explain that the garden is in the middle of the south side with two sidewalks leading north out of the garden, one on the west side and one on the east side of equivalent distance to the proposed ramps on each side (see below). The 2-14-23 drawing that includes the ramp on the east side and would not disadvantage a disabled person in the garden area.

The plan includes a handicapped access on both sides of the pavilion which seems duplicative and also reduces space for amenities such as bike racks.
