MEMORANDUM

Subject: Woodley Street and Spring Creek Road
Traffic Safety and Warrant Analysis Update
City of Northfield, Minnesota
Project No.: 24X134891000

Appendix B – Sight Line Analysis

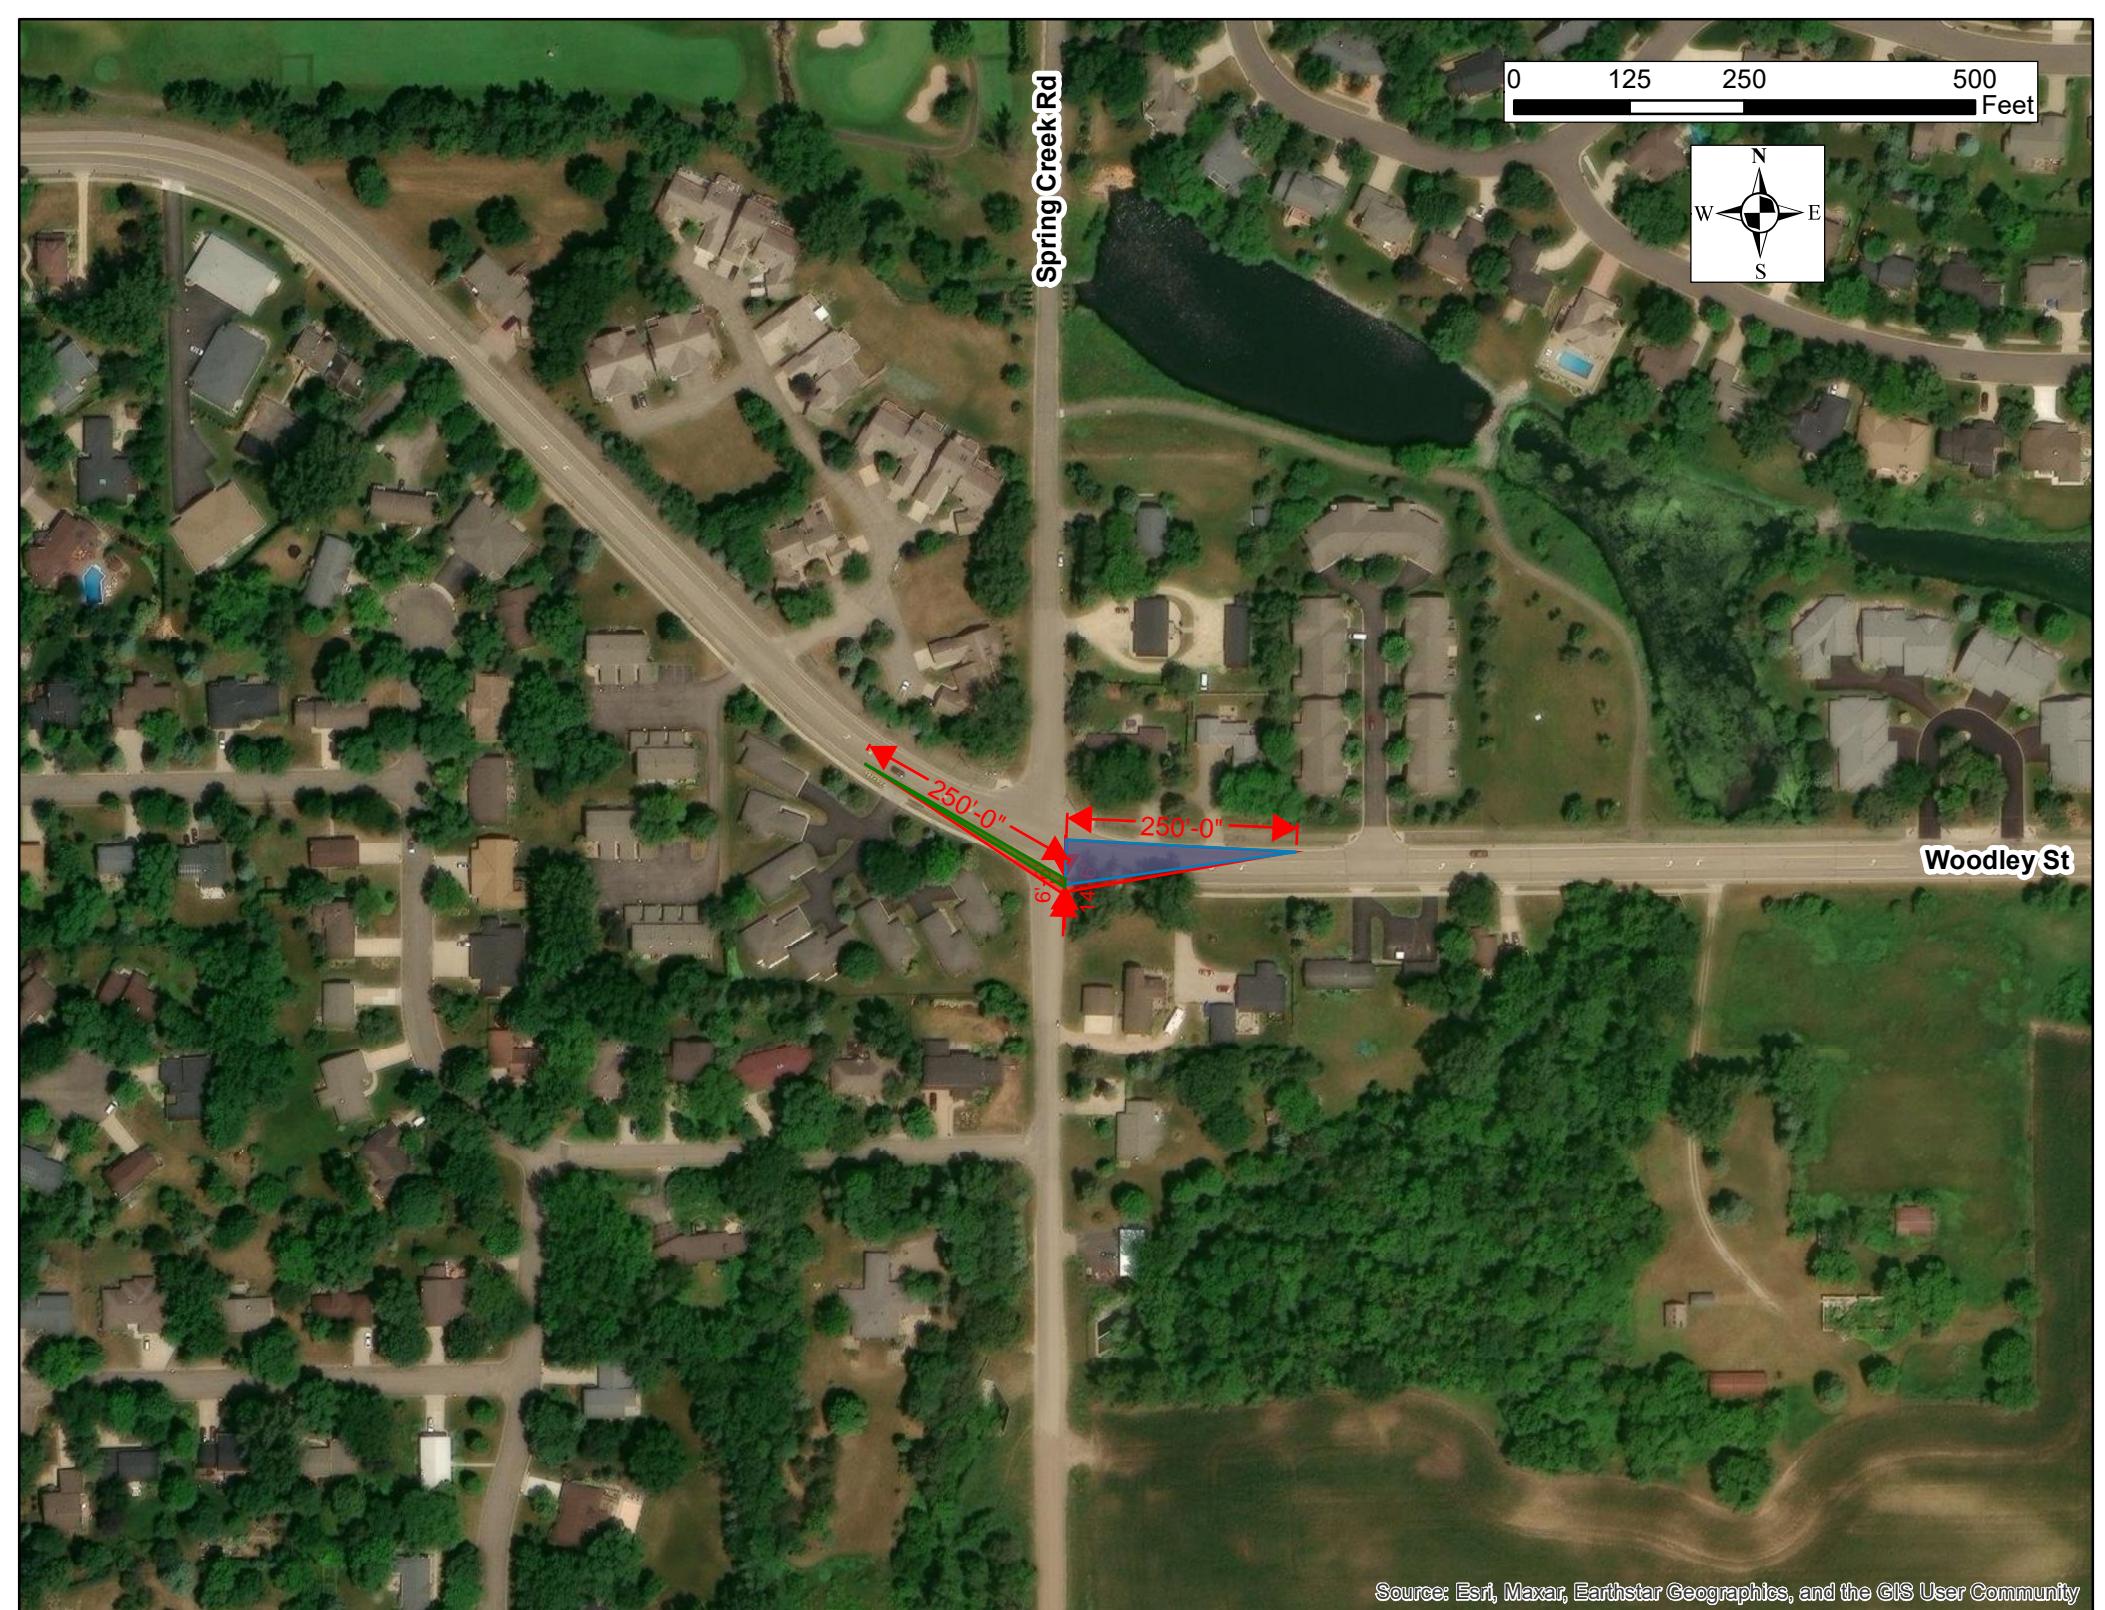
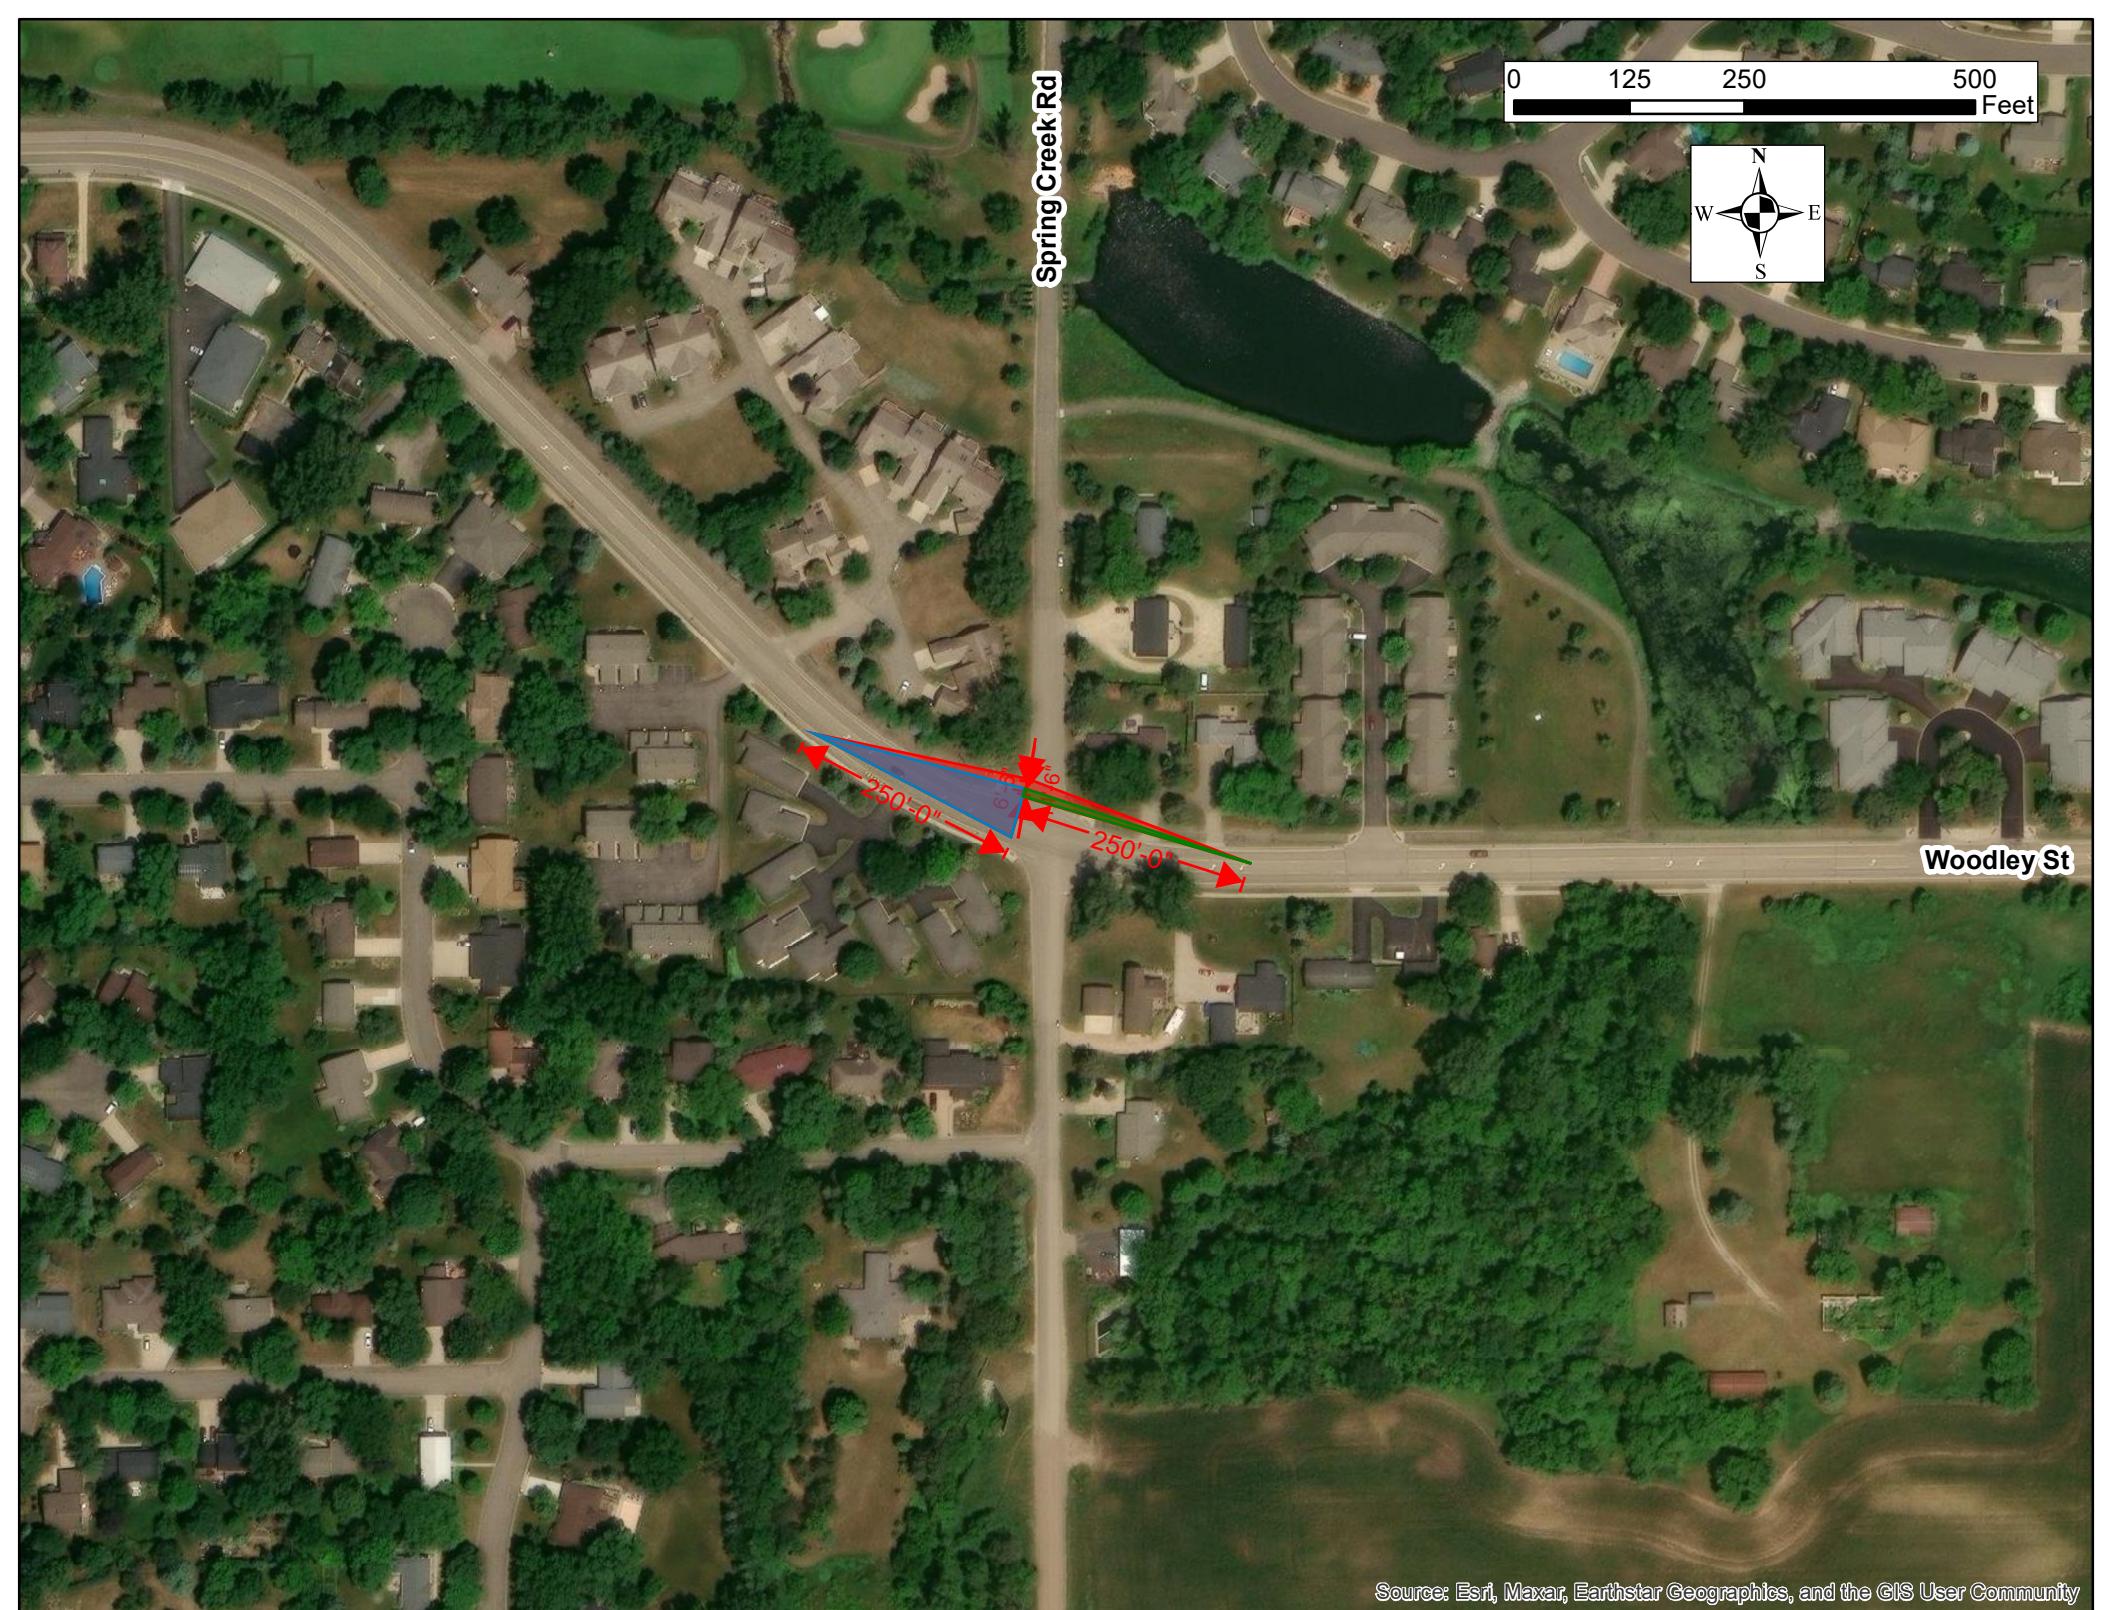
The sight line analysis for the intersection is attached in **Appendix B**.

The northbound approach has some minor sight line obstructions including trees and bushes on the SE corner under the conservative analysis but it is not considered to be a major concern since it can be remedied through the vehicle advancing forward of the stop sign but not impacting crossing traffic and the approach is on the outside of the curve.

Due to the roadway geometrics with the horizontal curve, power poles, utility boxes, and multiple bushes and trees on the NE and NW corners of the intersection, the southbound traffic from Spring Creek Road entering Woodley Street has poor sight lines where motorists cannot advance adequately to provide clear sight lines without impacting Woodley Street traffic. Assuming the driver's eye at 6.5 feet from the edge of Woodley Street would still have sight-line issues due to the curve (angle of driver's view), when looking west and east but is not considered to be a significant concern if the driver pulls ahead adequately. If higher speeds are experienced from the west, the sight line may end up being a concern.

To identify potential sight-line obstructions for vehicles and pedestrians making movements from stop-controlled approaches, intersection sight distance analysis was completed at the stop-controlled intersections following guidance in the *AASHTO Policy on Geometric Design of Highways and Streets*. This analysis evaluated departure distances for the north-south stop-controlled approaches to Woodley Street assuming side street stop control. Woodley Street was evaluated with the speed limit of 35 mph.

- **Conservative analysis** – this assumes that a driver's eye is 14.5 feet from the edge of the major road traveled way which would be typical for motorists that are stopped behind an adjacent sidewalk.
 - Analysis results for the conservative analysis are summarized in **Table 3**.
- **Typical driving behavior** – this assumes that a driver's eye is 6.5 feet from the edge of the major road traveled way (i.e. pulling closer to Woodley St to evaluate sight lines as allowed by state law).
 - Analysis results for the typical driving behavior analysis are summarized in **Table 4**.

While the roadway curve sightline impacts have not currently caused crashes, with an anticipated increase in volume on Spring Creek Road, this may be a concern. When warranted, changing the intersection control to all-way stop or roundabout control may be considered as traffic control options given the sight line issues at the intersection if they cannot be rectified through geometric improvements.

The intersection of Woodley Street and Spring Creek Road does not meet the criteria for All-Way Stop Warrants based on traffic volumes or crash history. Sight-line analysis identified sight line issues for vehicles, bicyclists, and pedestrians, almost exclusive from the north leg (southbound approach) due to vegetative obstructions at the intersection and the roadway curvature. The speed study shows that speeds near the intersection along Woodley Street is higher than the posted speed limit, increasing the crash risk and indicating that sight lines are even longer.
