AN ORDINANCE OF THE CITY OF NORTHFIELD, MINNESOTA DESIGNATING A HERITAGE PRESERVATION SITE

WHEREAS, the property proposed for heritage preservation site designation is known as the Chicago Milwaukee St. Paul & Pacific Railway Depot (Northfield Depot), located at 204 3rd Street W., and such location is depicted and legally described on Exhibit A, which is attached hereto and incorporated herein by reference; and

APPENDIX B
Archival and Current Exterior Photos

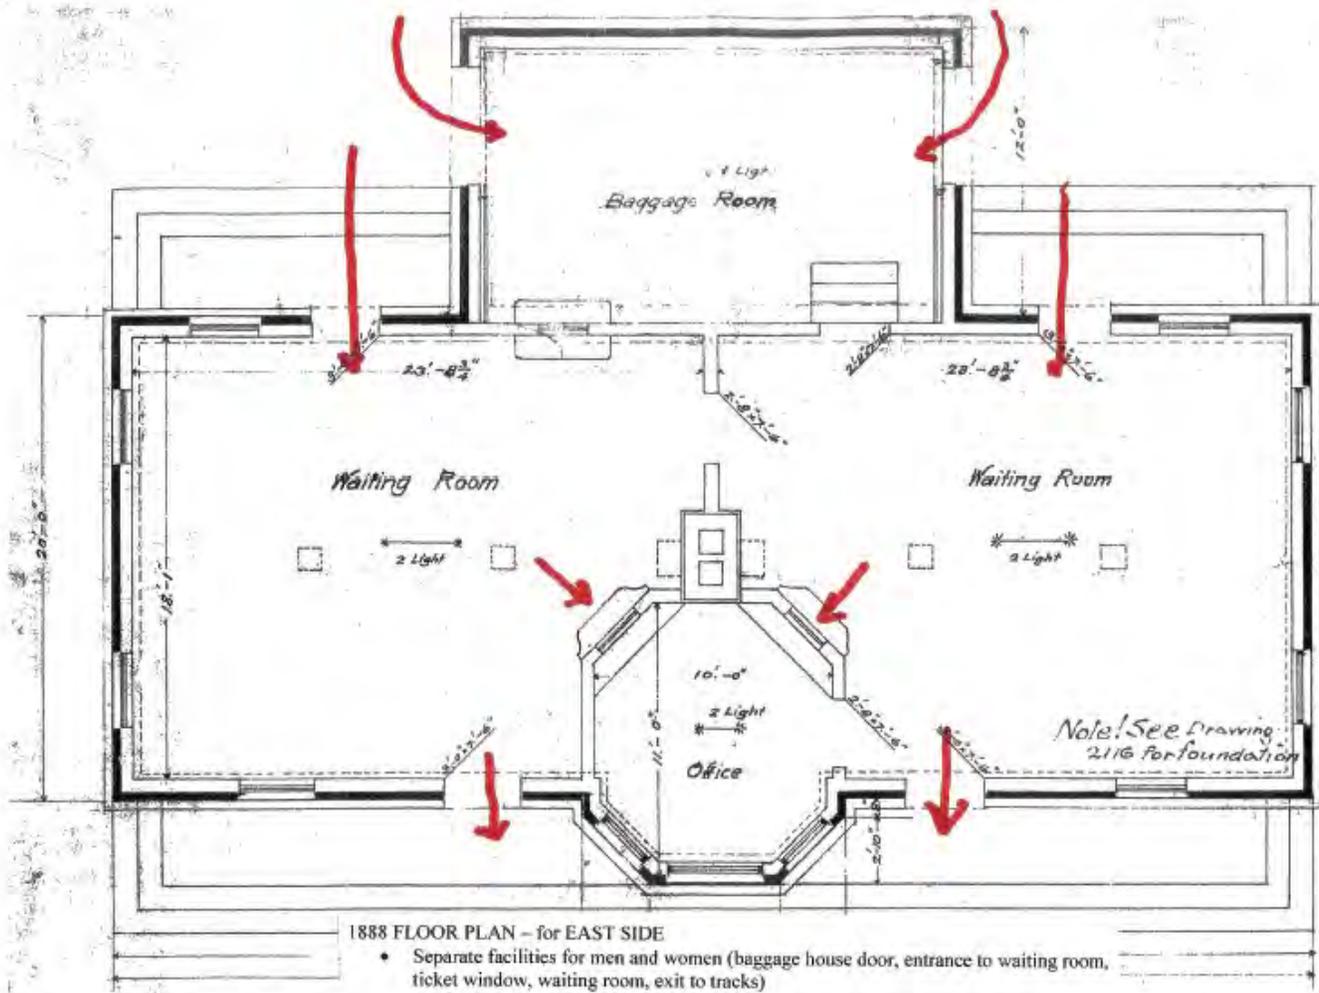
1888 Floor Plan (notes and arrows added to indicate separate facilities for women (on left) and men (on right))

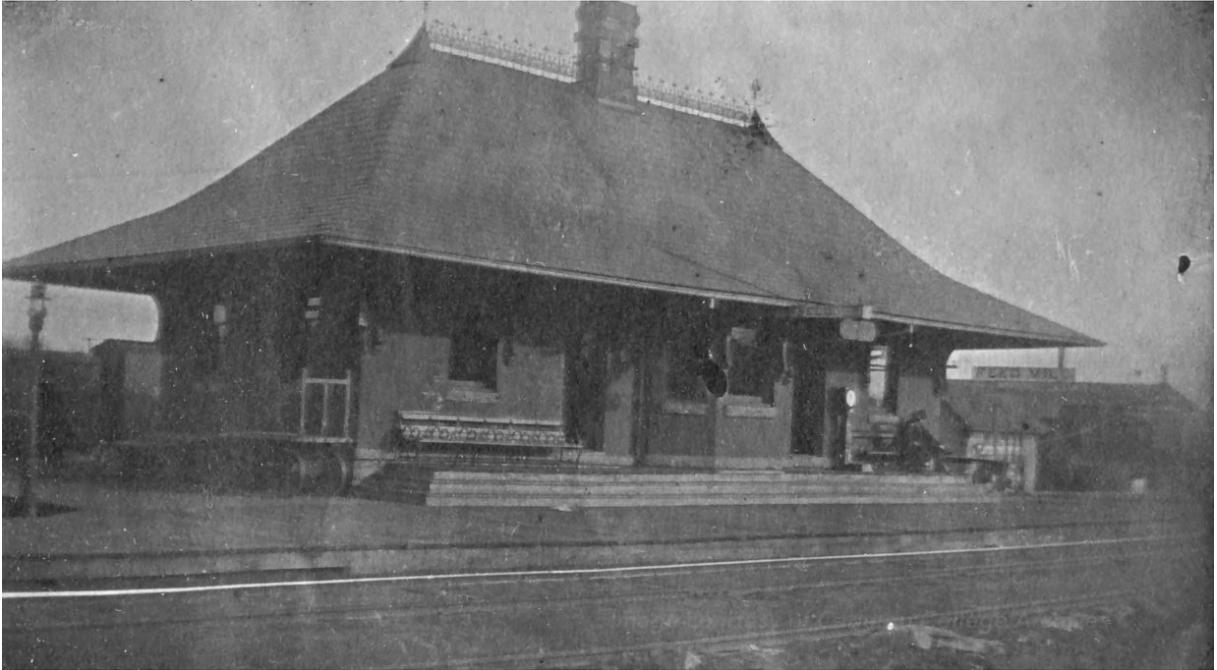
1896

Visible Features: Limestone foundation, water table, and window sill; steps spanning most of the wall; cottage style windows; large brackets; order board lamp signal; swooping, flared roof; roof cap, cresting and finials; detailed chimney.

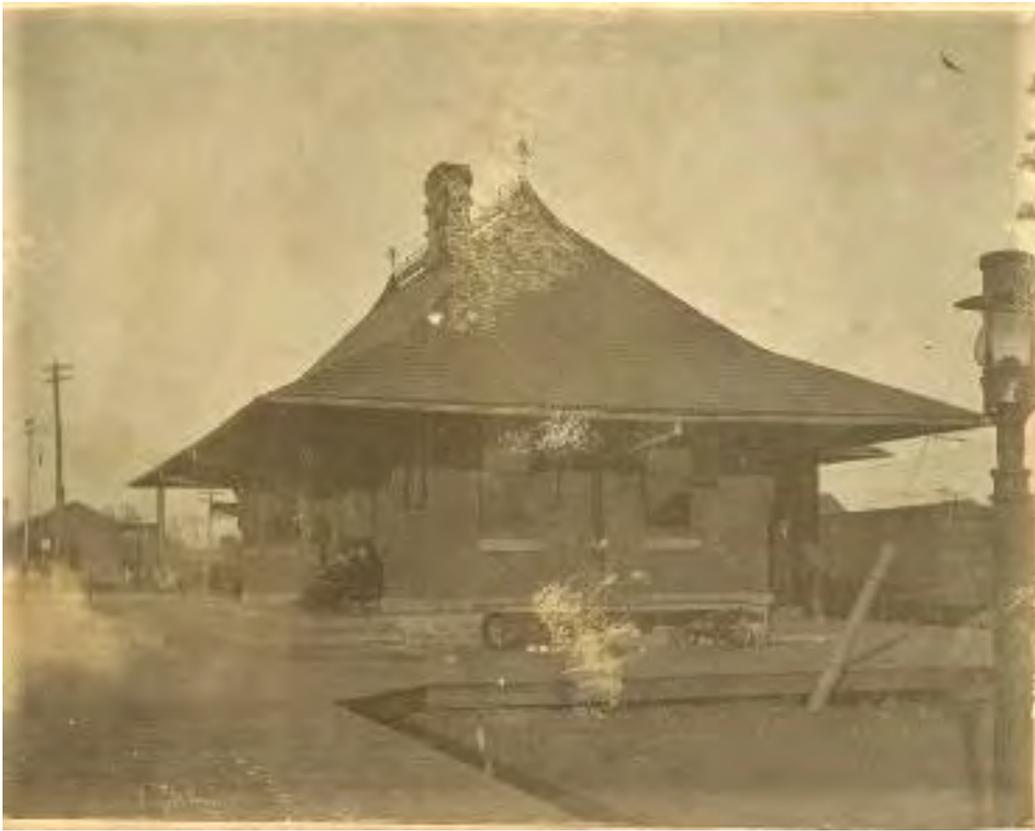
Before 1910

Visible Features: Limestone foundation, water table, and window sill; two windows in men's waiting room; swooping roof; roof cap and cresting; detailed chimney.

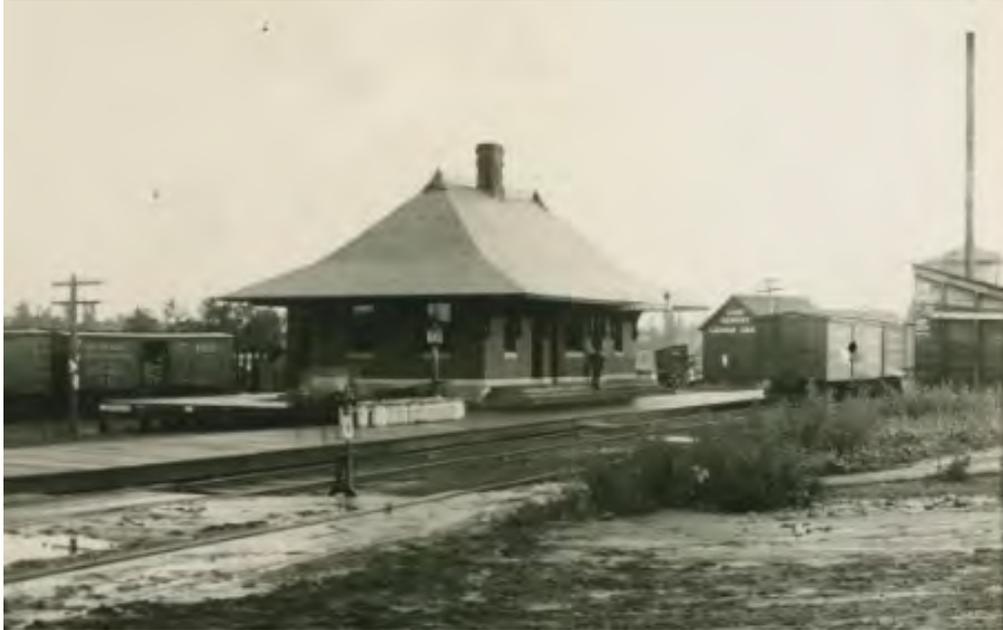
Before 1910

The above photo shows the depot west and north walls. It also shows the platform leading around to the east side baggage room door and the east side entrance to the main waiting room for women (see floor plan in Appendix A). The east wall would have included the platform on both the north end for women and on the south end for men. Photo also shows the outhouse for the depot (between depot and “*Lime, Cement, Lehigh Coal*” shed) used until the baggage room was converted in 1910 to two restrooms and a coal bin and boiler room.

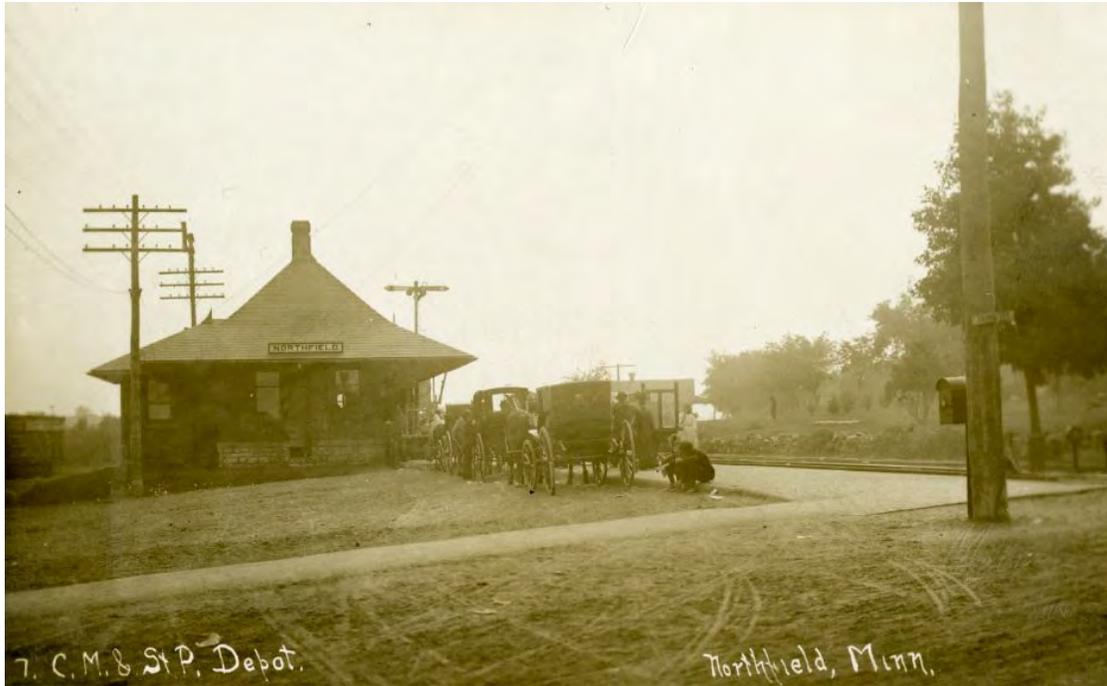
Before 1910

Visible Features: Limestone foundation, two windows in women's waiting room, swooping roof, roof cap on baggage room, Northfield sign, order blade signal, chimney (in center for heating stove in center serving both waiting rooms), baggage room door for women (far left).

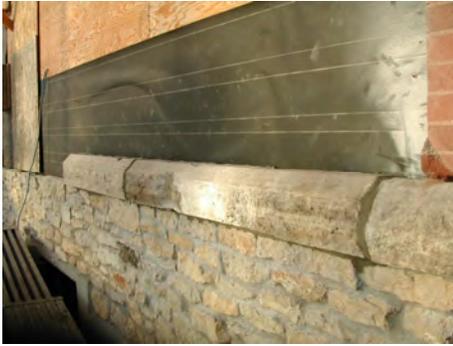
Original water table from baggage room bump-out added to new south wall.

To provide matching stone for the depot main room, those pieces were then used for the missing water table on the main building that had been removed in 1944, chiefly the south wall, and original bay area. Recycled, similar stone water table was then purchased for the baggage room bump-out. Thus, all sides of the main part of the building currently have the original stone water table, and the baggage room bump-out has the similar newly purchased recycled water table stone.

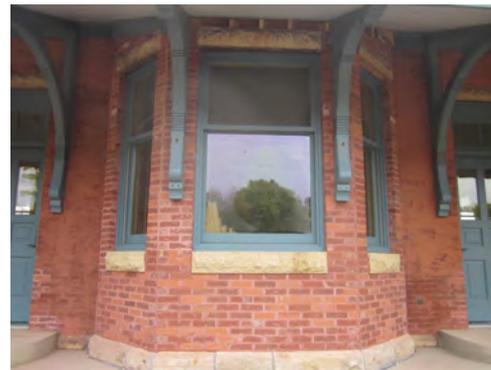
2019 Reconstructed station master bay

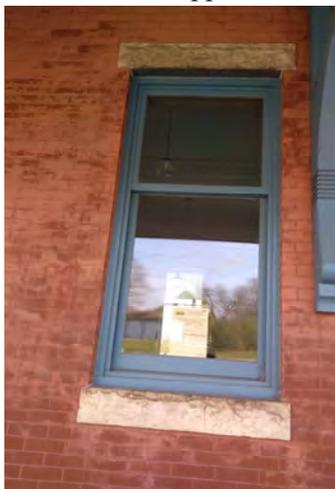
Original lintel and sill

All door lintels are the original rock-faced limestone lintels; the lintel above the 1944 picture window (now the double doorway) on the north side was likely created from the lintels of the two windows that were replaced by the picture window in 1944. That picture window lintel remains in place for the new handicapped accessible double door.

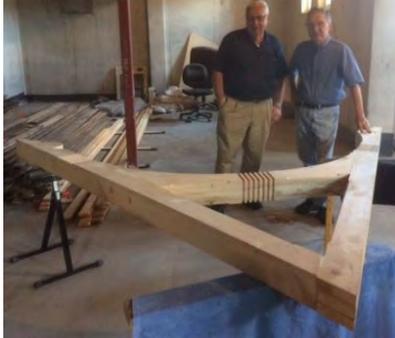
2014 Three-piece brackets crafted and assembled.

Brackets: All of the twelve large brackets on the west, north and east sides are original. Replacements for the eight large brackets and two smaller brackets removed in the 1944 work were crafted using the same type of wood as the original; clear pine from northern WI was harvested for this project and dried for a year. The craftsmen replicated the original three-piece bracket design and assembly using the same mortise and tenon technique. Some of the interior wall was opened temporarily to determine the technique used to anchor the brackets.

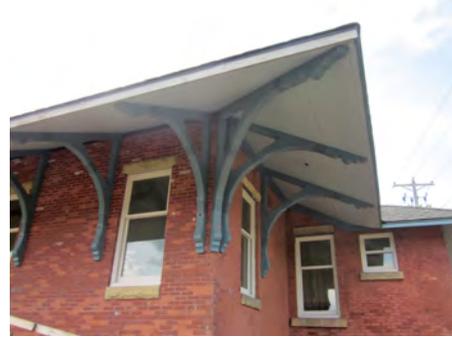
2019 Four new brackets on south(left) and two original on east (right).

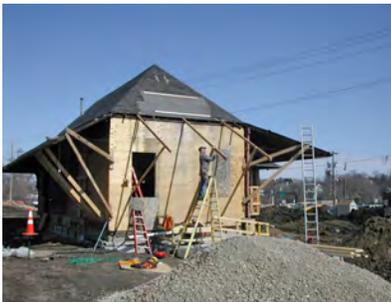
2016 South reconstructed wall

Soffit: On the west, north and east sides, all of the soffit v-board is original with only a few small repairs. In the 1944 work, the soffit was not removed above the station master bay or the southwest corner. For the missing roof on the south wall, new v-board was milled to match the width of the original soffit.

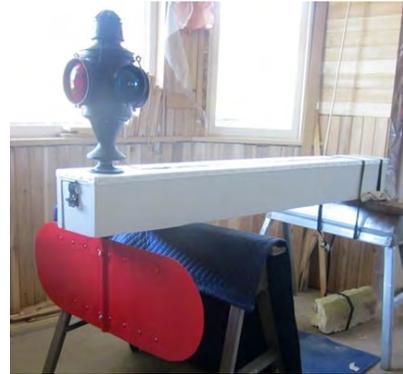
2019 Repaired (not yet mounted)

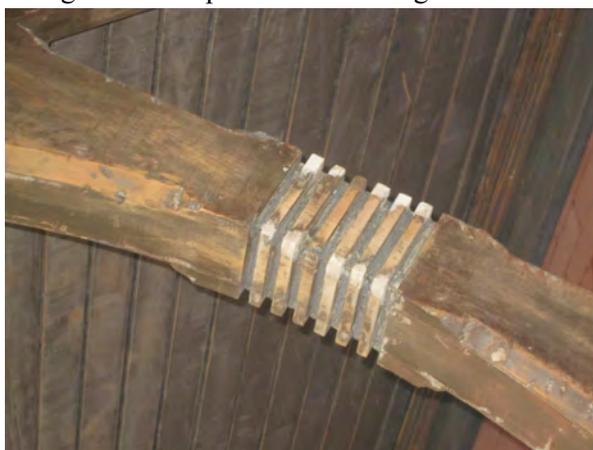
Repair: Some corners of bracket slots were missing, but repaired. Nail holes were filled. Wood in excellent condition.

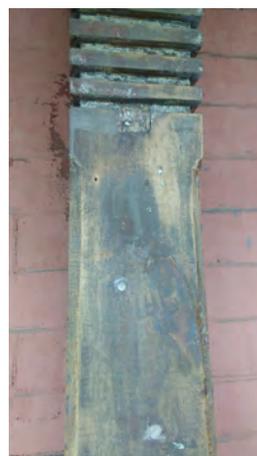
Removal of paint revealed original color.

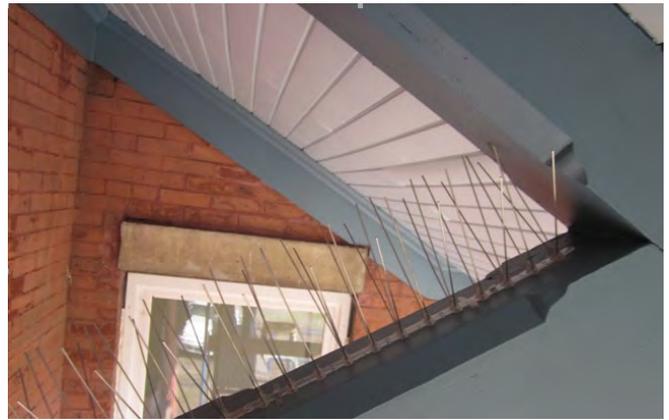
All old paint removed from original soffit v-board; painted with a very light shade of the gray-blue found under light mounting.

The soffits contained very little paint that remained in the form of dirty chips; the color could not be identified. However, when the remaining light fixtures were removed, a layer of a single color of paint was beneath that was a very light shade of the gray-blue of the brackets and other trim. Again, paint chips were brought to the depot and a matching color was selected for the soffit.

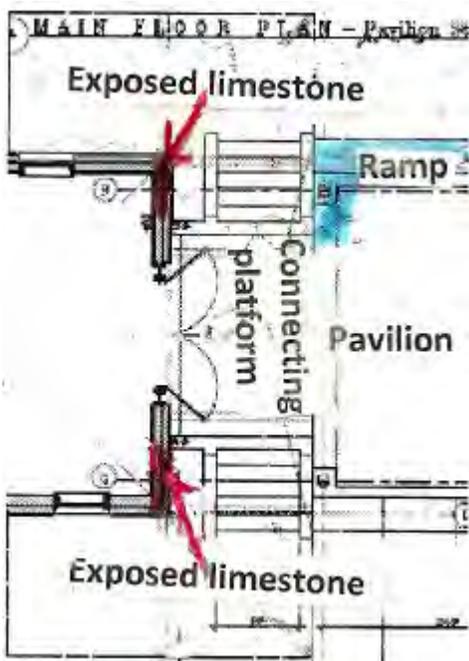
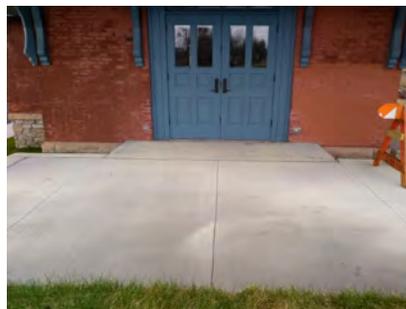
Connecting platform between depot double door and pavilion. Future ramp will be on the west edge of the pavilion (track side to the right). Top of water table visible in gap between platform and wall.

As shown below, the door entrance is level with the depot platform that will be contiguous with the pavilion floor (see site plans below). The depot and the new pavilion, a separate structure and City project, will be connected only by the platform. The ramp will start near the transit hub and run south on the track side of the pavilion providing access to both the pavilion and the depot. That ramp placement allows minimal intrusion on the depot building. As shown below, the stairs on both sides are significantly distanced from the foundation; the only portion of the north foundation that is covered is the area immediately outside the doorway.

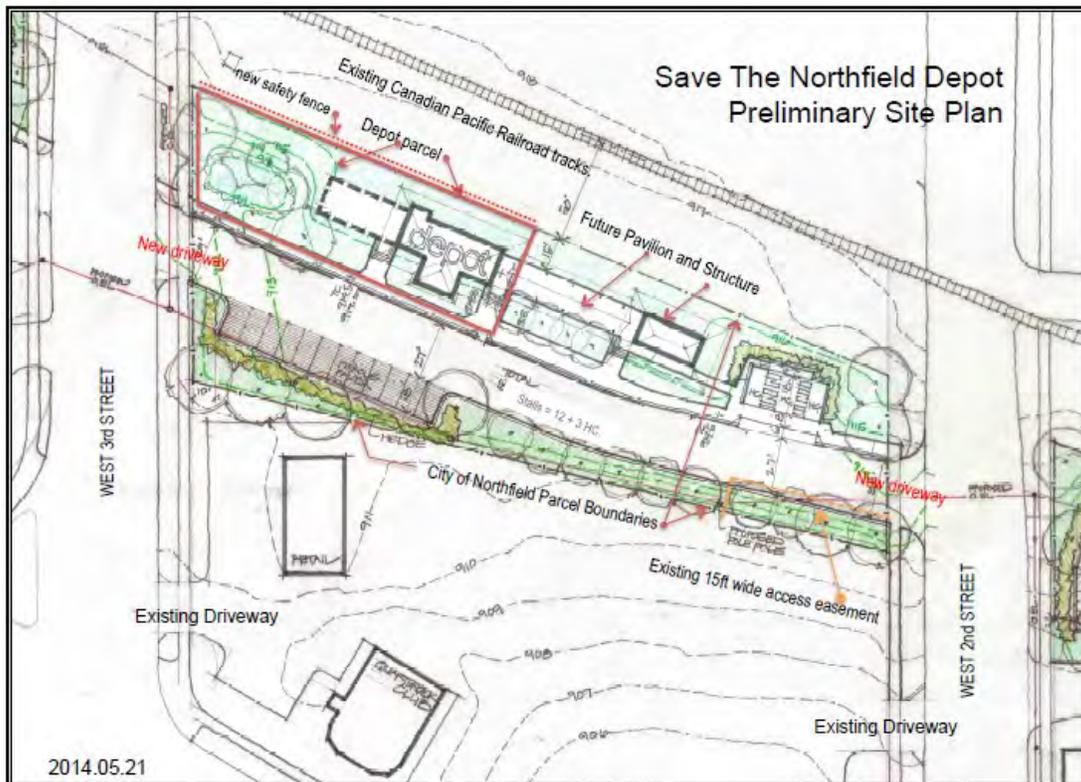
2014 Site Plan for New Location: Future Transportation Center

Note: The City of Northfield plans to build the pavilion and transit hub using this plan. The state bonding bill passed in November included this Northfield Regional Transit Hub.

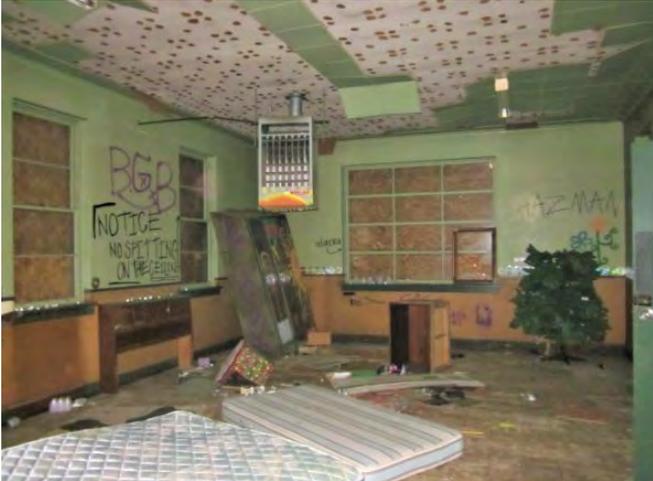
2016: Reflects 1944 changes: Ceiling lowered 2 ft.; acoustical tile used. Note also, all woodwork removed; 1” of plaster added over wood walls; windows replaced; concrete & tile added on top of wood floor.

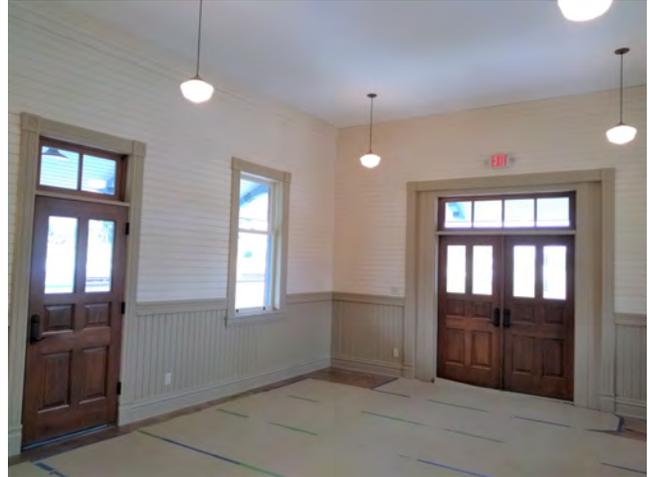
2018: Ceiling raised 2’ to original position on original rafters.

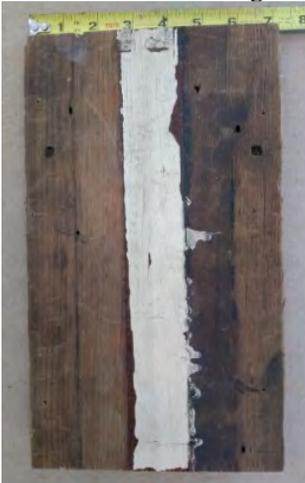
2016: Crown moulding component found in attic

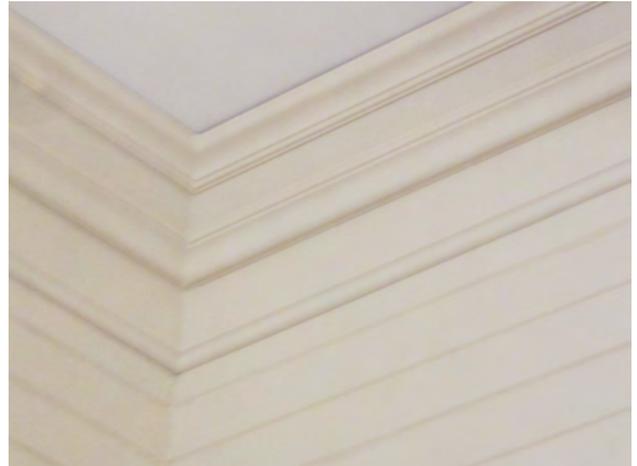
2019: New crown moulding using of same dimensions of original.

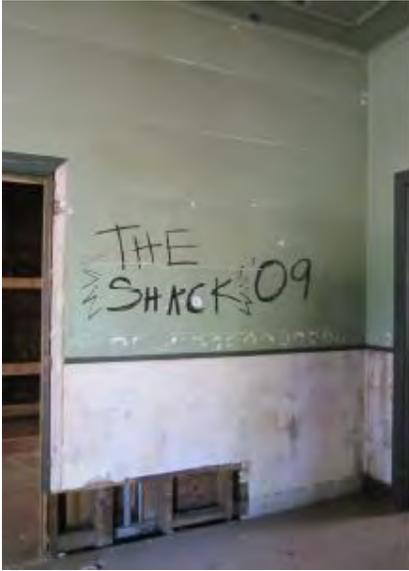
2016 (after move)

Left photo: Regularly spaced horizontal cracks appeared on the walls after the move – an indication that it was not likely to be lathe beneath.

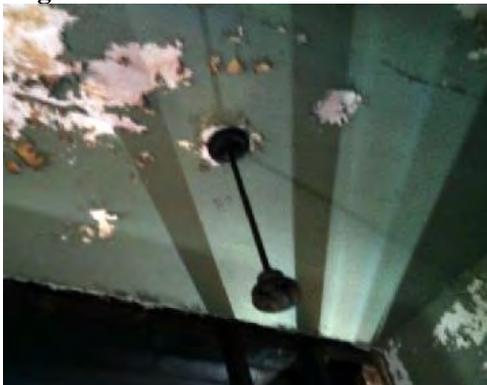
One pendant light fixture was found in the original ceiling of the baggage room area. The ceiling had never been removed and lowered, in contrast to the main room.

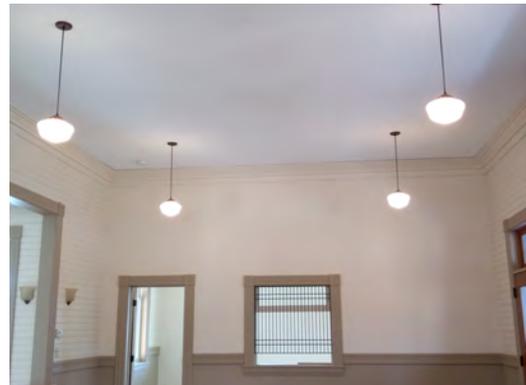
Recycled pendant light fixtures with school house style globes were installed in the main rooms and office area.

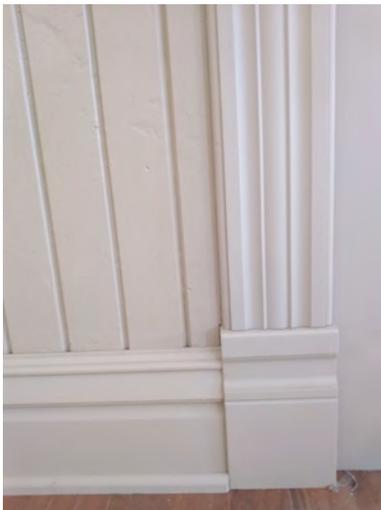
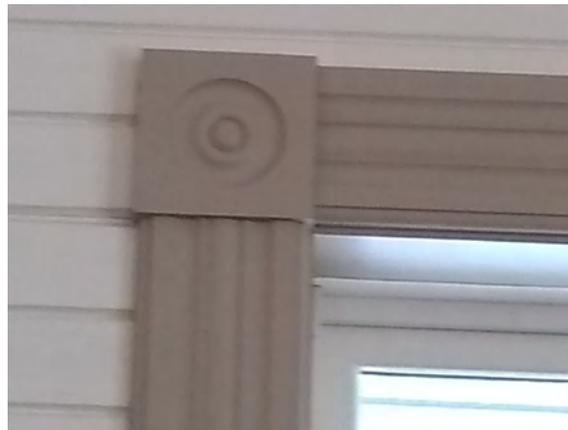
Above photos include original v-board, window and door casing, milled plinths and baseboard, and the newly crafted rosettes. Some of the elements were hand crafted because of the width needed for the casing. Fortunately, symmetrical casing of the width needed was available for purchase and being discontinued, and there was enough for the depot work. The width of all elements was consistent with the width of the shadows of the original.

As noted above, the plinths and baseboard were newly milled. All baseboards were removed in 1944; the original height was determined by the shadow on the unpainted v-board above the concrete floor. About 1 1/2" was added to that shadow measurement since the 1" concrete had been laid on top of the original wood flooring and the new wood flooring was about one-half inch on top of the concrete (see milled plinth and baseboard photo above).

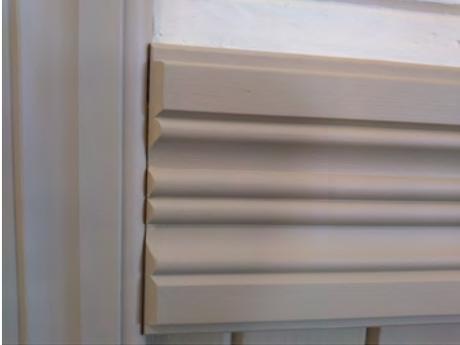
The wainscoting trim was milled to the width of the unpainted shadow found on the v-board wall. The profile used is very similar to that of the pieces of original casing found in the attic.

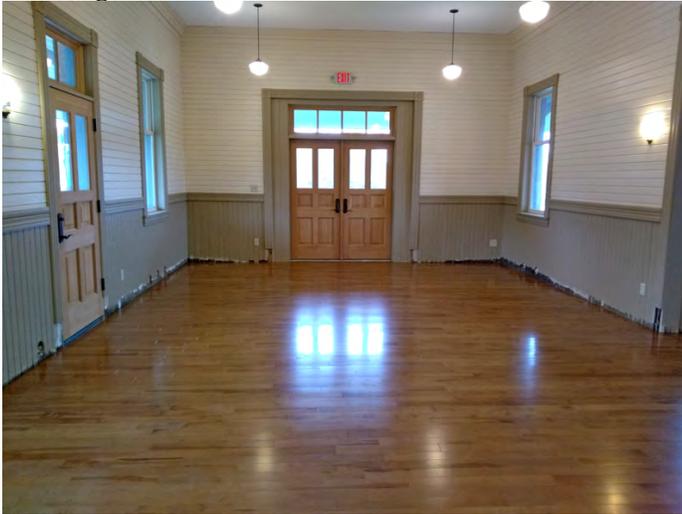
The 1888 maple flooring was covered with concrete and rubber tile in the 1944 remodeling. That work included the removal of the dividing walls around which the original flooring had likely been laid.

In the 2019 renovation, small areas of wood on the edge of the concrete was exposed and determined to be maple. Manufactured maple flooring was then installed on the stable concrete running the same direction. Doors were stained to match.

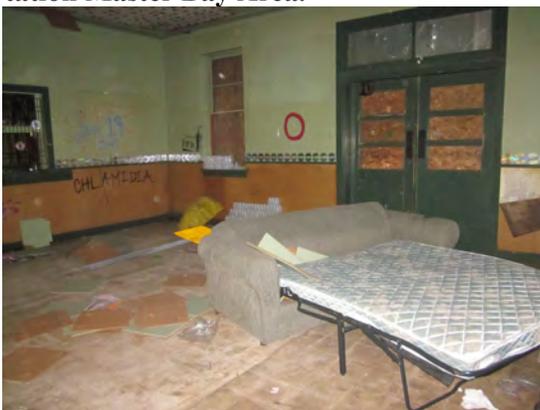
2016. 1944 remodeling converted a door into the window (left); removed the station master bay and replaced with a double door.

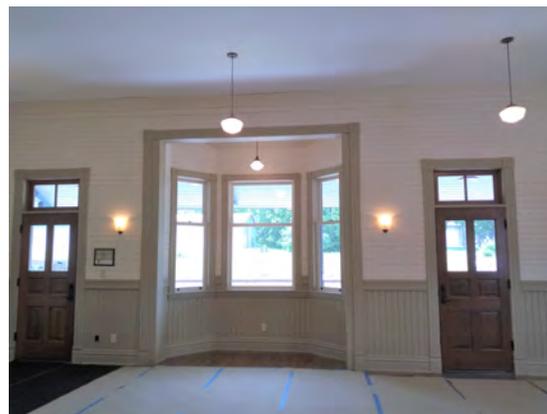
2019. Turned the two 1944 windows back into doors as in 1888; restored the 1888 station master bay and installed cottage windows.

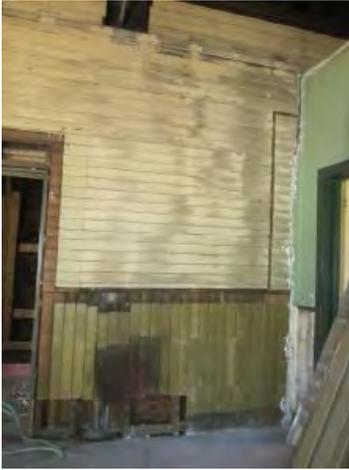
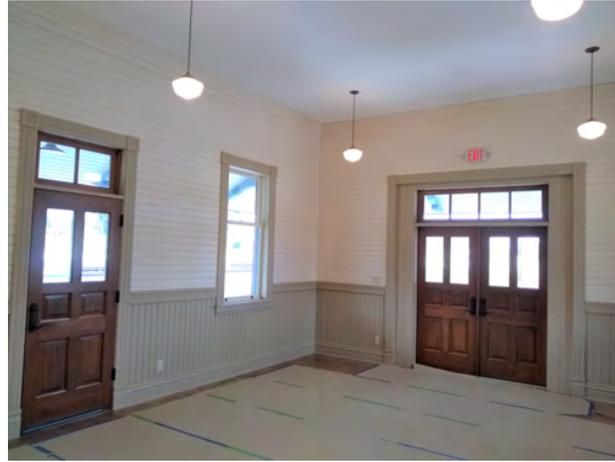
Evidence of the colors used in the interior were gathered from the original existing v-boards (chipped paint and nail holes from the plaster board) and pieces of the casing found in the attic.

1888. The first coat of finish on the v-board and the casing found in the attic indicated a varnished surface, similar in color to the finish used on the 2019 newly installed doors and flooring. Within the picture frame below (added in 2018 to preserve signature), the original v-board with cream paint can be seen. The signature area in the center is darker because it was not scrubbed. The dark spots of varnish are visible where the paint chipped off.

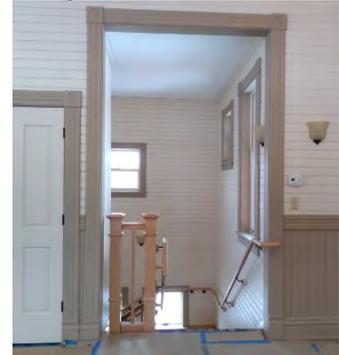
The area on the south (right) was opened for a stairway to the basement. V-board was custom crafted for stairway walls. Much of the original had been badly damaged by a fire in the boiler room. Several of the studs and rafters in the stairway south wall were sistered due to fire damaged areas.
